This is the 1st Affidavit of Noor Mann
in this case and was made on February 27, 2025

Building Assessment Report

**3335-3345 Sexsmith Rd.
Kelowna, BC**

October, 2024

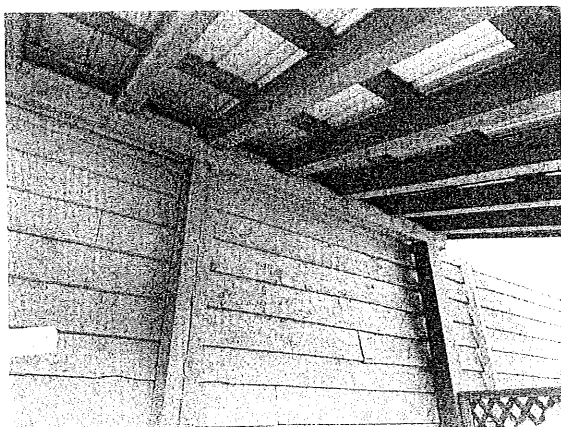
Wood structure not adequately secured to building

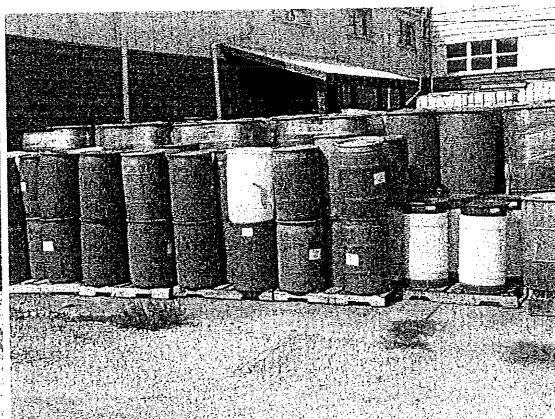
Site debris/ materials may contain hazardous materials

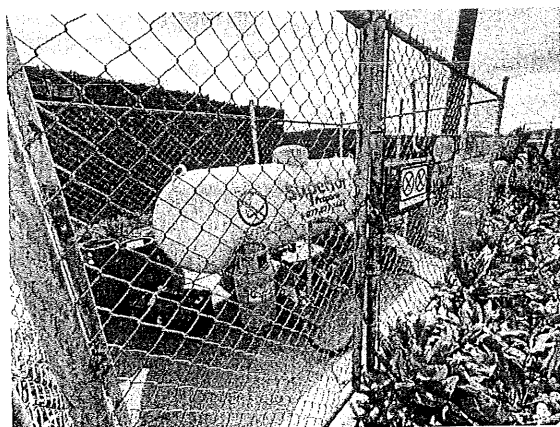
Site containers may contain hazardous materials

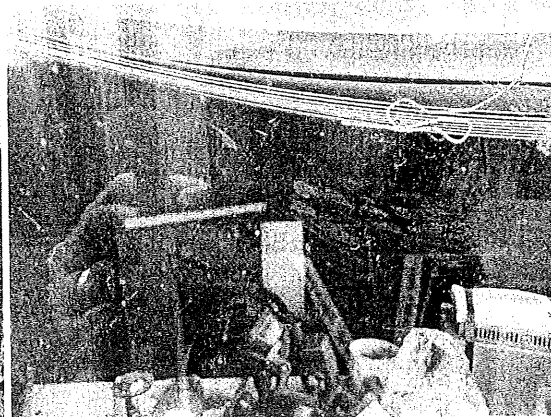
Old damaged storage shed

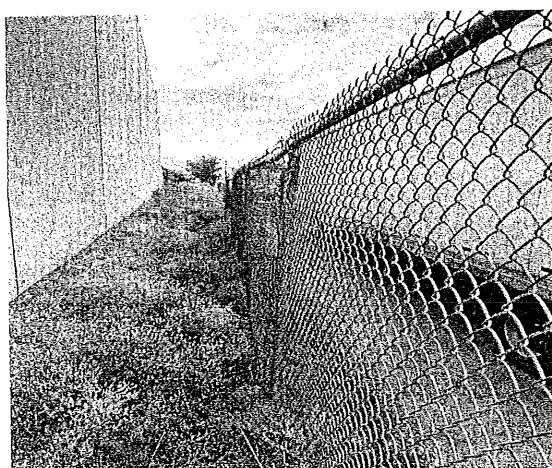
Possible hydrocarbon spills noted

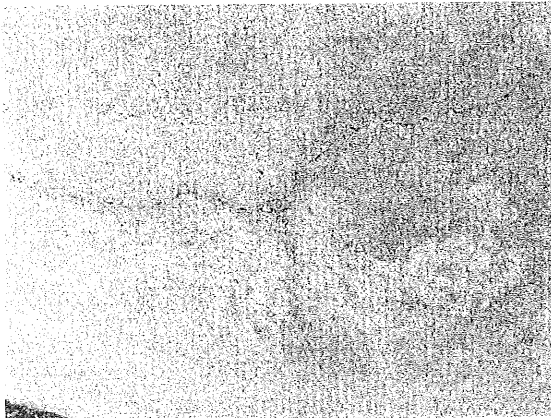
- 5.2.8 The exterior concrete tilt up panels exhibit a significant amount of shrink and movement cracking and failed joints. This has caused water/air/insect ingress and damage to the interior exposed insulation surfaces. These joints require full renewal and the interior insulation repaired promptly.

Significant joint/ sealant failure at tilt up panel connection

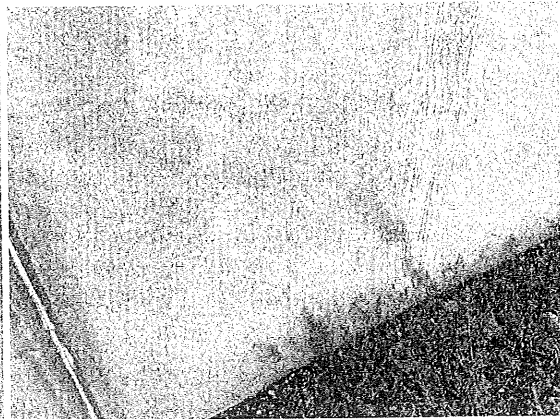
- 5.2.4 There are significant and many tight cracks in the tilt up panels that suggests further evaluation and possible structural and surface sealing repairs be undertaken prior to closing.

Visible cracking in tilt up panel

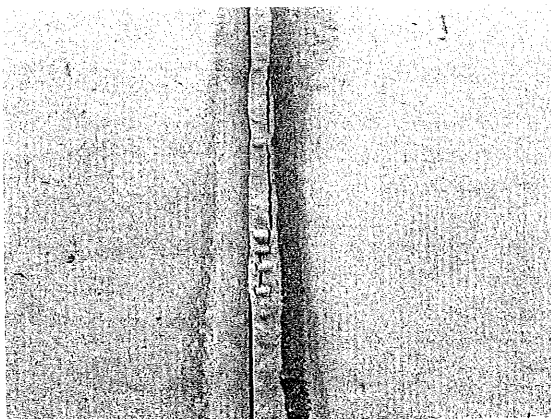
Visible corner cracking in tilt up panel.

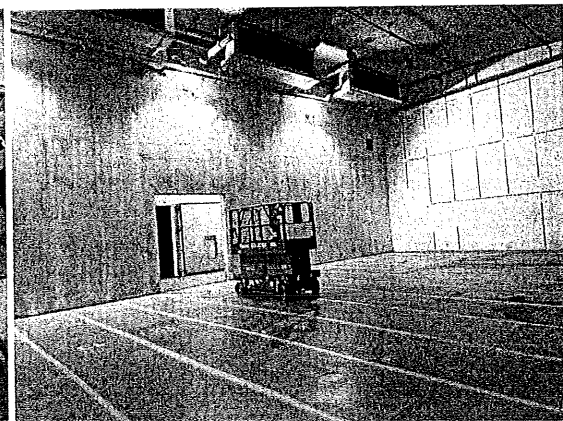
Non-standard guard openings and open structures

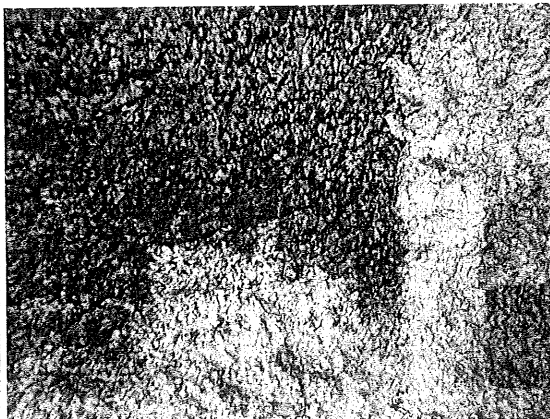
Possible rodent impact CA room walls

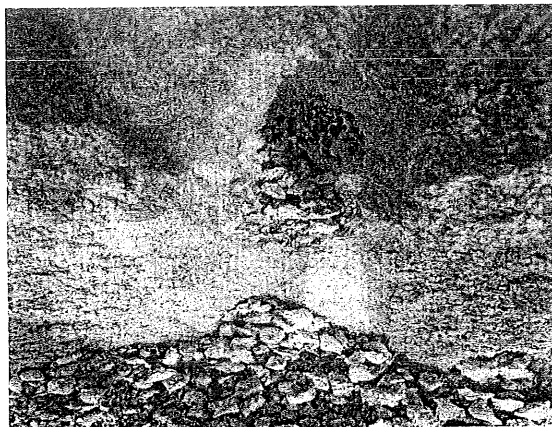
Possible moulds/ chemical stains in CA room walls

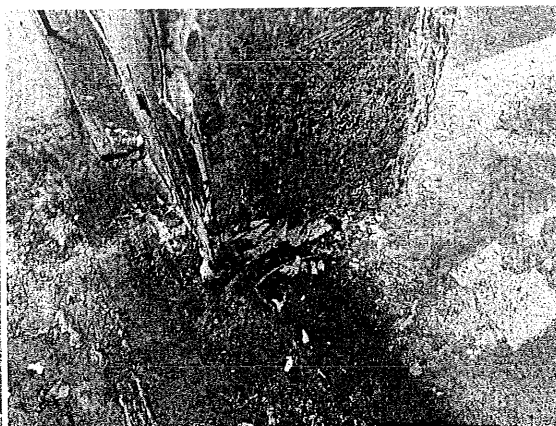
Poor quality repair with foam did not last. Repair

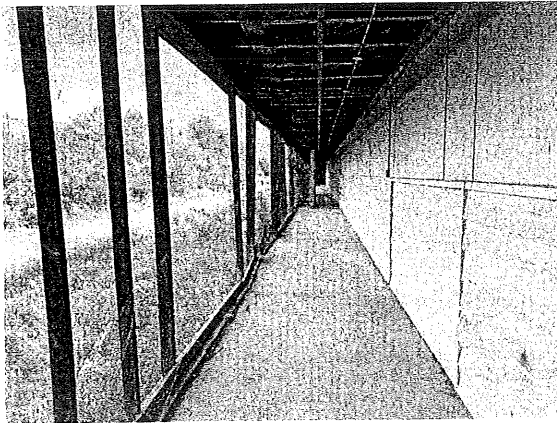
Newer post to beam techniques due to prior damages

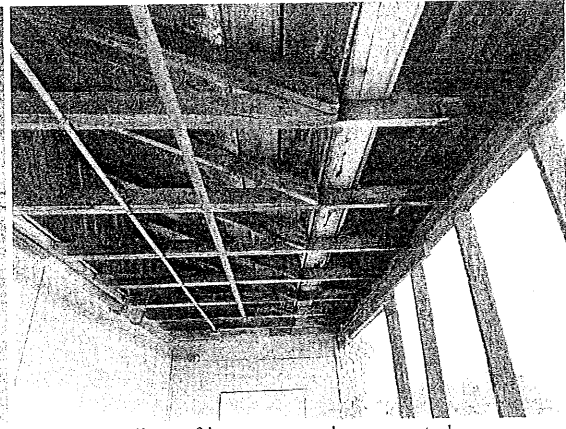
- The exterior railside open walkway roof structure is improperly supported by missing wall joists and is unsafe. Correct or seal off immediately.
- The electrical system was generally found to be in good functional condition but with issues denoted in the report including end of life components. Its overall service capacity was difficult to verify. The main MCC is 1600 amp 3 phase. Original transformers were observed. Older

Rail side walk roof is not properly supported now.

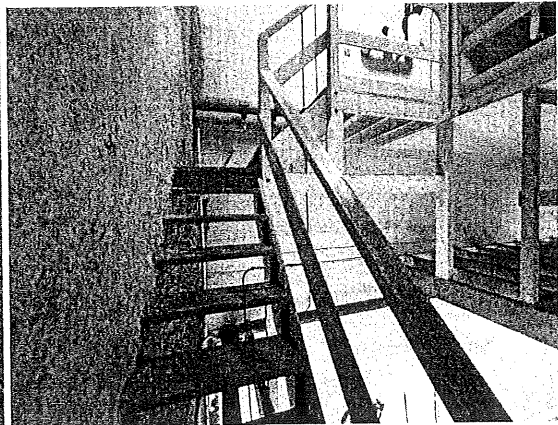
Uneven, unsafe stairway without handrailing

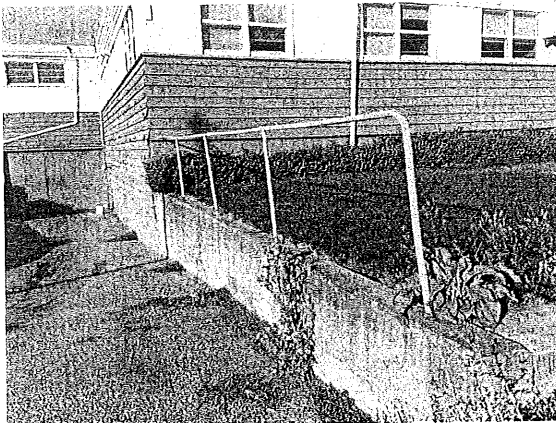
Unsafe open stairs and guards

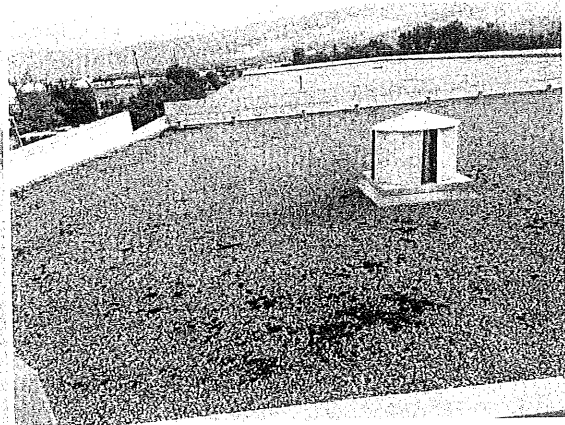
All openings should be caulk sealed

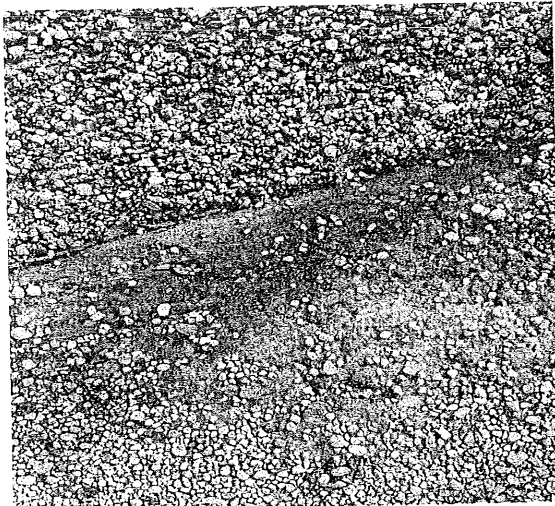
- The CA buildings roof membranes are older tar and gravel type with damages observed. These roof membranes have a limited life of 15-20 years. Obtain age from vendor and expect to replace in the near term.

CA buildings tar and gravel roofs

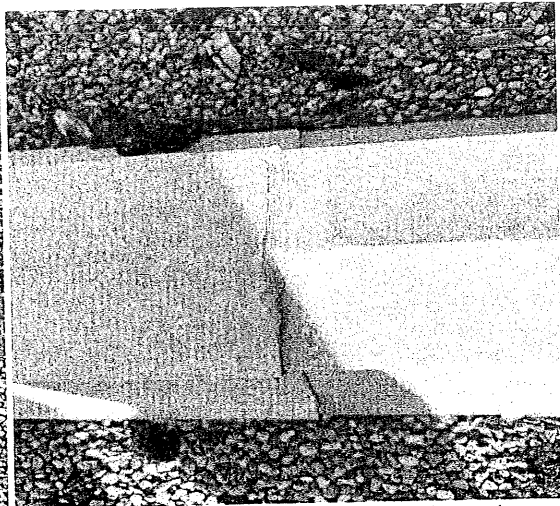
Localized tar paper exposure and likely roof leak

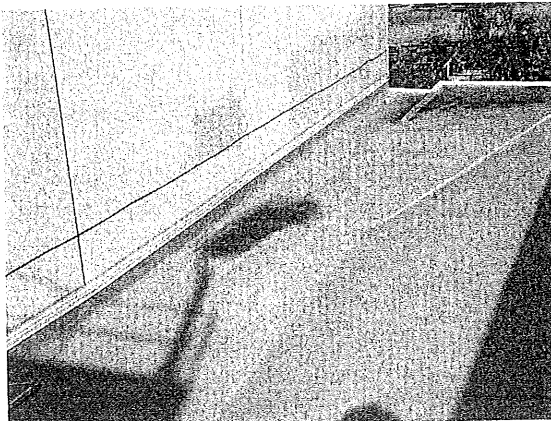
The dark spot indicates extended duration water ponding

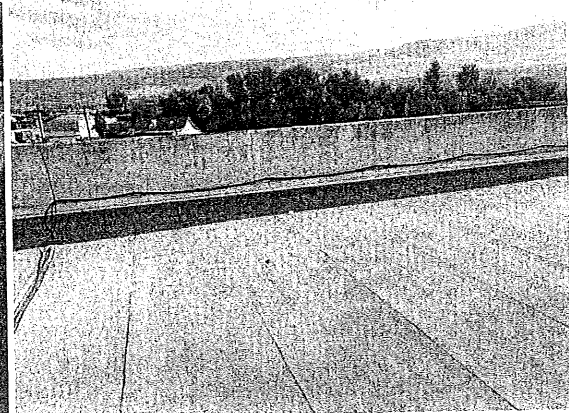
EPDM lower roof membrane with ponding staining

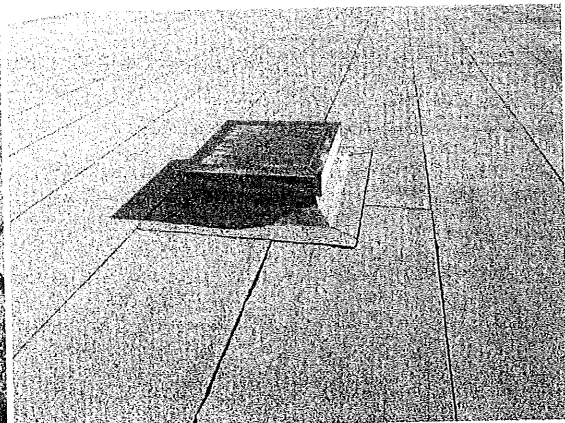
Localized degradation can be remedied by maintenance

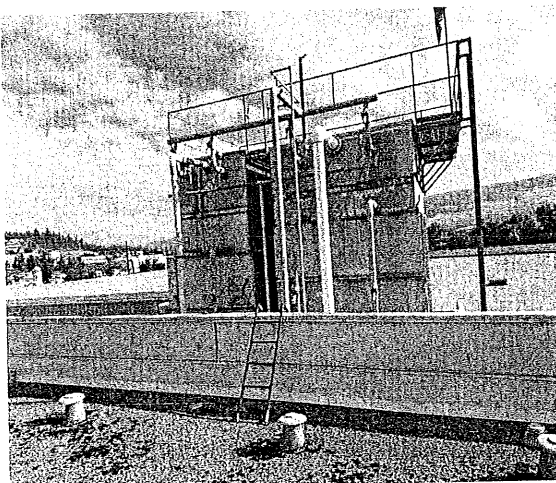
General roof photo. Metal cover should be improved.

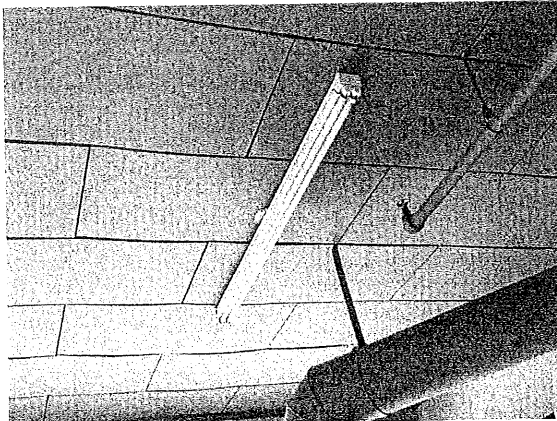
Loose ceiling tiles
