**RESPONDING MOTION RECORD
OF PRIMARIS MANAGEMENT INC.
(VOLUME 2 OF 3)**

FINAL **Baseline Property** **Condition Assessment**

2271 Harvey Avenue
Kelowna, British Columbia

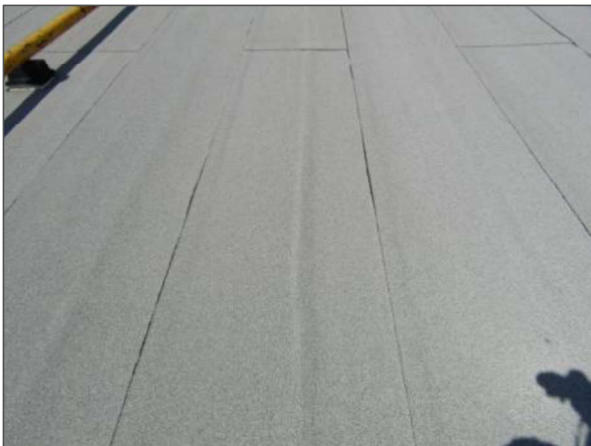
Areas of membrane wrinkling of the modified bitumen membrane roof system were noted atop Roof Section A1.

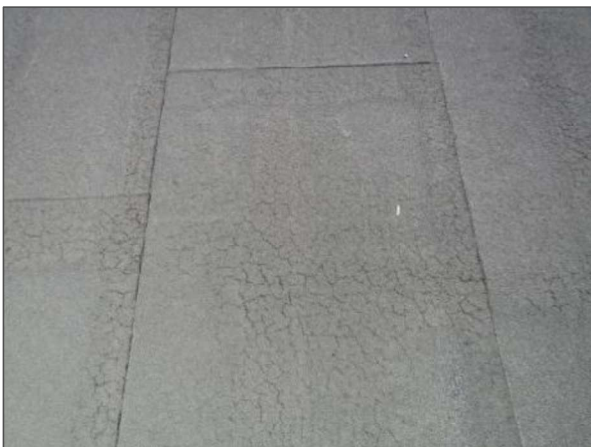
Areas of membrane crazing of the modified bitumen membrane roof system were noted atop Roof Section A3 in multiple locations.

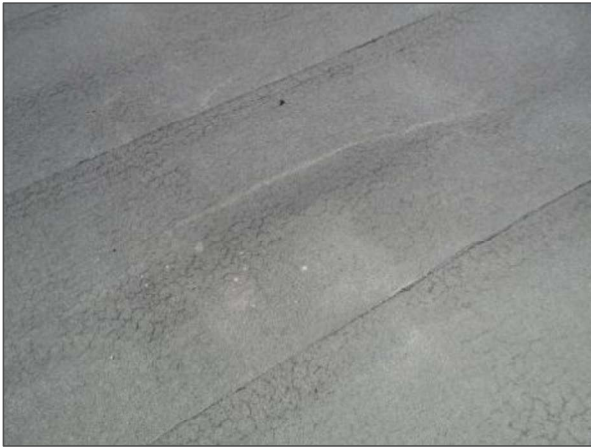
Areas of membrane crazing of the modified bitumen membrane roof system were noted atop Roof Section A3 in multiple locations.

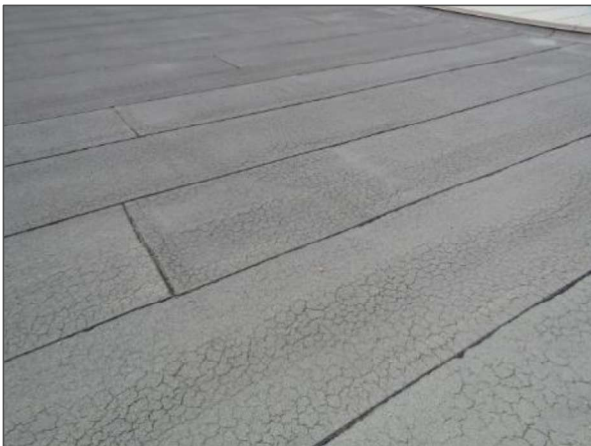
Areas of membrane crazing of the modified bitumen membrane roof system were noted atop Roof Section A3 in multiple locations.

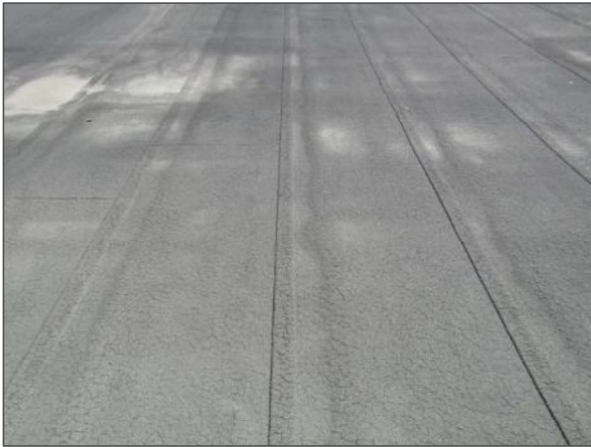
Areas of membrane crazing of the modified bitumen membrane roof system were noted atop Roof Section A4 in multiple locations.

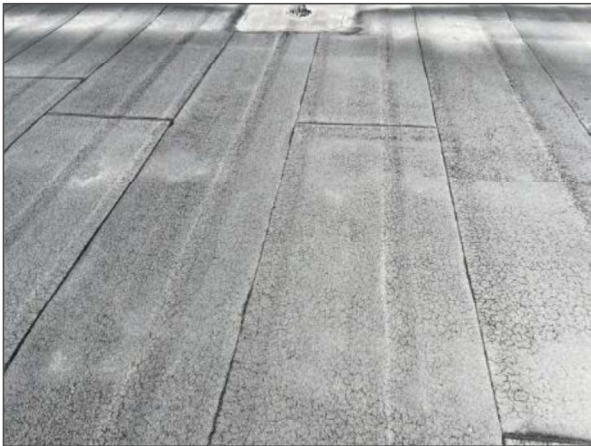
Areas of membrane crazing of the modified bitumen membrane roof system were noted atop Roof Section A5 in multiple locations.

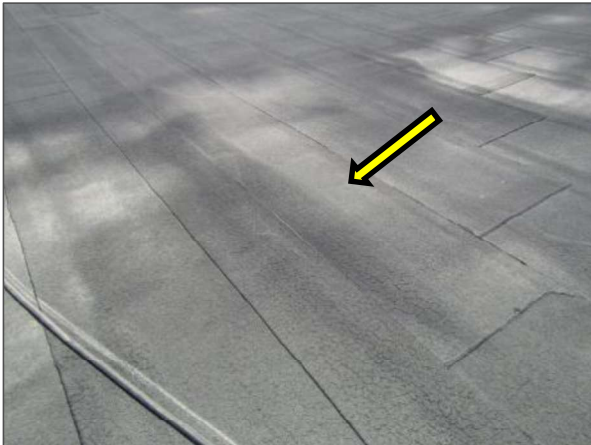
Areas of membrane blistering of the modified bitumen membrane roof system were noted atop Roof Section A4 in multiple locations.

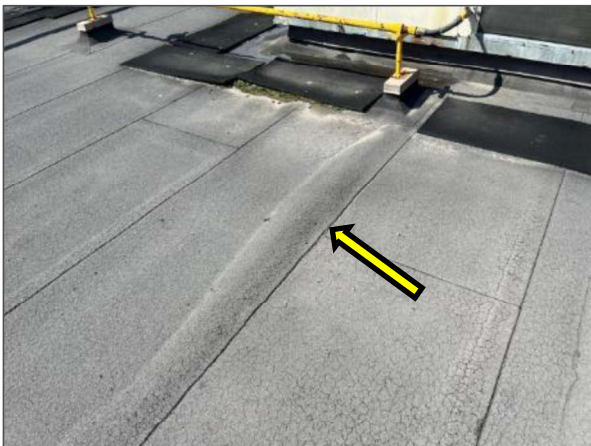
Areas of membrane blistering of the modified bitumen membrane roof system were noted atop Roof Section A5 in multiple locations.

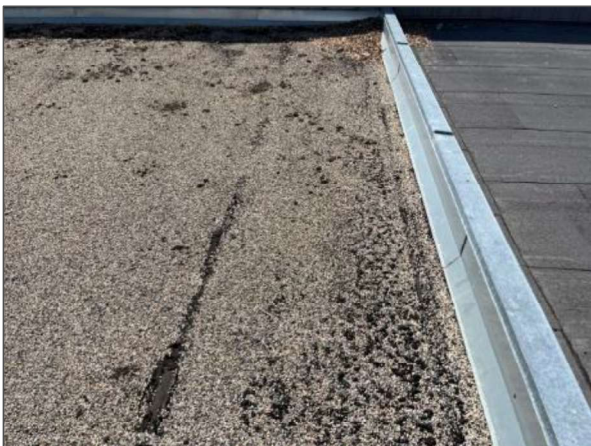
Areas of asphalt bleed through were noted atop the BUR system serving Roof Section 6.

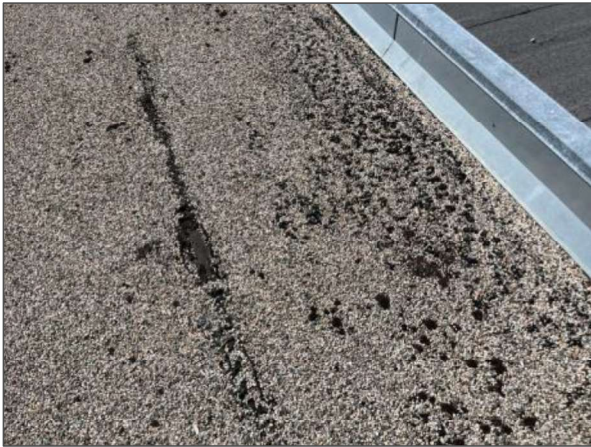
Areas of asphalt bleed through were noted atop the BUR system serving Roof Section 6.

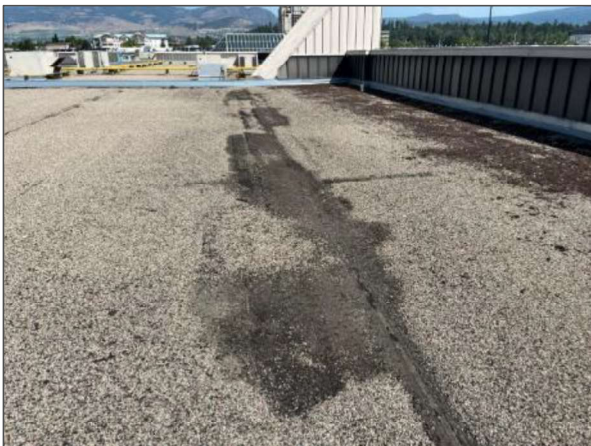
Areas of exposed membrane and previous repair work to the BUR system serving Roof Section 6 were observed.

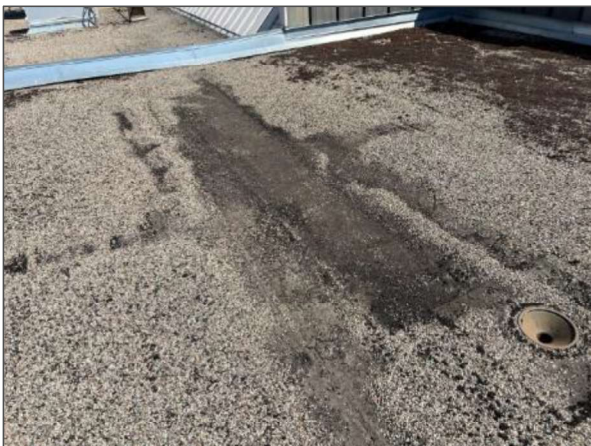
Areas of exposed membrane and previous repair work to the BUR system serving Roof Section 6 were observed.

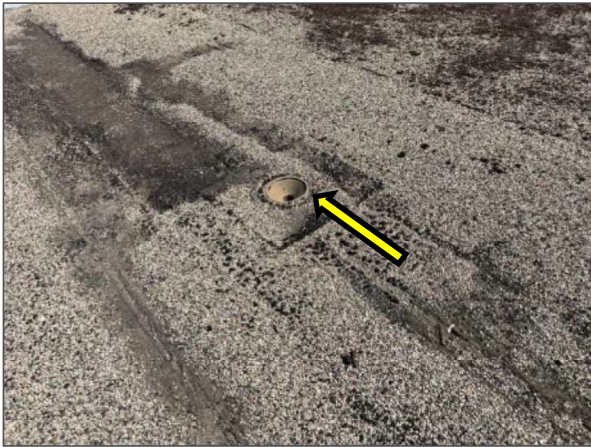
Missing debris strainers were noted atop Roof Section 6.

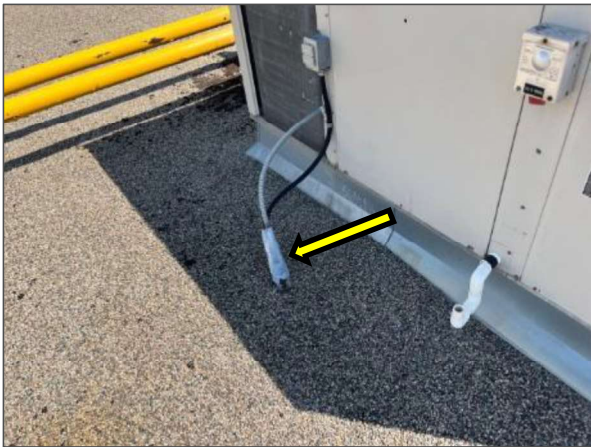
Poorly executed service penetrations were noted in multiple locations atop the Roof Sections of the Site Building.

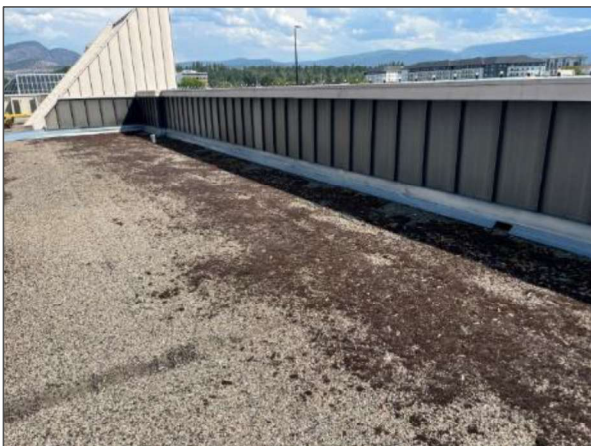
Areas of organic growth/debris were noted atop the Roof Sections of the Site Building.

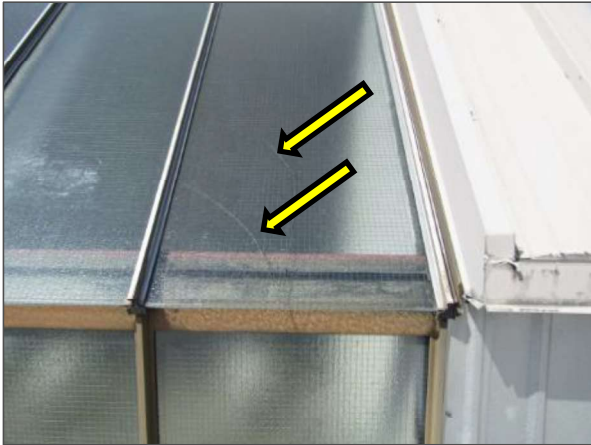
Cracked glazed units serving the glazed roof noted on the north portion of the Site Building were observed.

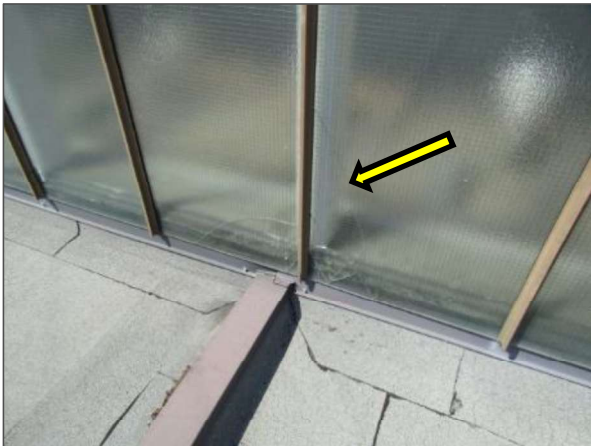
Cracked glazed units serving the glazed roof noted on the north portion of the Site Building were observed.

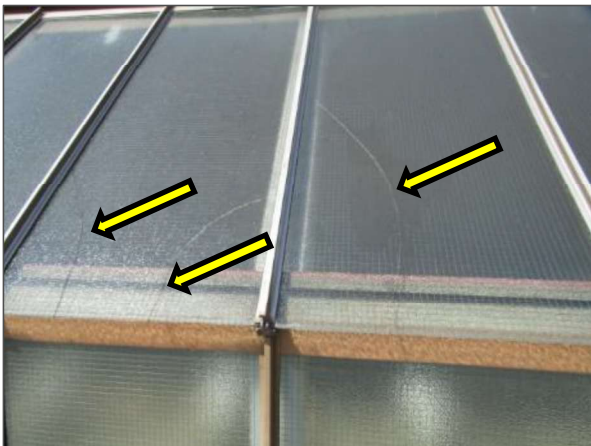
Cracked glazed units serving the glazed roof noted on the north portion of the Site Building were observed.

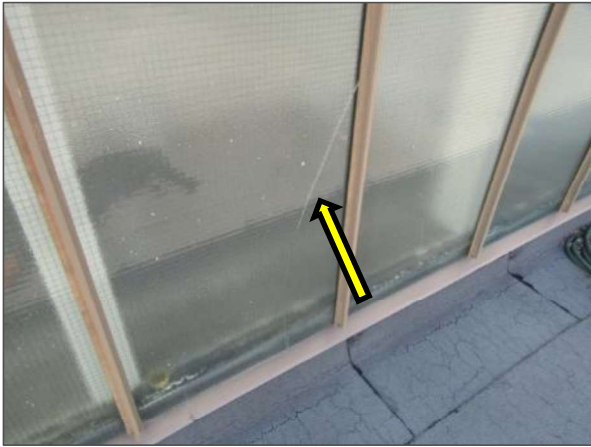
Cracked glazed units serving the glazed roof noted on the west portion of the Site Building were observed.

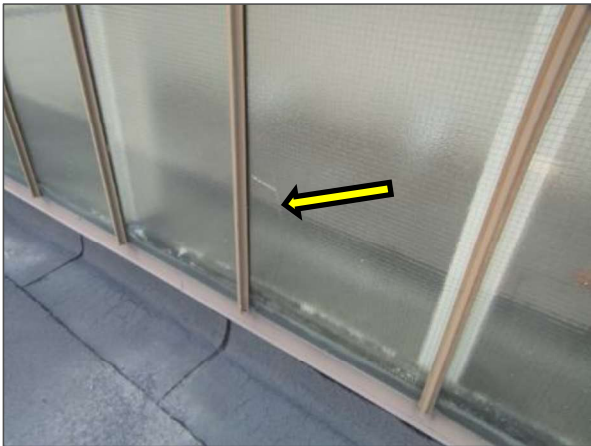
Cracked glazed units serving the glazed roof noted on the west portion of the Site Building were observed.

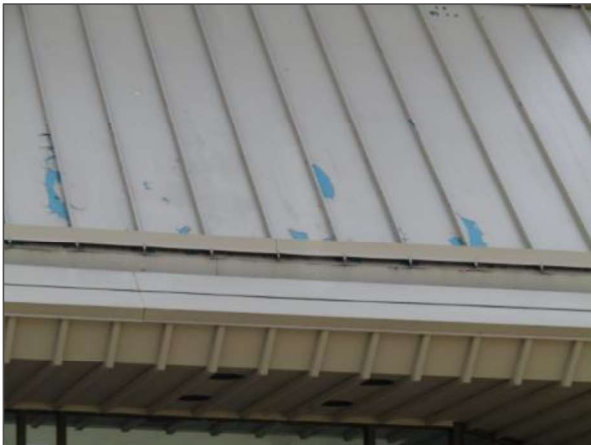
Areas of delaminated paint were noted atop the sloped metal mansard style roof areas.

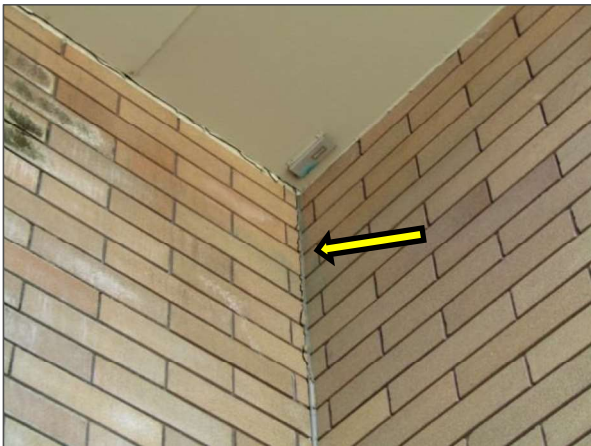
Localized areas of cracking within the brick veneer masonry were noted on the north elevation of the Site Building.

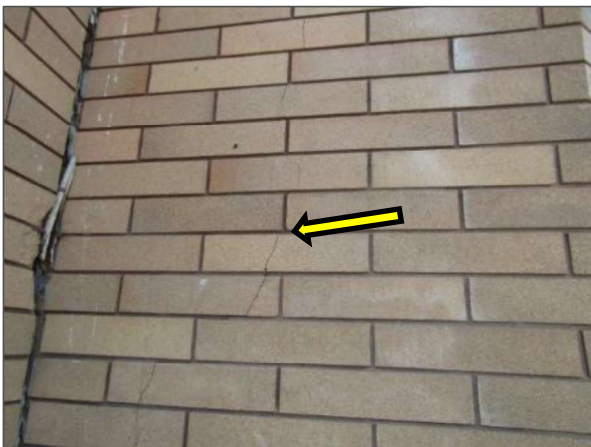
Localized areas of cracking within the brick veneer masonry were noted on the north elevation of the Site Building.

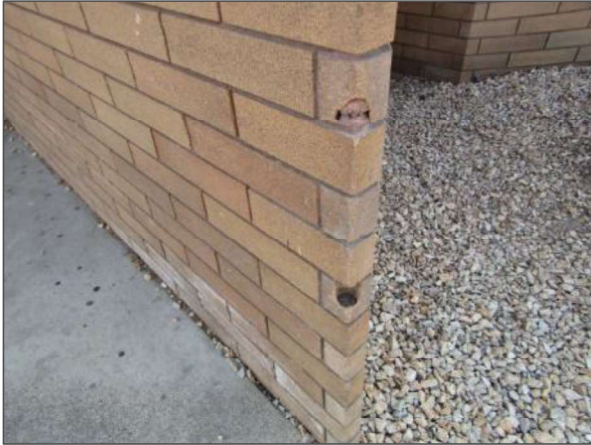
Areas of damaged brick veneer masonry were noted on the north elevation of the Site Building.

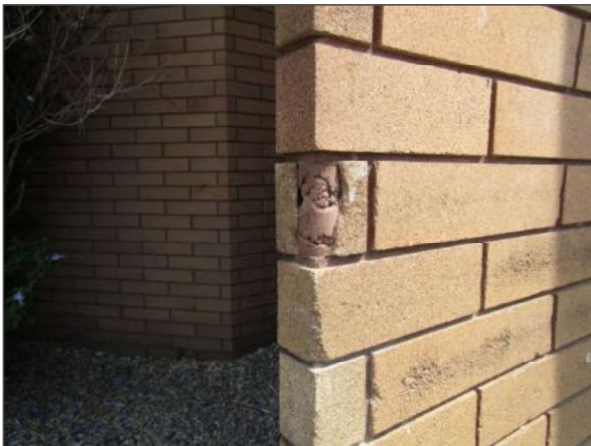
Areas of damaged brick veneer masonry were noted on the west elevation of the Site Building.

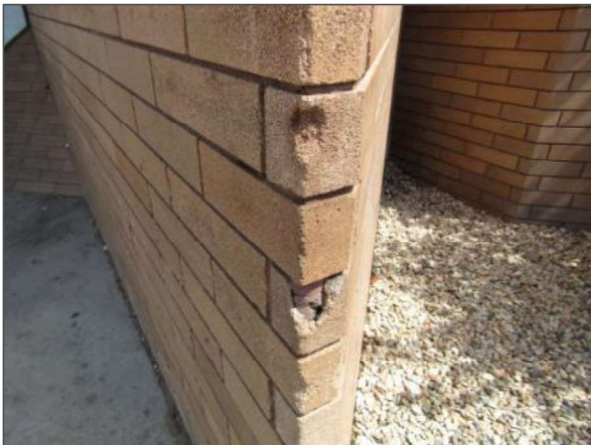
Areas of damaged brick veneer masonry were noted on the west elevation of the Site Building.

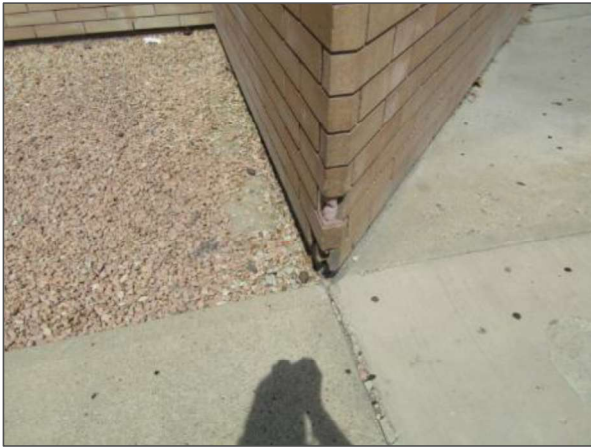
Areas of damaged brick veneer masonry were noted on the south elevation of the Site Building.

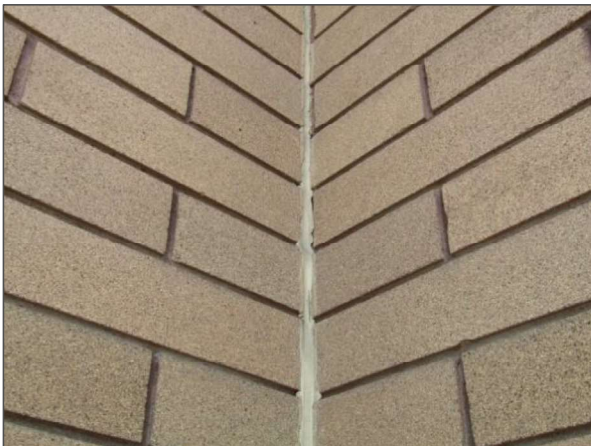
Areas of aged transition sealant were noted multiple elevations.

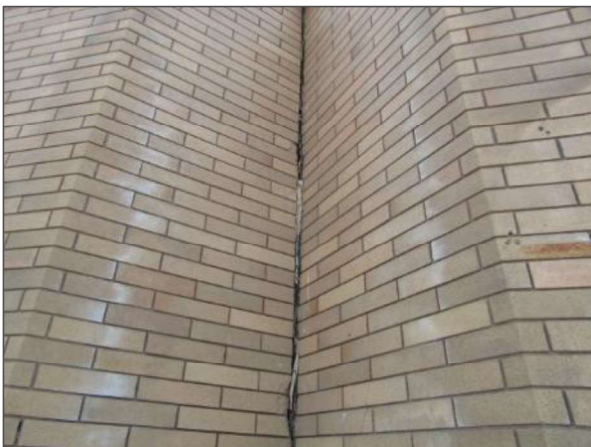
Missing transition sealant were noted on the north elevation.

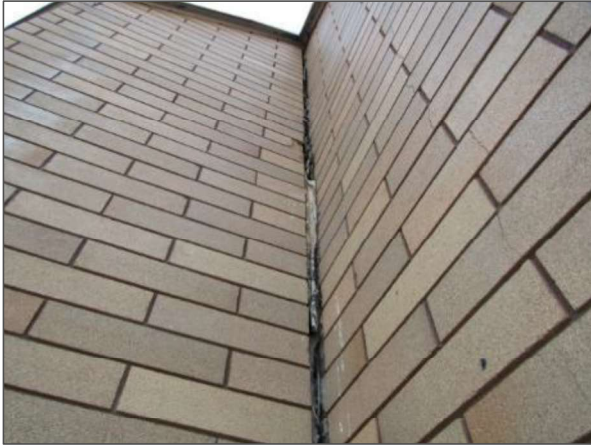
Missing transition sealant were noted on the north elevation.

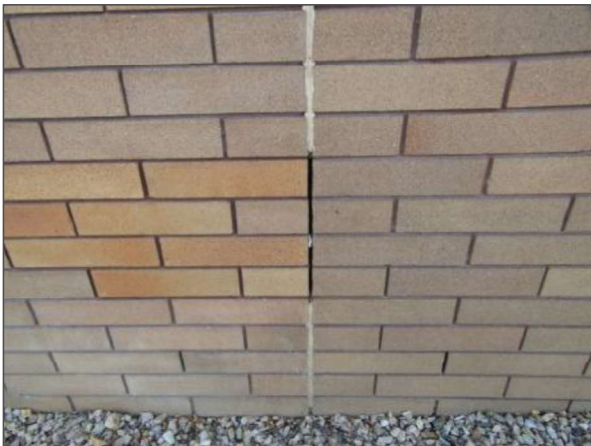
Missing transition sealant were noted on the north elevation.

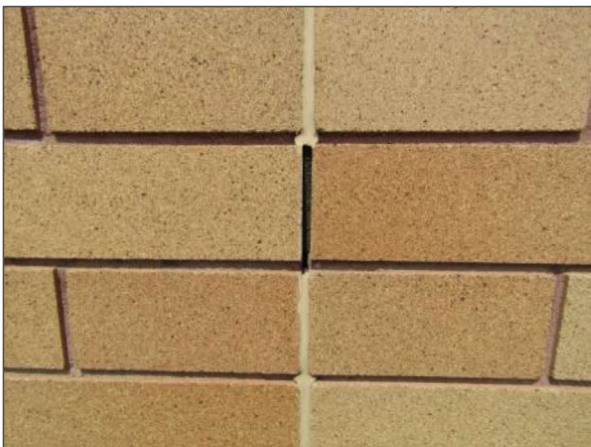
Missing transition sealant were noted on the south elevation.

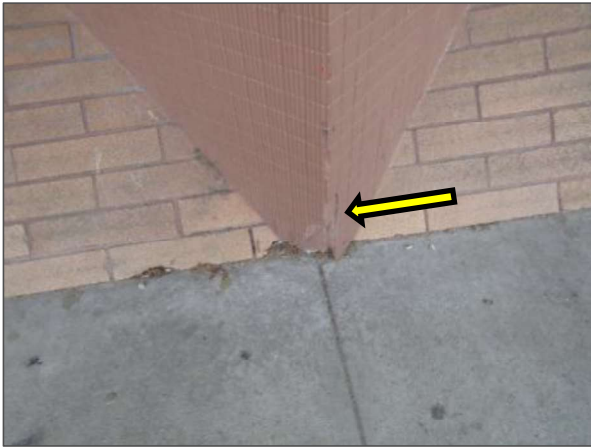
Damaged clay wall tile was noted on the north elevation.

<ul style="list-style-type: none"> Damaged clay wall tile was noted on the north and west elevations. 	<ul style="list-style-type: none"> Undertake localized repairs.
<ul style="list-style-type: none"> Aged door sealants were noted in multiple locations. 	<ul style="list-style-type: none"> Replace the deteriorated door sealants.
<ul style="list-style-type: none"> Aged window sealants were noted on the north elevation. 	<ul style="list-style-type: none"> Replace the deteriorated window sealants.
<ul style="list-style-type: none"> Unsealed wall penetrations were noted on the north and south elevations. 	<ul style="list-style-type: none"> Seal wall penetrations.
<ul style="list-style-type: none"> A damaged SG door was noted on the north elevation. 	<ul style="list-style-type: none"> Repair damaged SG door.

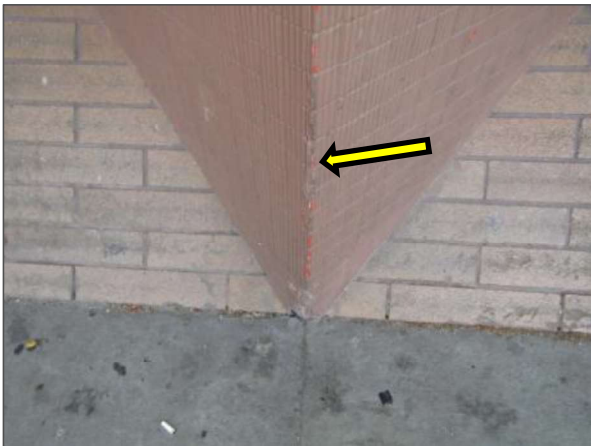
Damaged clay wall tile was noted on the west elevation.

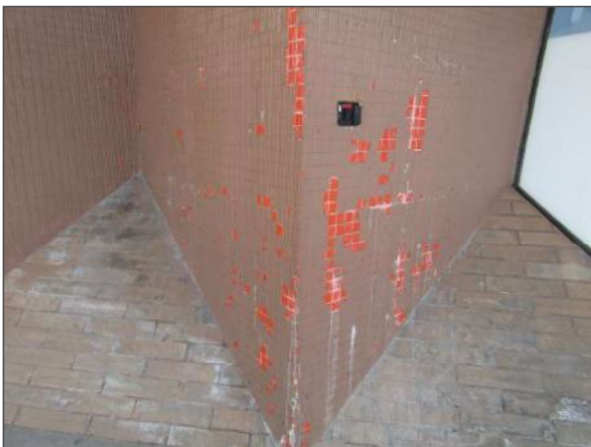
Damaged clay wall tile was noted on the west elevation.

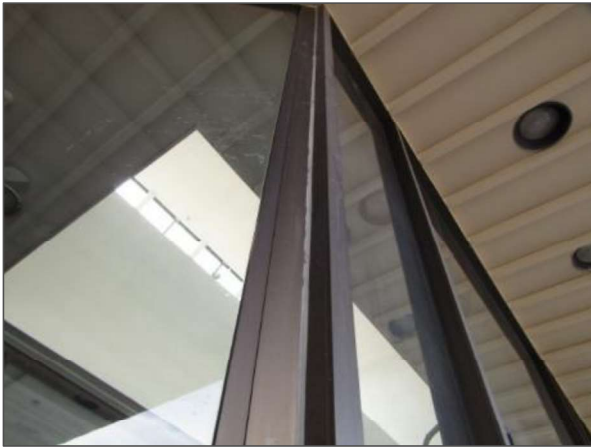
Aged door sealants were noted in multiple locations.

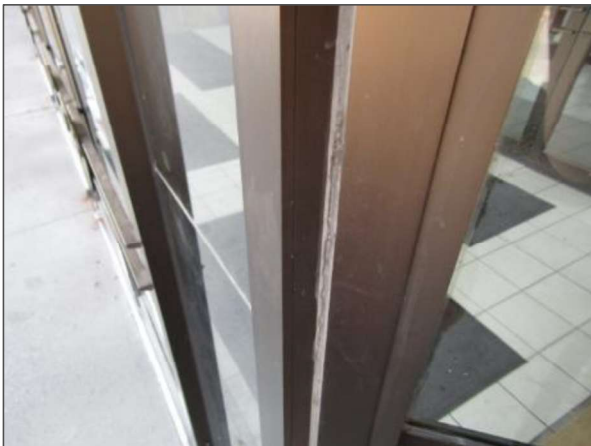
Aged door sealants were noted in multiple locations.

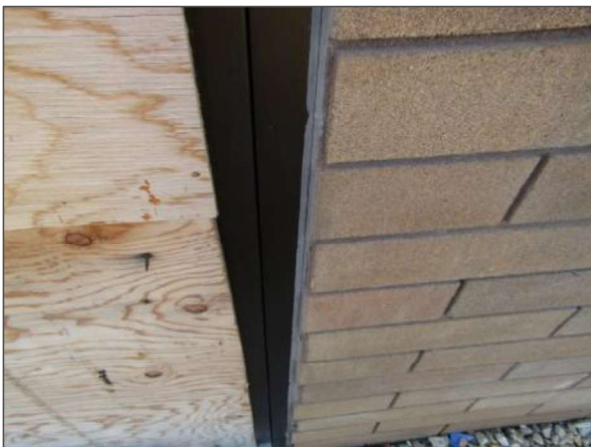
Aged door sealants were noted in multiple locations.

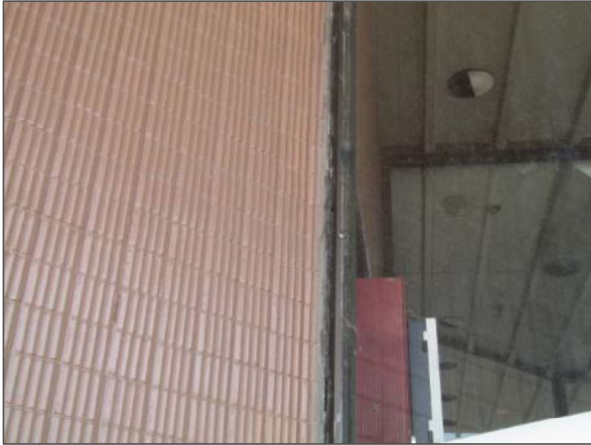
Aged door sealants were noted in multiple locations.

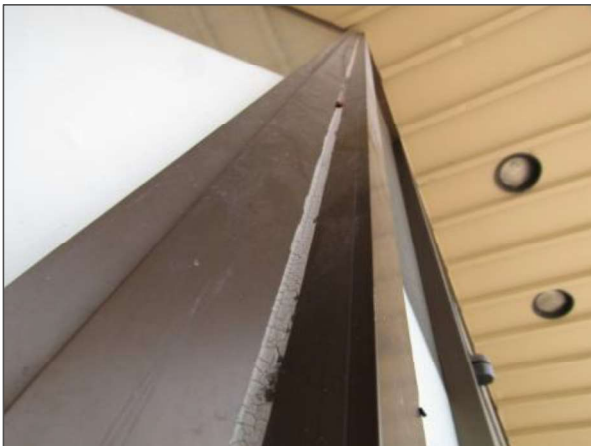
Aged door sealants were noted in multiple locations.

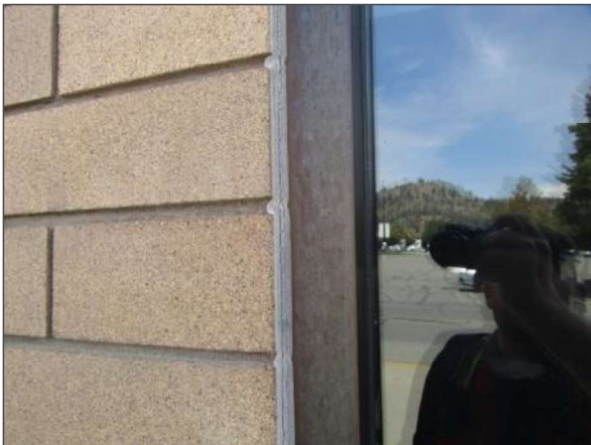
Aged window sealants were noted on the north elevation.

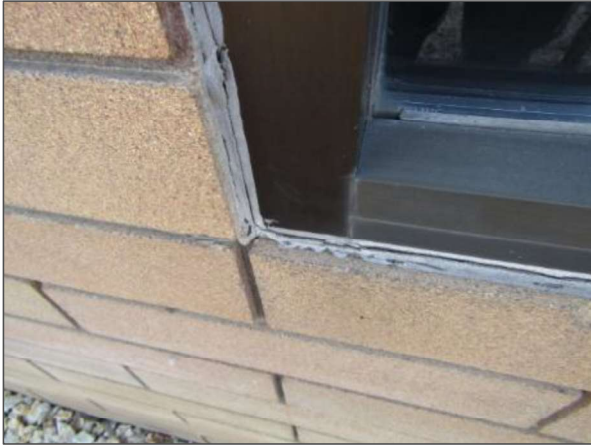
Aged window sealants were noted on the north elevation.

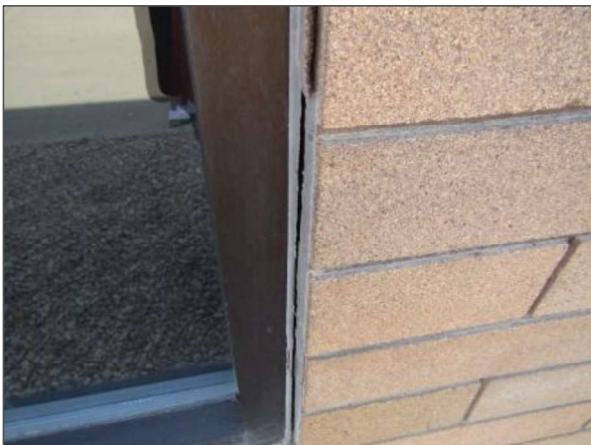
Aged window sealants were noted on the north elevation.

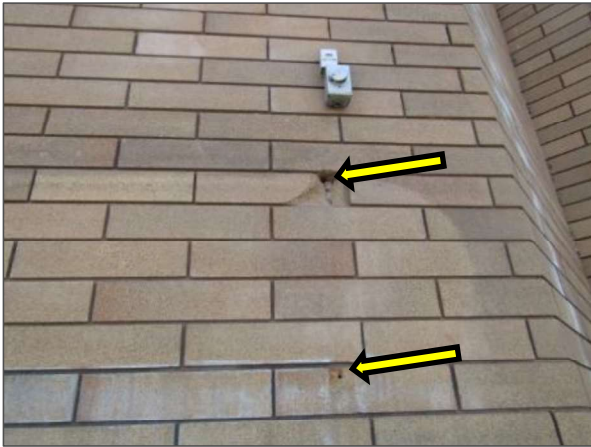
Unsealed wall penetrations were noted on the north elevation.

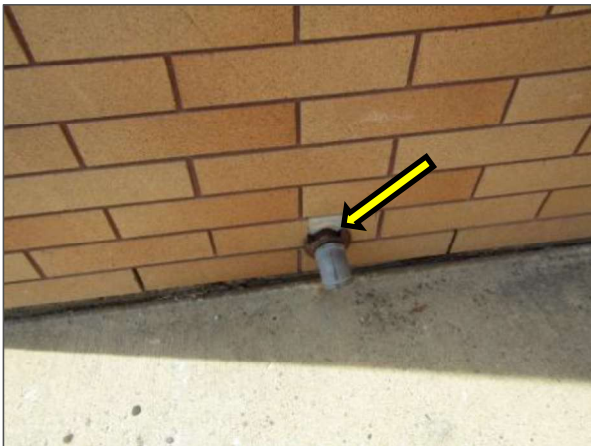
An unsealed wall penetration was noted on the south elevation.

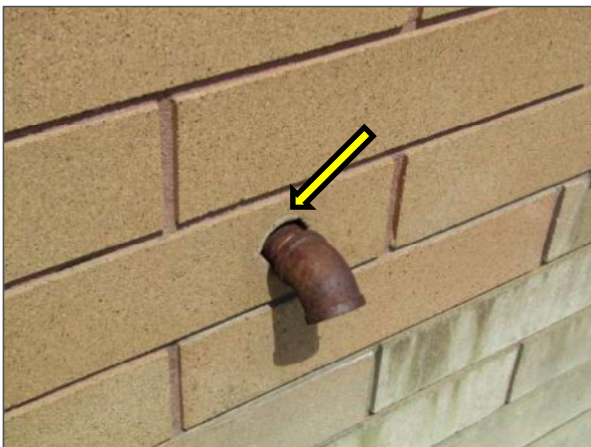
An unsealed wall penetration was noted on the south elevation.

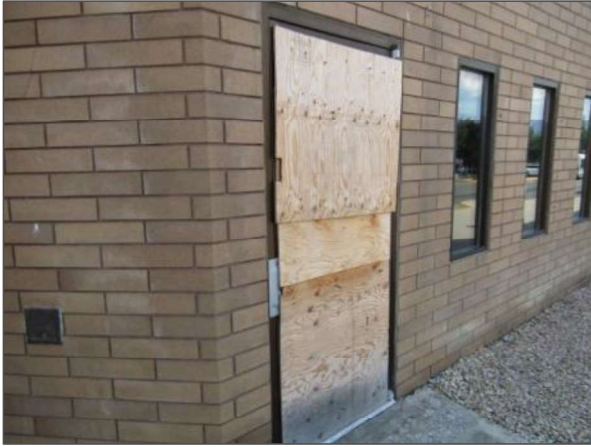
A damaged SG door was noted on the north elevation.

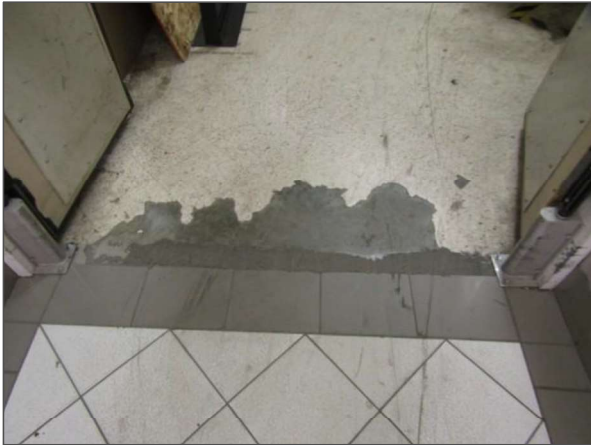
Damaged vinyl flooring was noted in multiple locations of the Site Building.

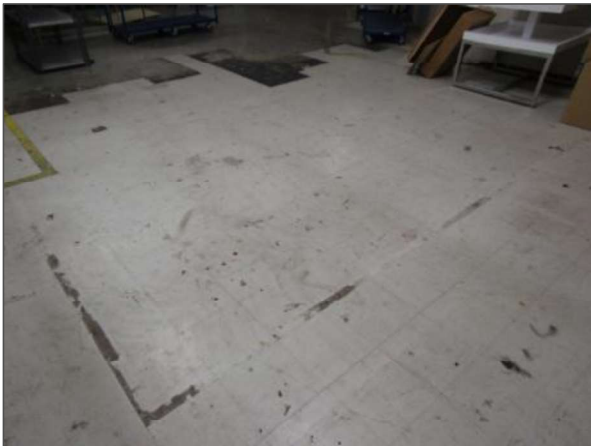
Damaged vinyl flooring was noted in multiple locations of the Site Building.

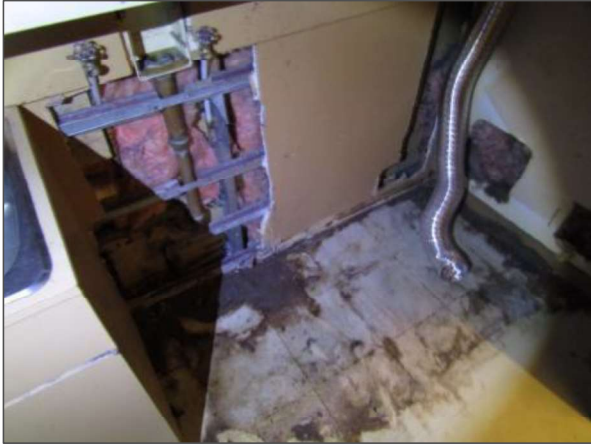
Damaged vinyl flooring was noted in multiple locations of the Site Building.

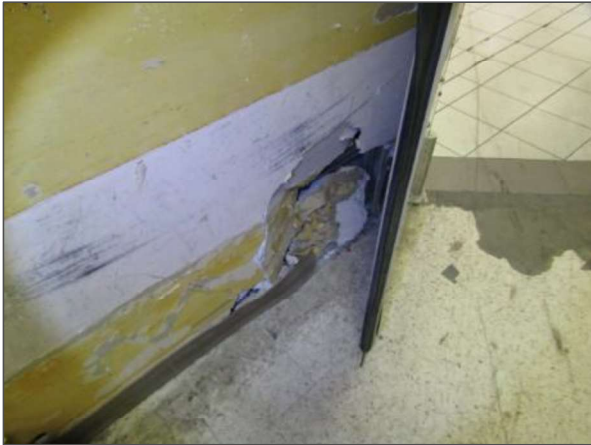
Damaged gypsum wall board was noted in multiple locations of the Site Building.

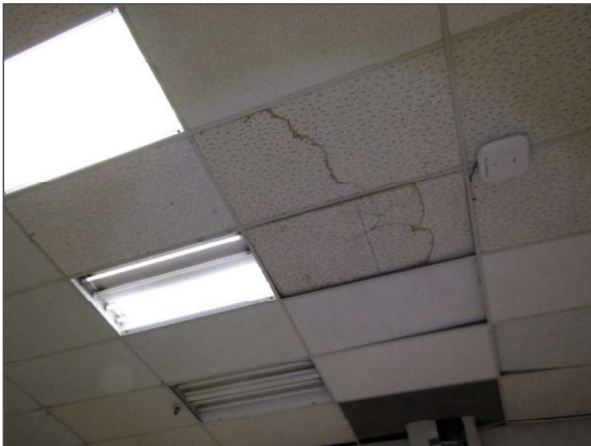
Missing/damaged/moisture stained ceiling tiles were noted in multiple locations of the Site Building.

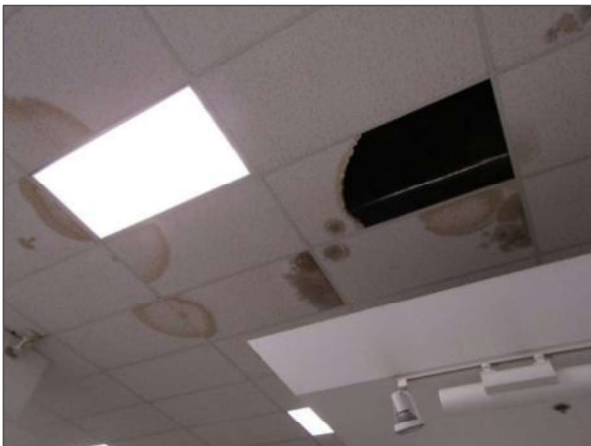
Missing/damaged/moisture stained ceiling tiles were noted in multiple locations of the Site Building.

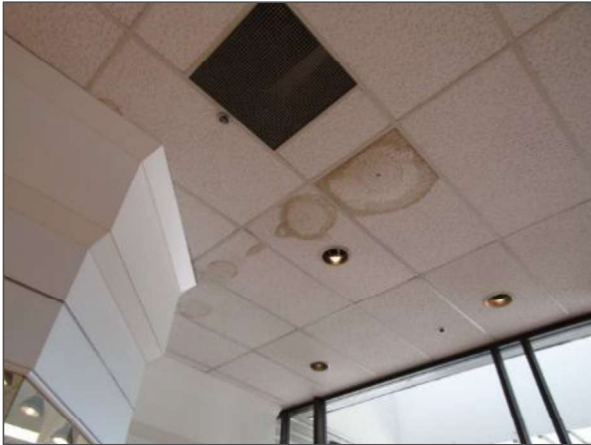
Missing/damaged/moisture stained ceiling tiles were noted in multiple locations of the Site Building.

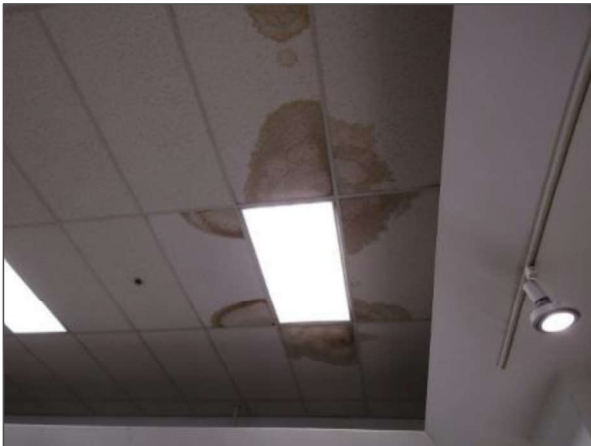
Missing/damaged/moisture stained ceiling tiles were noted in multiple locations of the Site Building.

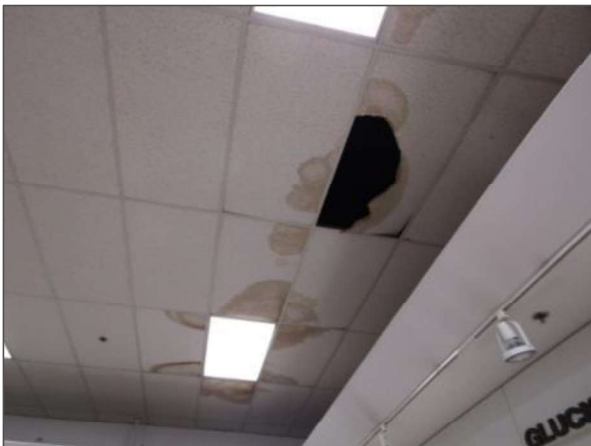
Missing/damaged/moisture stained ceiling tiles were noted in multiple locations of the Site Building.

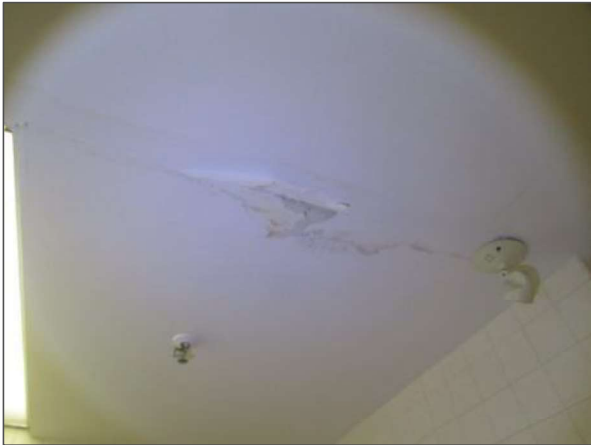
Moisture damage/stained gypsume ceiling board was noted in multiple locations of the Site Building.

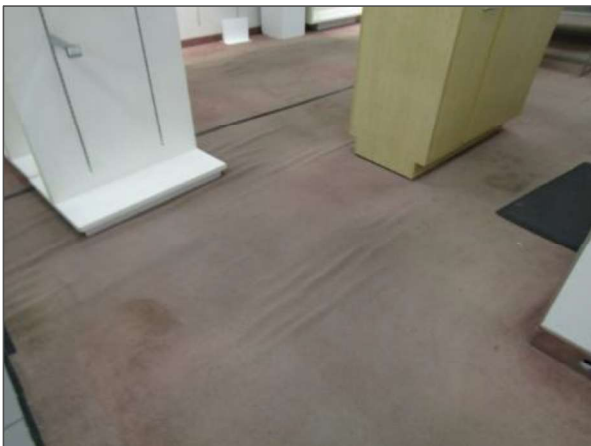
Damaged carpeting was noted in multiple locations of the Site Building.

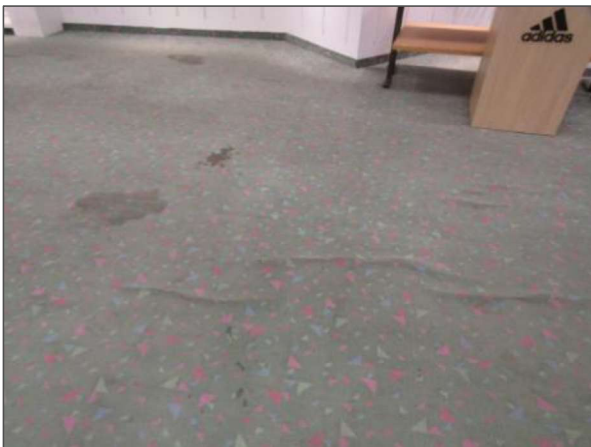
Damaged carpeting was noted in multiple locations of the Site Building.

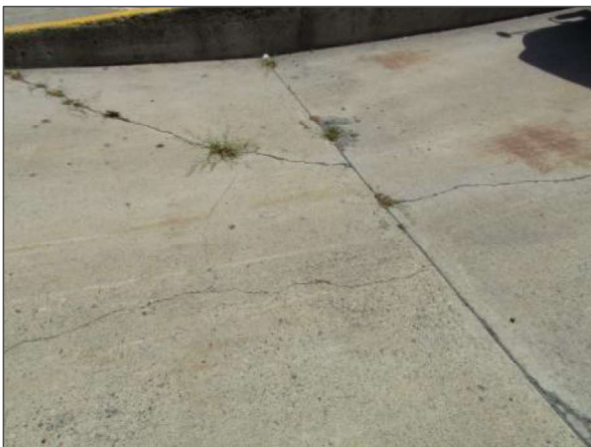
Localized areas of cracking were noted within the north concrete loading ramp.

Table 3.7 – Site Features	
Findings	Remarks/Recommendations
Major Deficiencies/Findings	
<ul style="list-style-type: none"> • None observed/reported. 	<ul style="list-style-type: none"> • None required.
Minor Deficiencies/Findings	
<ul style="list-style-type: none"> • Localized areas of cracking were noted within the north concrete loading ramp. 	<ul style="list-style-type: none"> • Repair/seal affected areas of cracking.

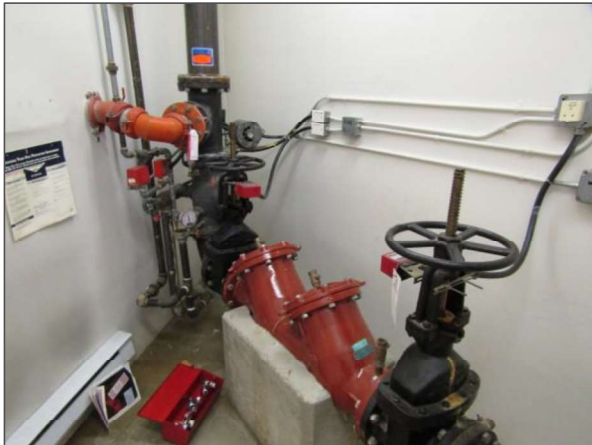
General view of a typical sprinkler riser and the observed backflow prevention device.

Note: The cabinet containing a extra supply of sprinkler heads and an installation tool was dislodged from its mounting spot.
