**RESPONDING MOTION RECORD
OF PRIMARIS MANAGEMENT INC.
(VOLUME 1 OF 3)**

FINAL **Baseline Property** **Condition Assessment**

419 King Street West, Oshawa,
Ontario

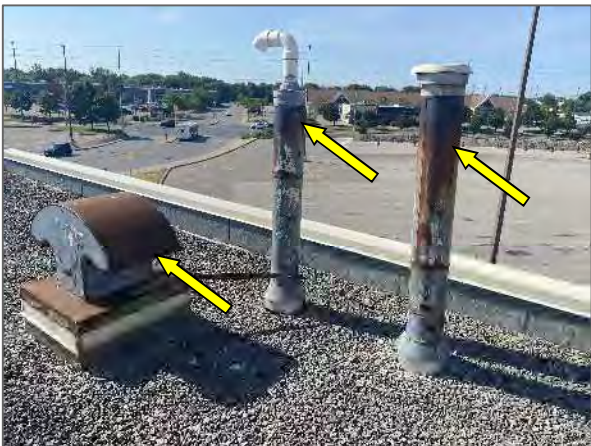
View of corrosion noted on the combustion and exhaust vents on the south portion of the Site Building.

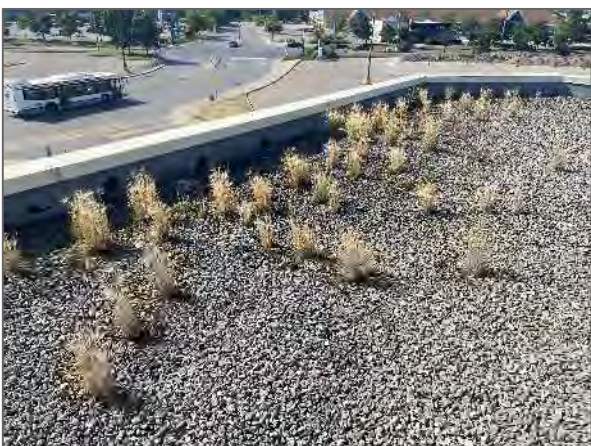
View of organic growth noted on the south portion of the Site Building.

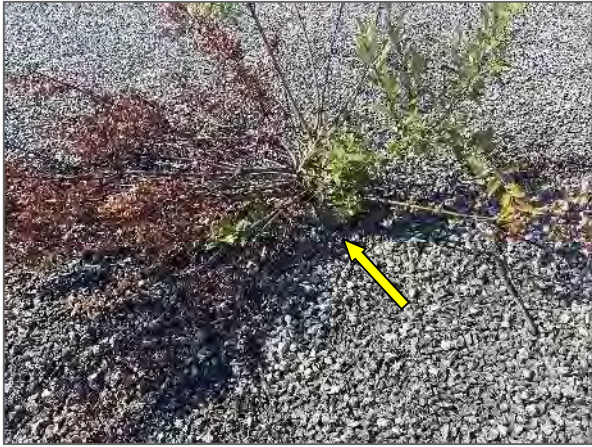
View of a partially obstructed roof drain noted in the central portion of the primary IRMA system.

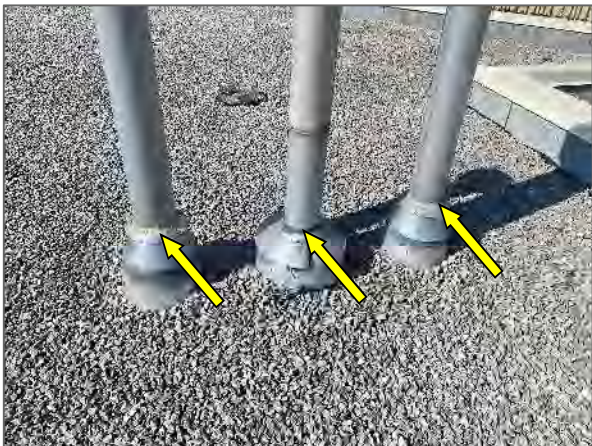
View of deteriorated sealants noted on vent penetrations in the southeast portion.

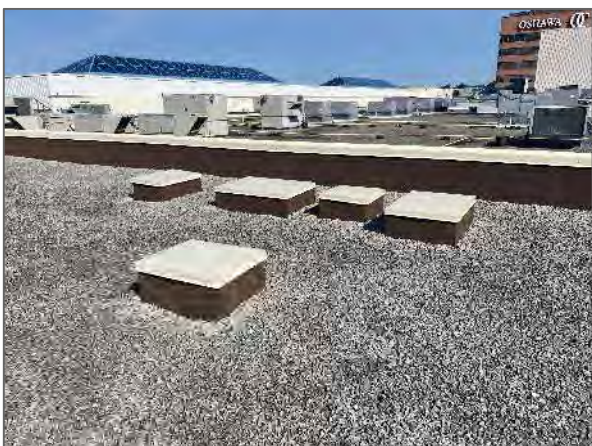
View of redundant HVAC curbs noted in the north portion of the primary IRMA system.

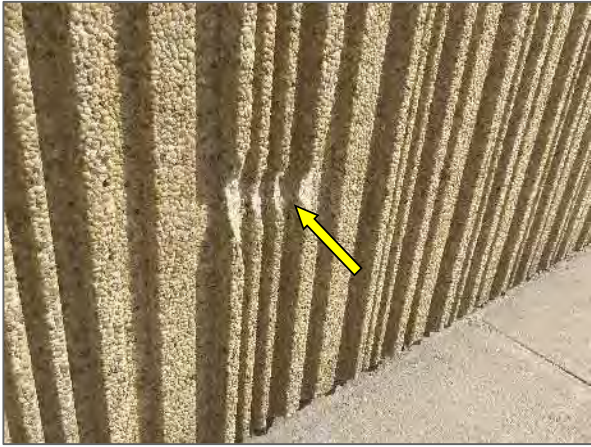
View of deterioration in the precast concrete wall panels noted on the south elevation of the Site Building.

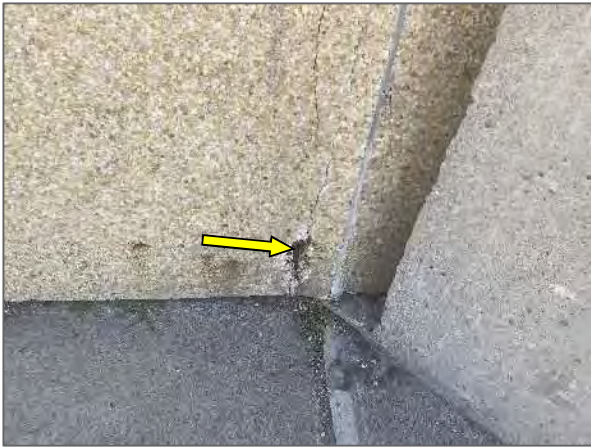
View of localized cracking and exposed rebar noted in a precast concrete wall panel on the south elevation of the Site Building.

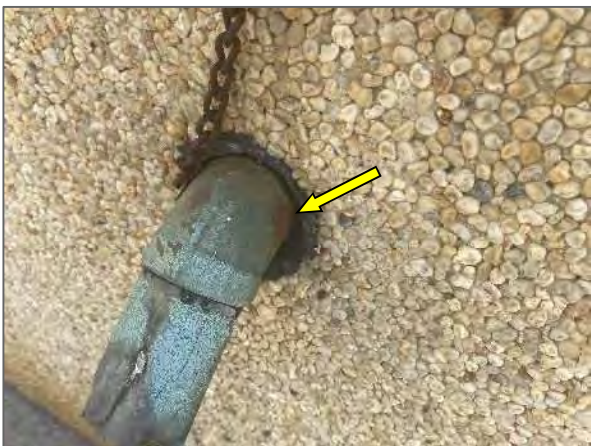
View of a typical unsealed penetration noted on the south elevation of the Site Building.

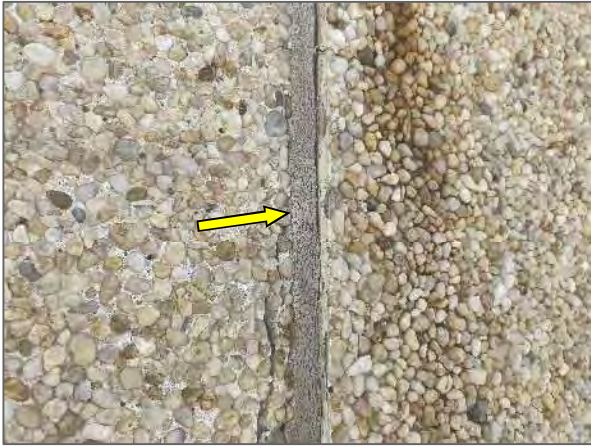
View of typical crazed/de-bonded wall panel sealant noted on the south elevation of the Site Building.

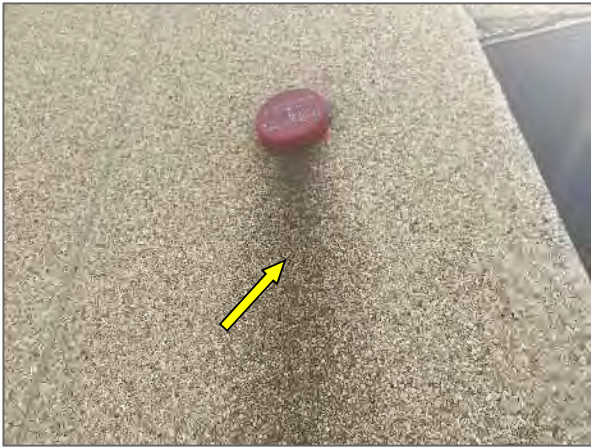
View of typical moisture staining noted on the south elevation of the Site Building.

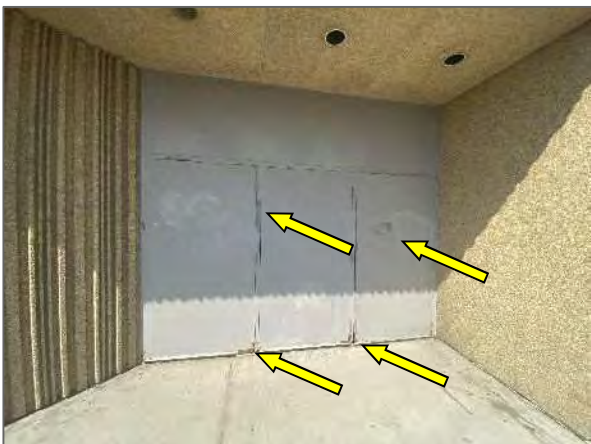
View of typical worn corrosion and worn finishes noted on hollow metal doors on the east elevation of the Site Building.

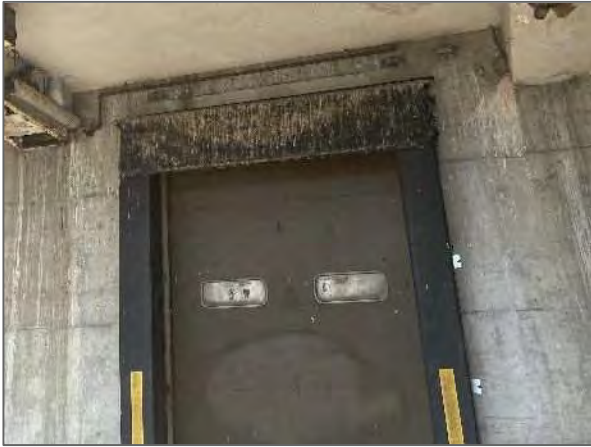
View of a typical aged sectional metal overhead door.

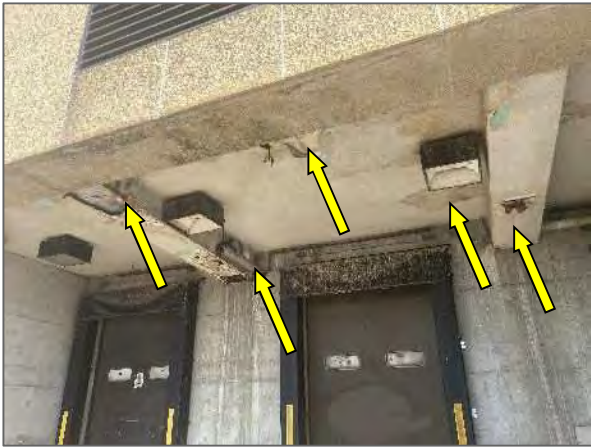
View of water-damaged gypsum board and exterior finishes on the soffit above the shipping/receiving area.

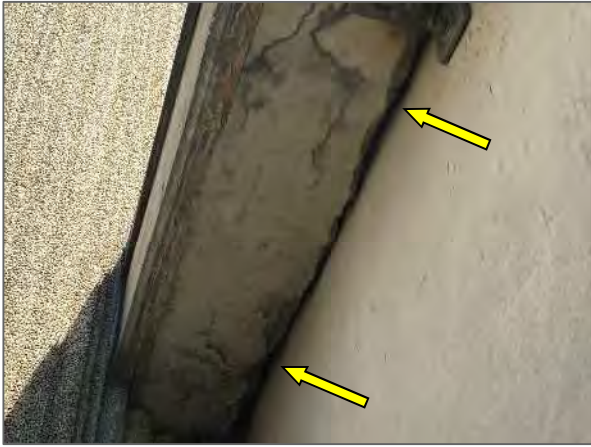
View of deteriorated concrete noted on a reinforced concrete beam in the southeast portion above the secondary roof.

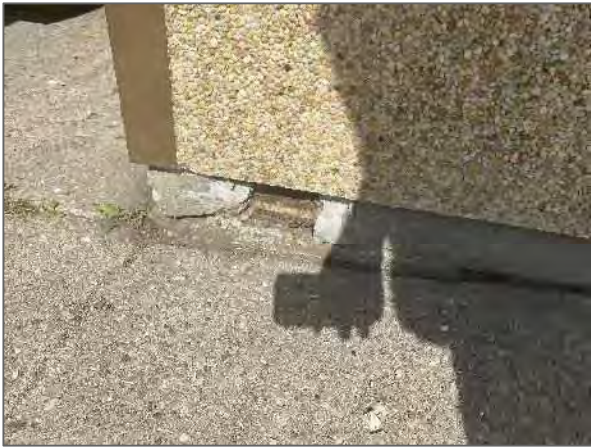
View of delaminated concrete in the cast-in-place concrete foundation wall noted on the east elevation of the Site Building.

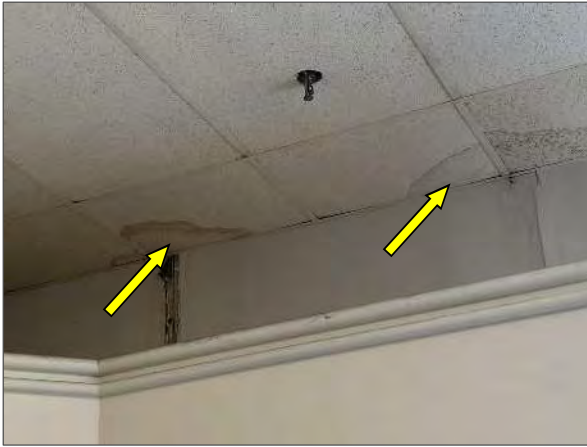
View of moisture/water-stained ceiling tiles noted adjacent to the south entrance of the Site Building.

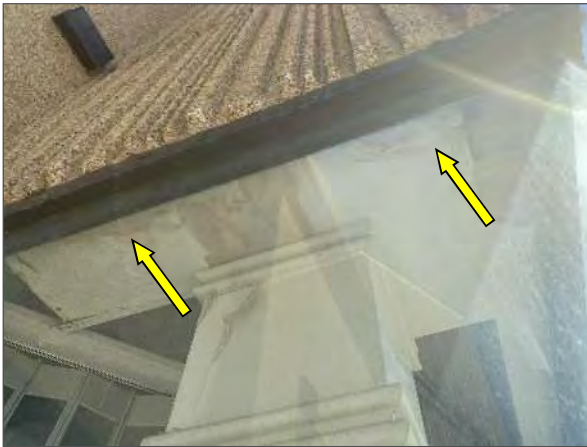
View of water damage in the gypsum wall and ceilings boards, reportedly due to a previous pipe leak noted adjacent to the south entrance of the Site Building.

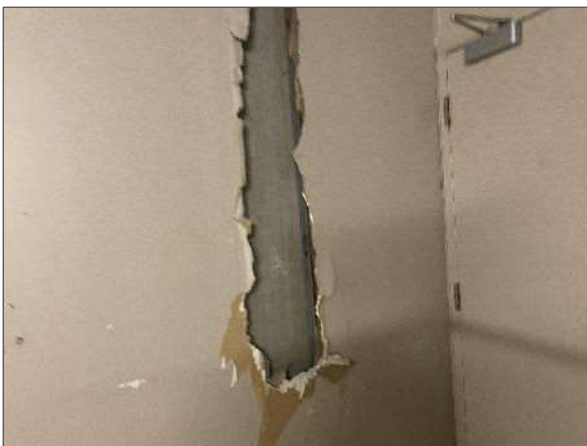
View of typical damaged gypsum wall board noted in the stairwell in the southeast portion.

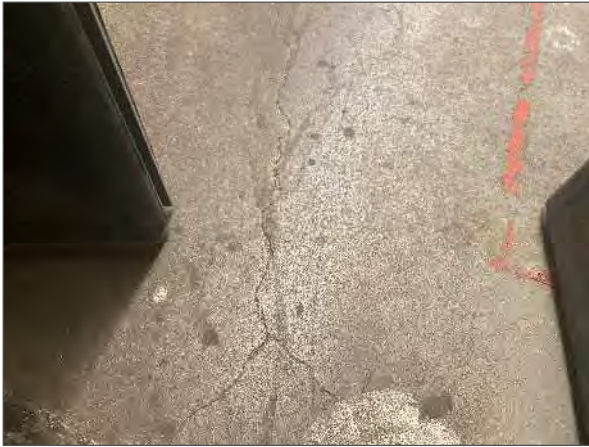
View of typical cracking in the exposed concrete floor slab noted within the shipping/receiving area.

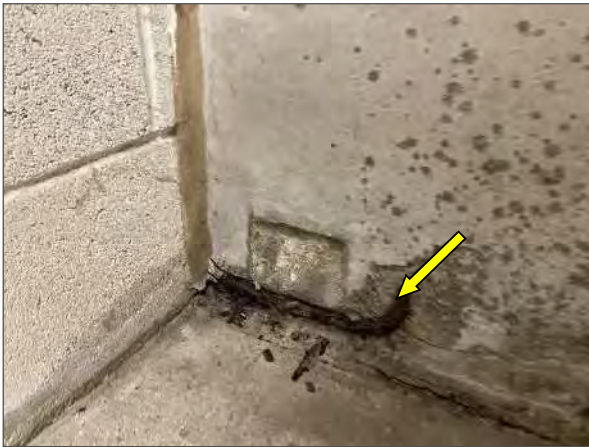
View of the area of exposed rebar noted in the southeast portion of the first floor.

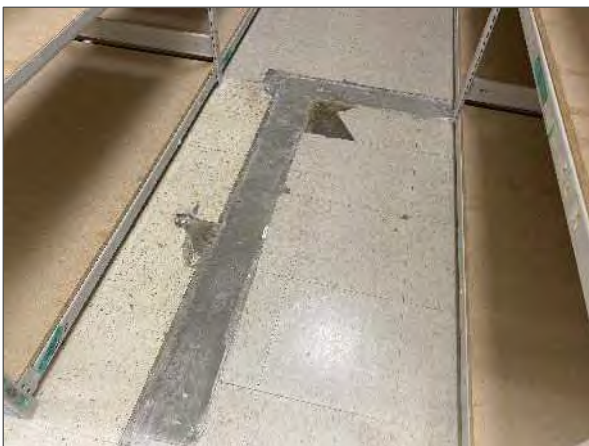
View of damaged/missing vinyl floor tiles noted on the second floor of the Site Building.

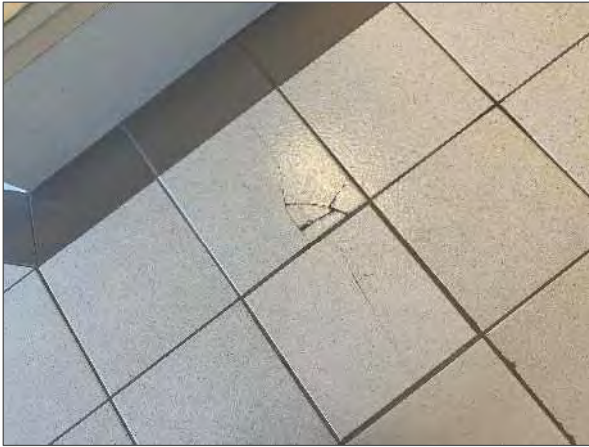
View of typical cracked/broken ceramic floor tiles noted in the west portion of the first floor of the Site Building.

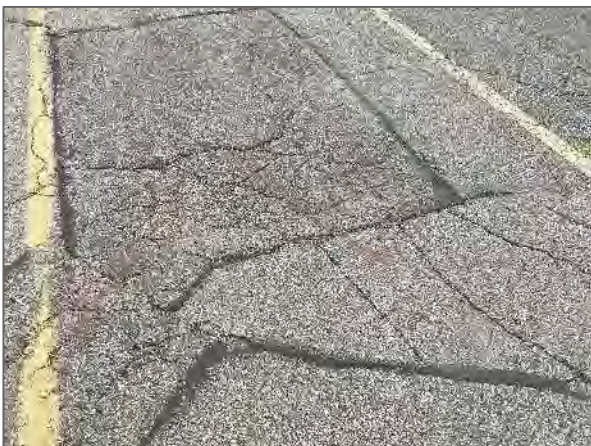
View of typical deteriorated asphalt pavement noted to the south of the Site Building.

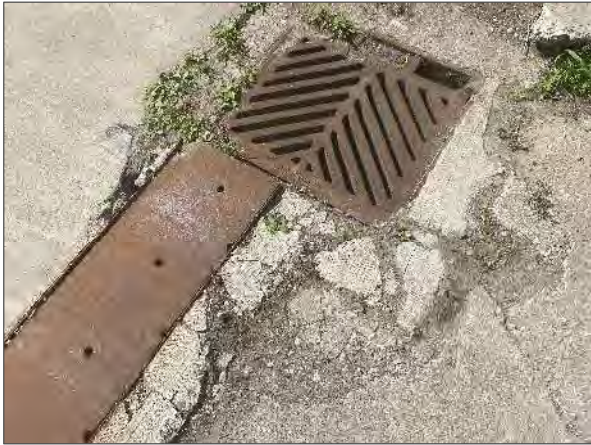
View of deterioration in the cast-in-place concrete apron serving the shipping/receiving area.

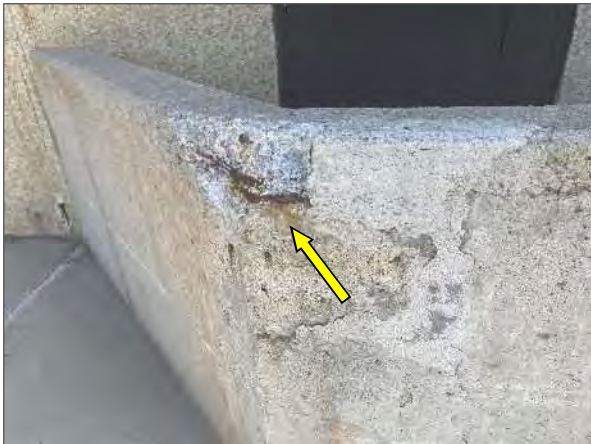
View of an area of deteriorated concrete noted at the concrete stairs at the southeast portion.

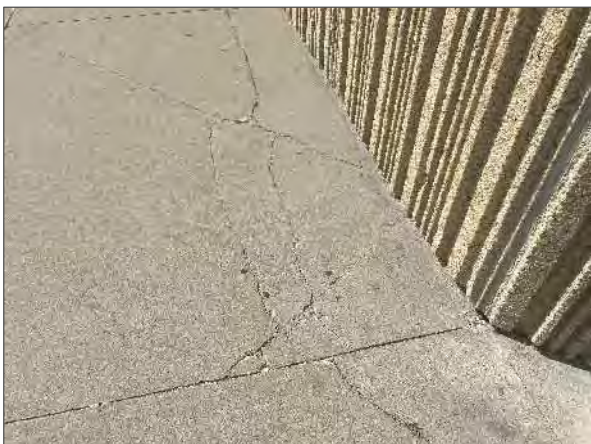
View of typical cracking in the cast-in-place concrete walkways noted to the east of the Site Building.

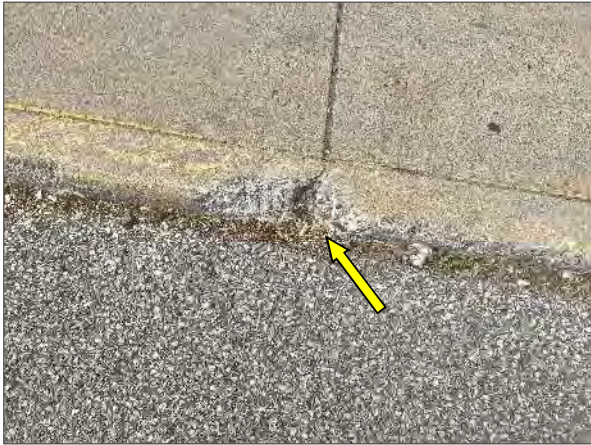
View of typical deterioration in the concrete curbs noted to the east of the Site Building.

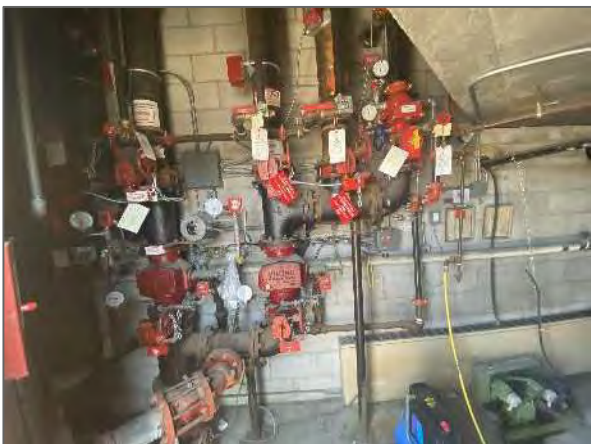
View of the "wet" fire sprinkler main riser and shut-off valves.

Note: No backflow prevention device noted/reported.

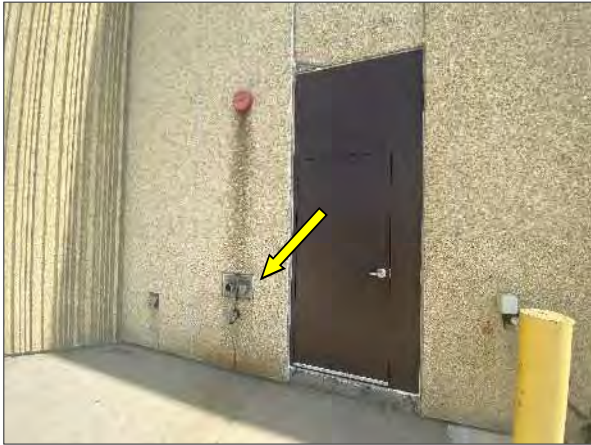
View of the fire department connections located on the south elevation of the Site Building.

Note: Missing signage indicating the location.

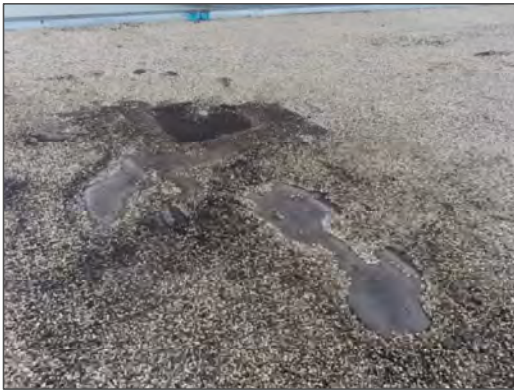
View of typical area of historic repairs atop
multiple BUR sections of the Site Building.

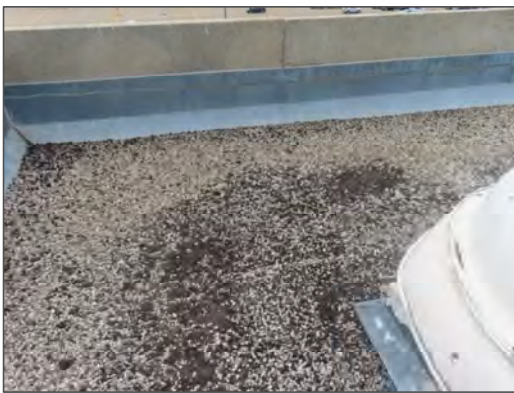
View of typical asphalt bleed through atop multiple BUR sections of the Site Building.

Note: Section 7 is shown.

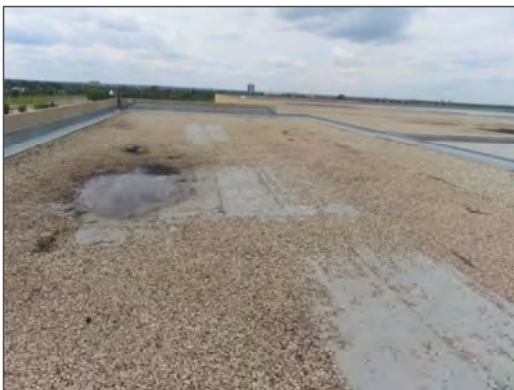
View of typical area of historic repairs atop multiple BUR sections the Site Building.

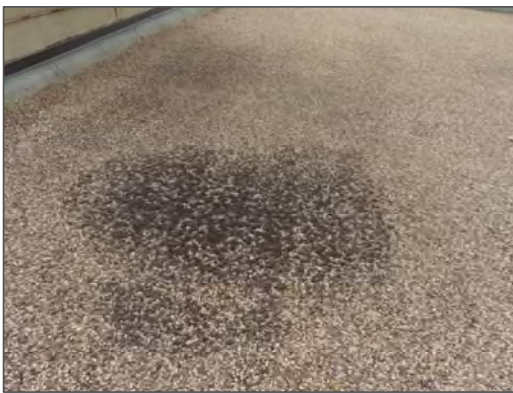
View of typical asphalt bleed through atop multiple BUR sections of the Site Building.

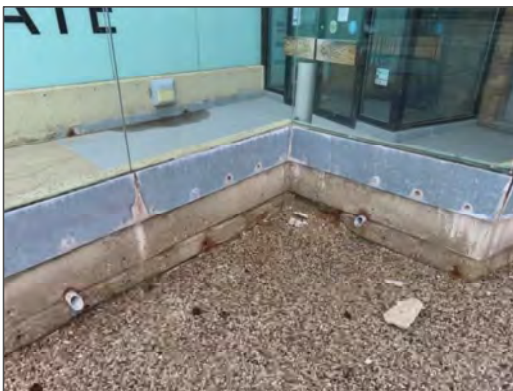
View of an area which poorly diverts water atop the northwest portion of Section 9 of the Site Building.

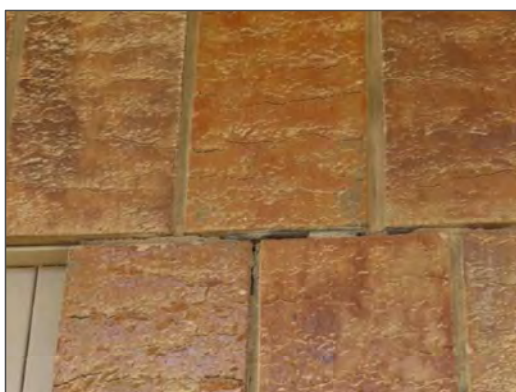
View of cracking in the ceramic tile joints on the east elevation the Site Building.

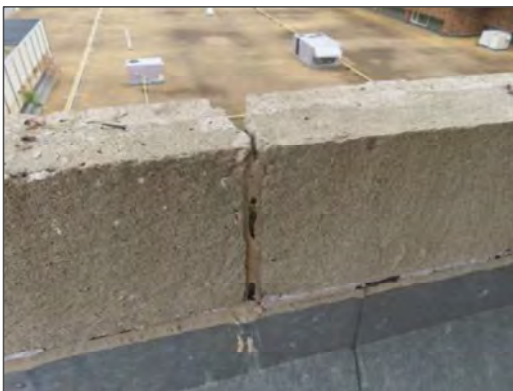
View of typical deteriorated precast concrete panel control joint sealant on multiple elevations the Site Building.

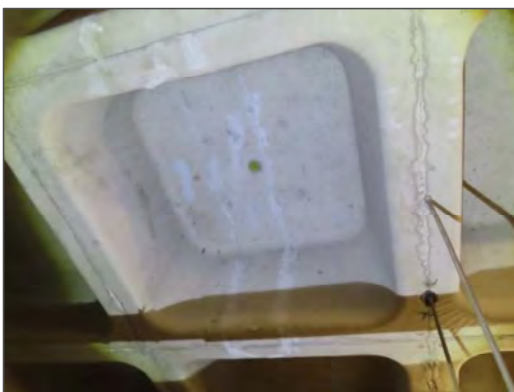
View cracking and moisture intrusion within the waffle slab observed from the main floor of the Site Building.

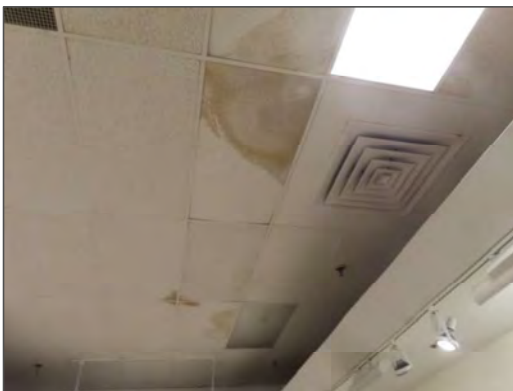
View of typical moisture stained ceiling tiles throughout the sales area of the Site Building.

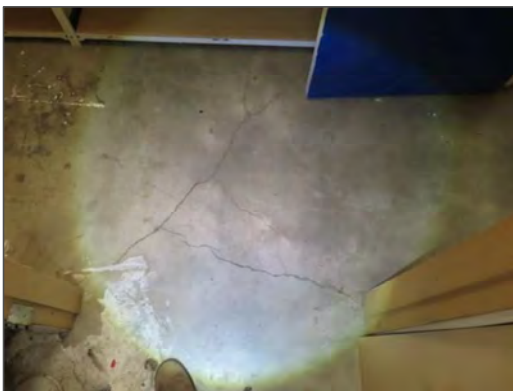
View of typical cracked concrete floor slab throughout the Site Building.

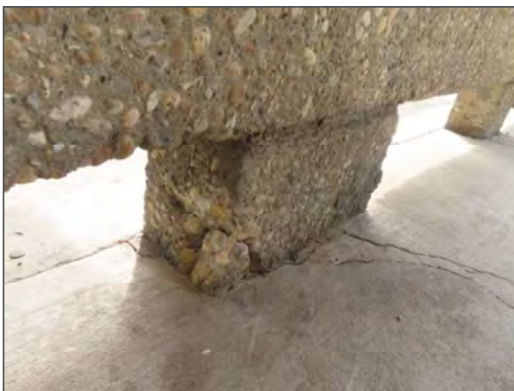
View of cracking and spalling of guardrail adjacent to the south elevation of the Site Building.

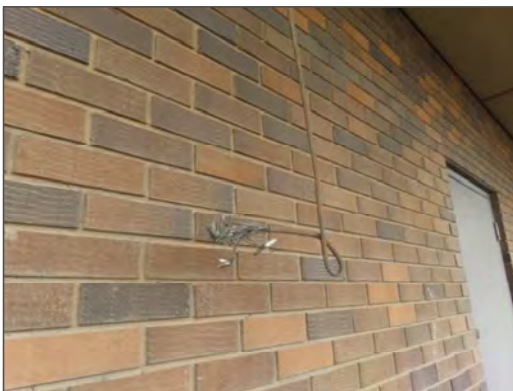
View of exposed wires atop 2nd floor roof of the Site Building.

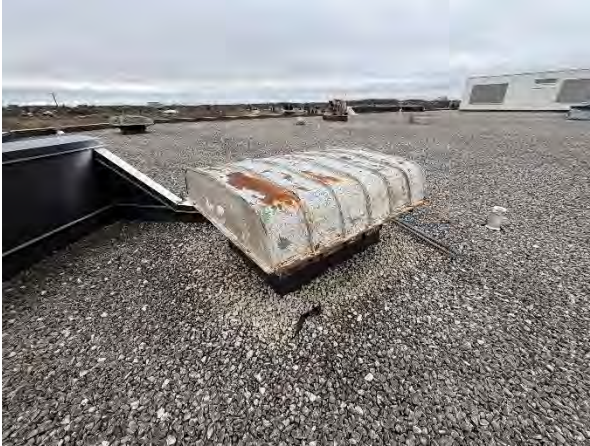
Figure 5: Exhaust hoods are typically corroded.

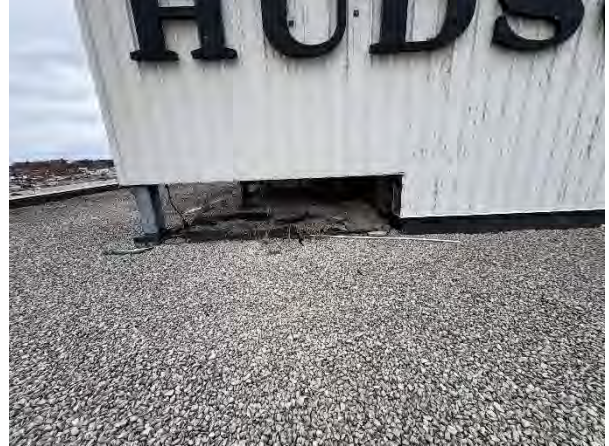
Figure 6: Vegetation growth observed near mechanical penthouse.

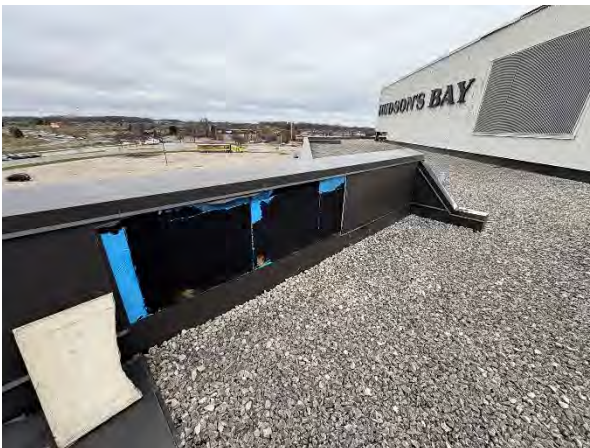
Figure 7: Missing parapet cladding removed, exposed membrane flashing.

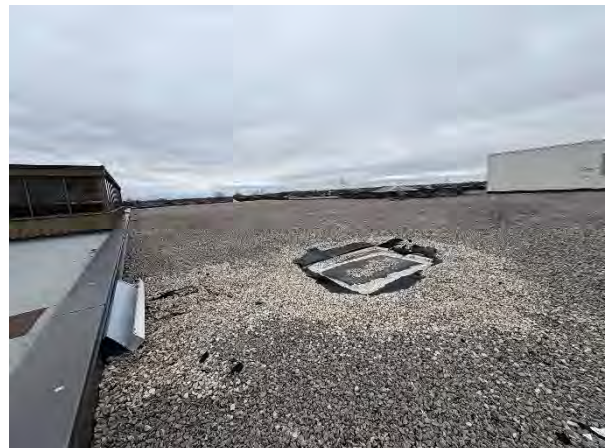
Figure 8: Damaged metal panel and flashing are visible on the west wall of the roof.

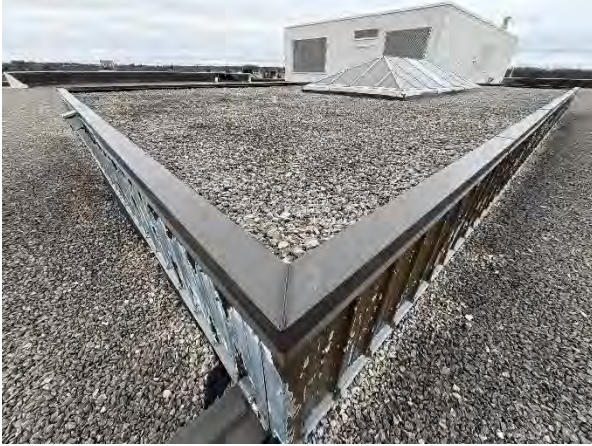
Figure 9: Peeling paint finish at metal siding.

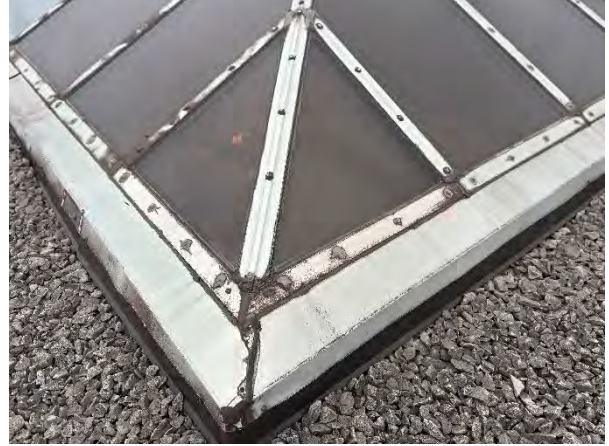
Figure 10: Deteriorated face sealant observed at skylight.
