**ONTARIO
SUPERIOR COURT OF JUSTICE
COMMERCIAL LIST**

AFFIDAVIT OF PATRICK SULLIVAN

FINAL Baseline Property Condition Assessment

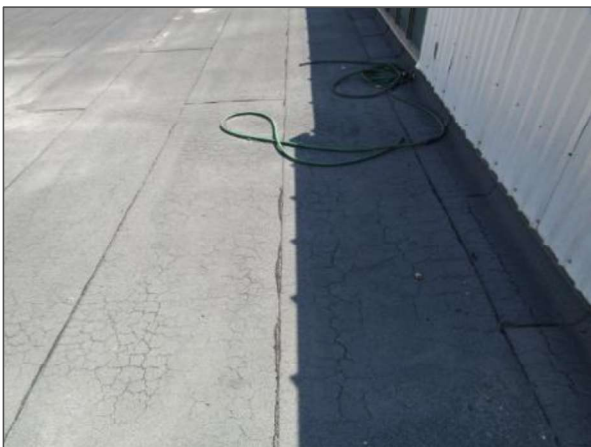
Areas of membrane crazing of the modified bitumen membrane roof system were noted atop Roof Section A3 in multiple locations.

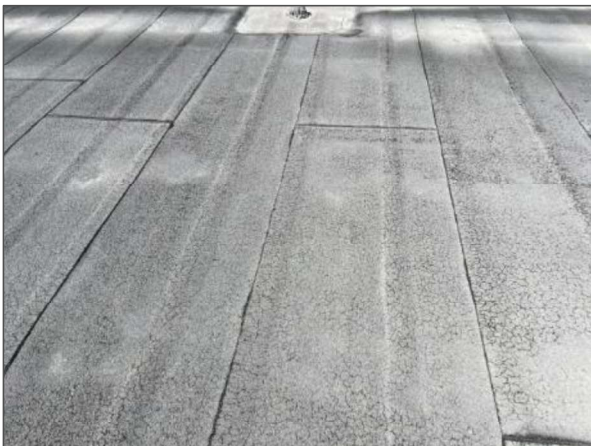
Areas of membrane crazing of the modified bitumen membrane roof system were noted atop Roof Section A5 in multiple locations.

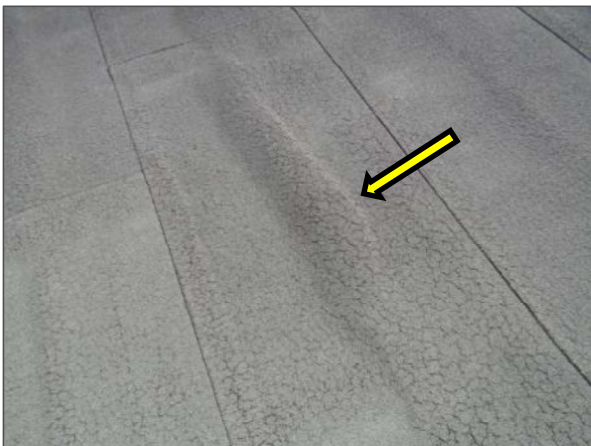
Areas of membrane blistering of the modified bitumen membrane roof system were noted atop Roof Section A3 in multiple locations.

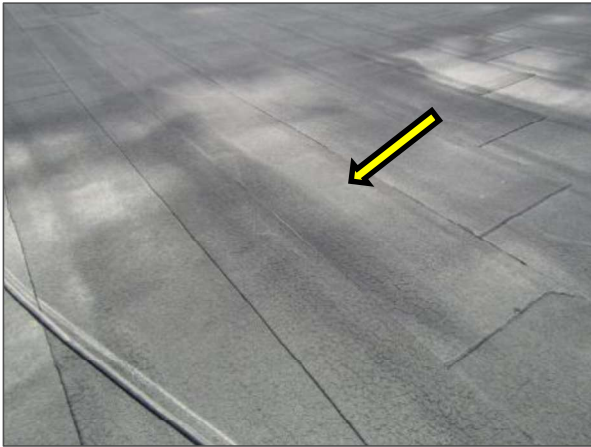
Areas of membrane blistering of the modified bitumen membrane roof system were noted atop Roof Section A4 in multiple locations.

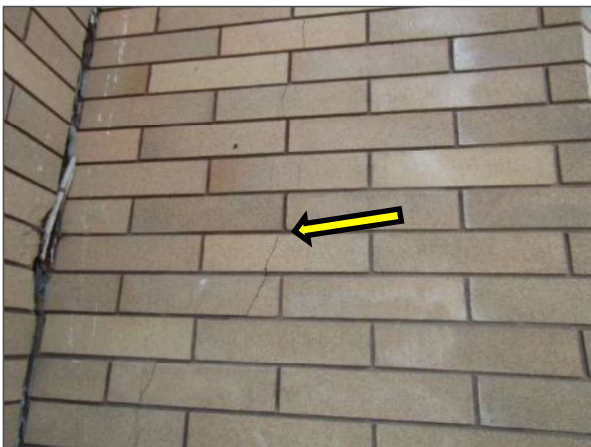
Localized areas of cracking within the brick veneer masonry were noted on the north elevation of the Site Building.

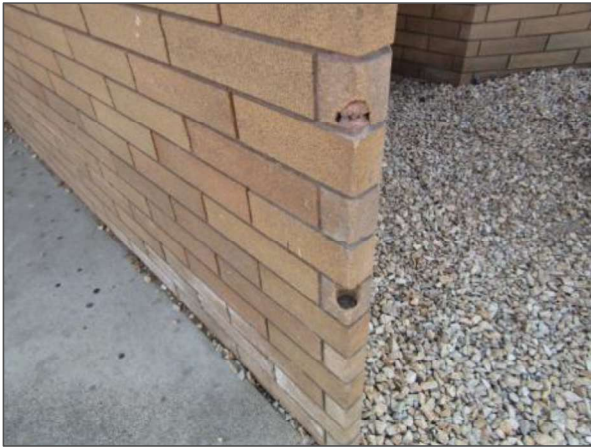
Areas of damaged brick veneer masonry were noted on the north elevation of the Site Building.

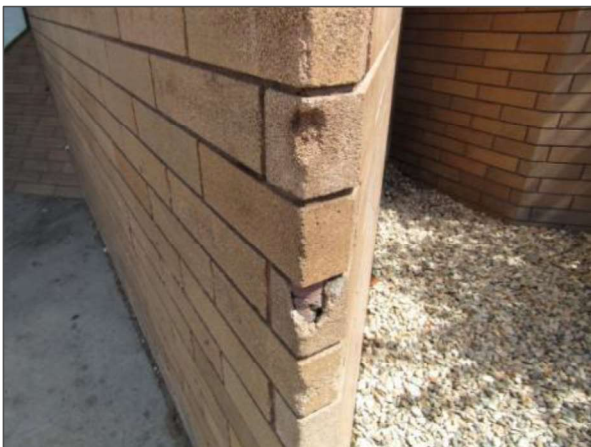
Areas of damaged brick veneer masonry were noted on the west elevation of the Site Building.

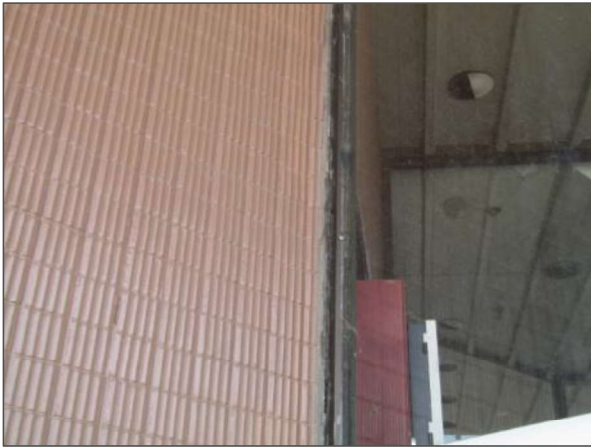
Aged door sealants were noted in multiple locations.

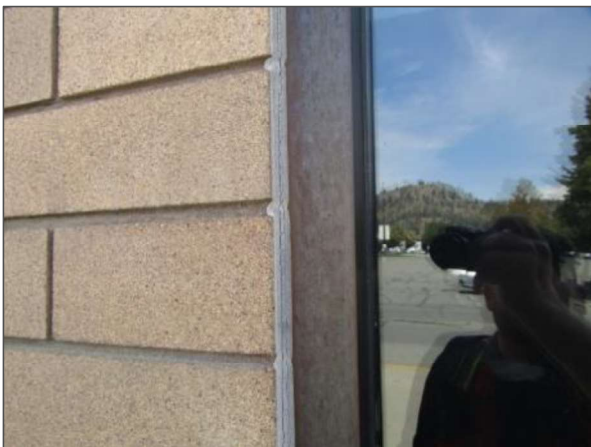
Aged window sealants were noted on the north elevation.

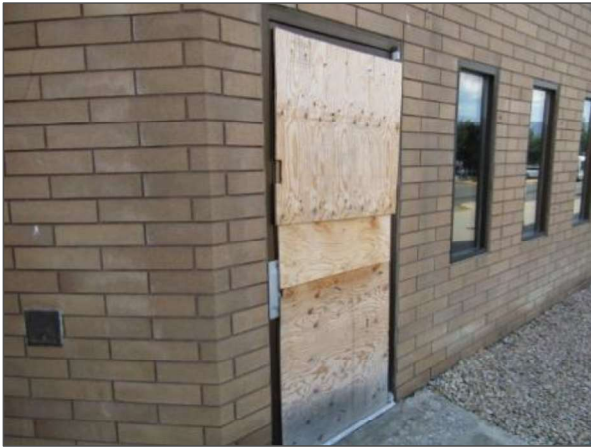
A damaged SG door was noted on the north elevation.

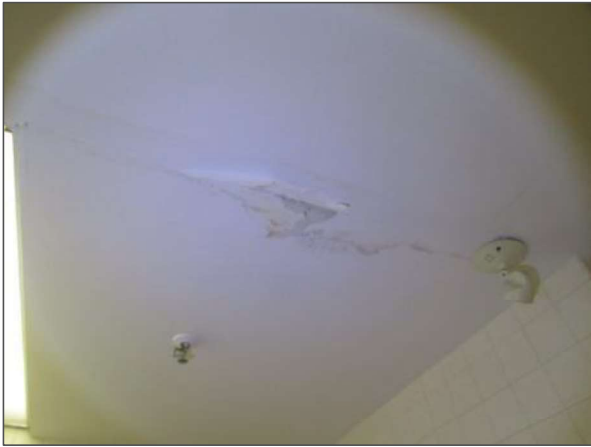
Moisture damage/stained gypsum ceiling board was noted in multiple locations of the Site Building.

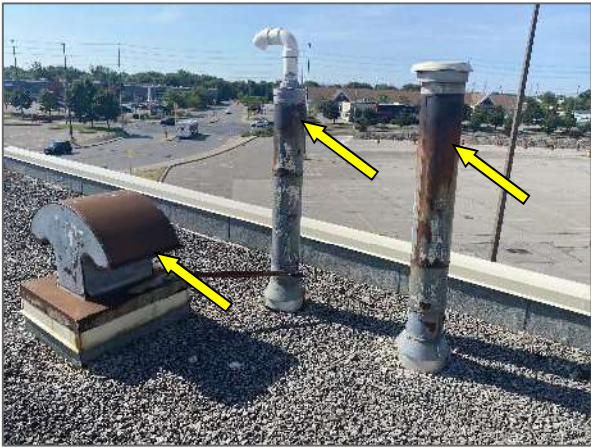
View of corrosion noted on the combustion and exhaust vents on the south portion of the Site Building.

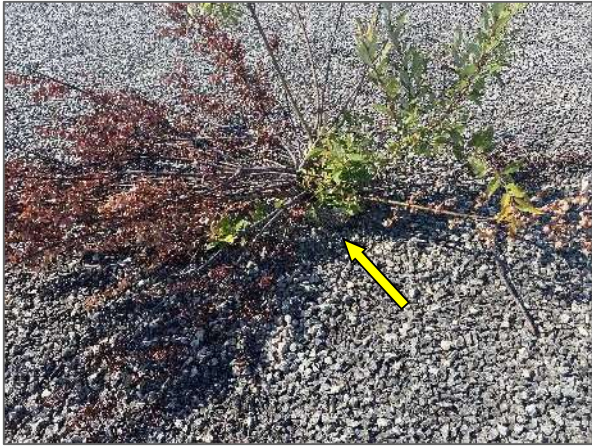
View of a partially obstructed roof drain noted in the central portion of the primary IRMA system.

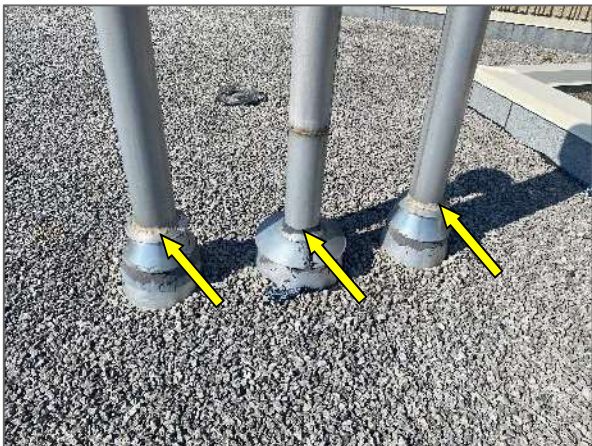
View of deteriorated sealants noted on vent penetrations in the southeast portion.

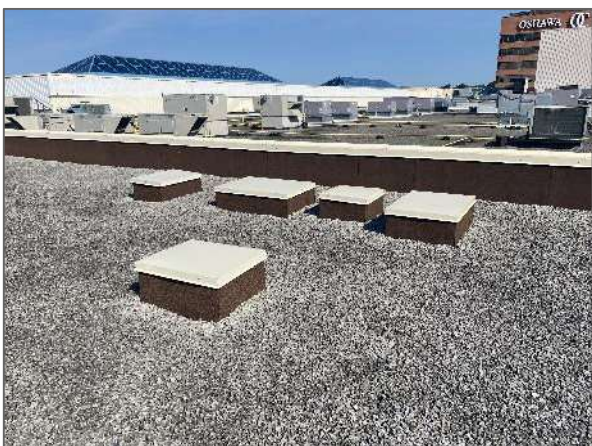
View of redundant HVAC curbs noted in the north portion of the primary IRMA system.

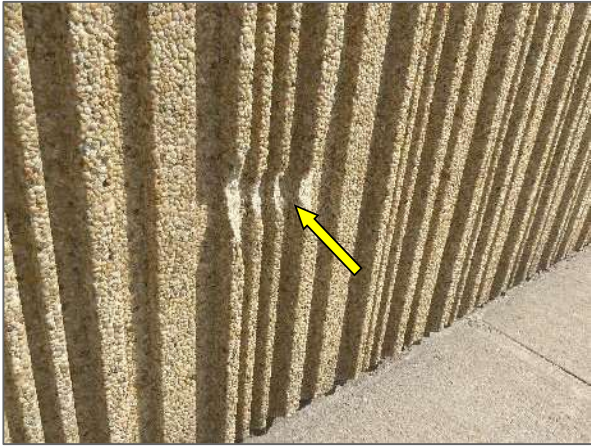
View of deterioration in the precast concrete wall panels noted on the south elevation of the Site Building.

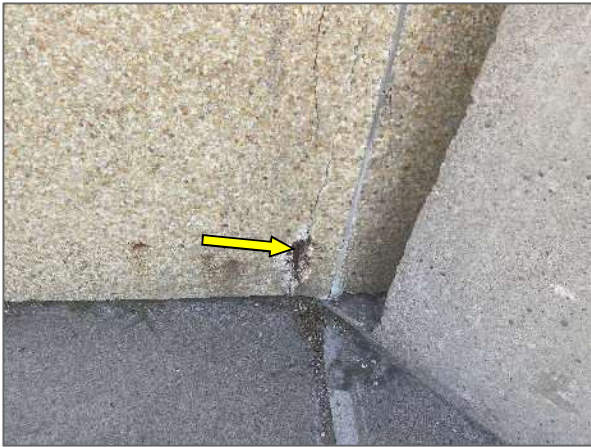
View of localized cracking and exposed rebar noted in a precast concrete wall panel on the south elevation of the Site Building.

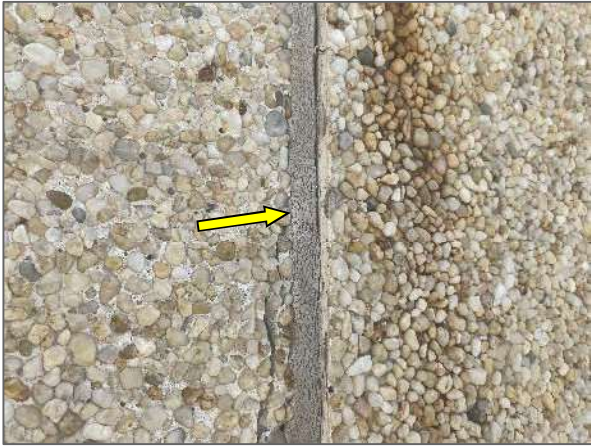
View of typical crazed/de-bonded wall panel sealant noted on the south elevation of the Site Building.

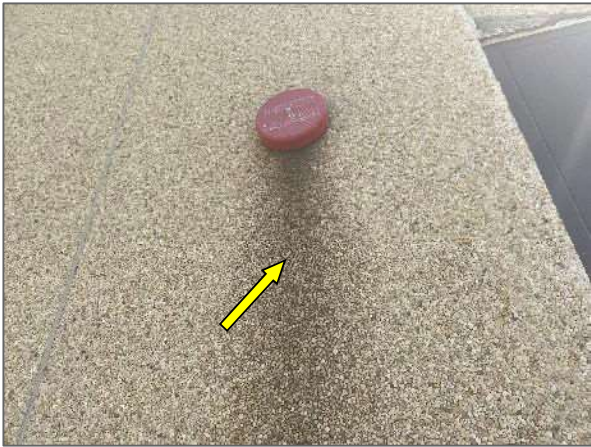
View of typical moisture staining noted on the south elevation of the Site Building.

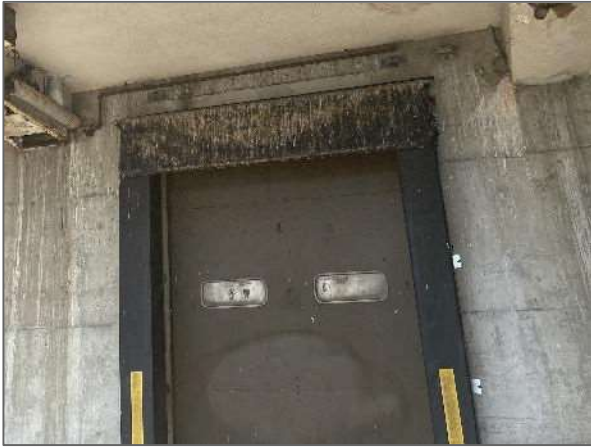
View of a typical aged sectional metal overhead door.

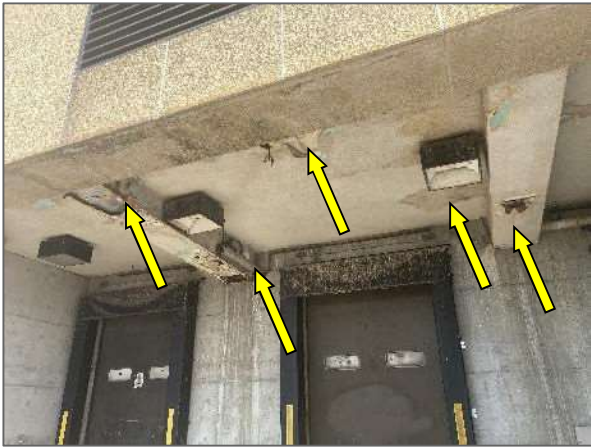
View of water-damaged gypsum board and exterior finishes on the soffit above the shipping/receiving area.

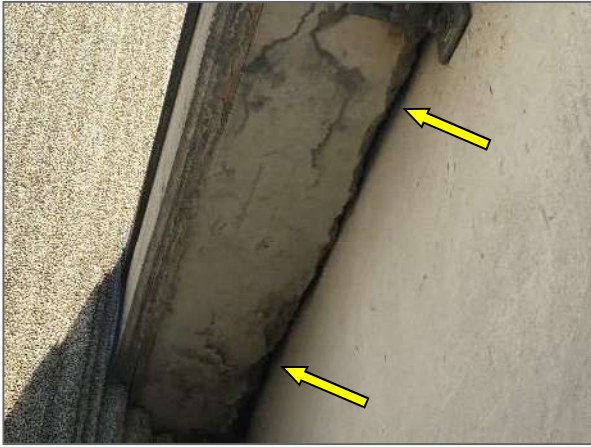
View of deteriorated concrete noted on a reinforced concrete beam in the southeast portion above the secondary roof.

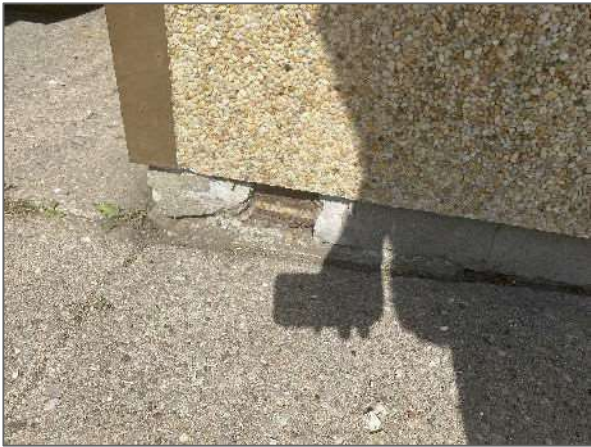
View of delaminated concrete in the cast-in-place concrete foundation wall noted on the east elevation of the Site Building.

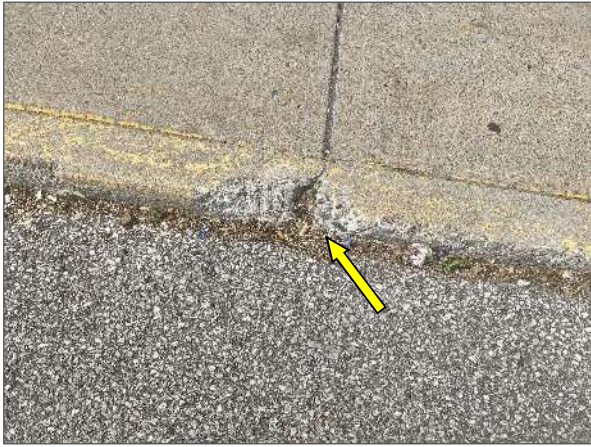
View of typical deterioration in the concrete curbs noted to the east of the Site Building.

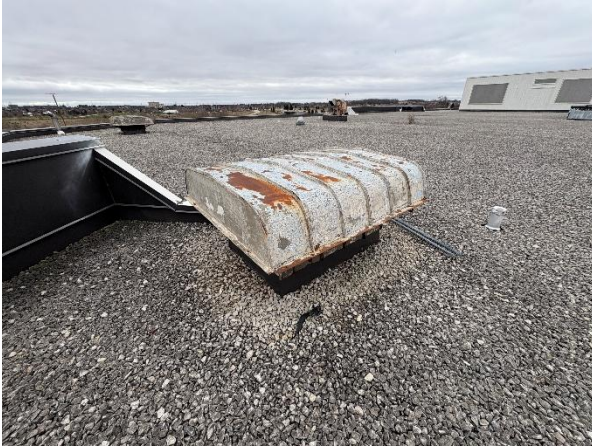
Figure 5: Exhaust hoods are typically corroded.

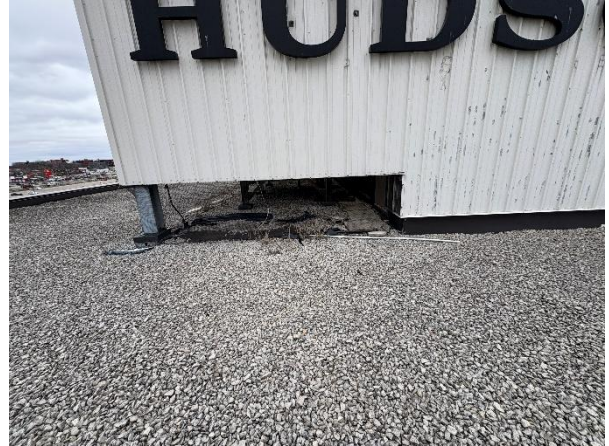
Figure 6: Vegetation growth observed near mechanical penthouse.

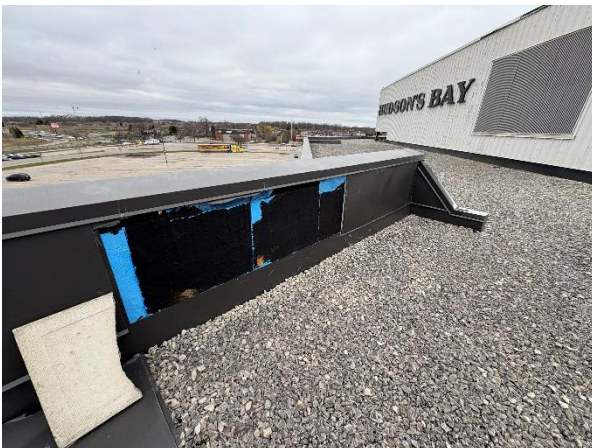
Figure 7: Missing parapet cladding removed, exposed membrane flashing.

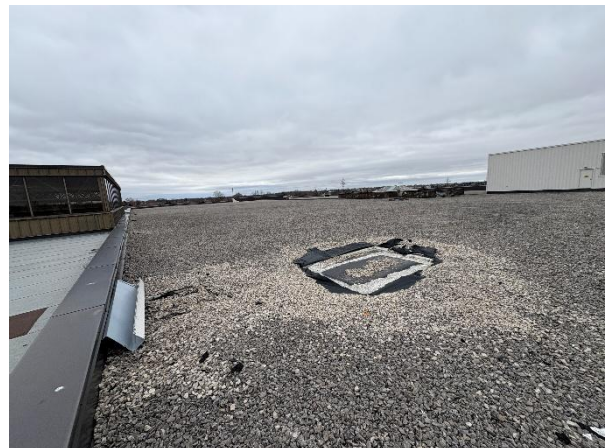
Figure 8: Damaged metal panel and flashing are visible on the west wall of the roof.

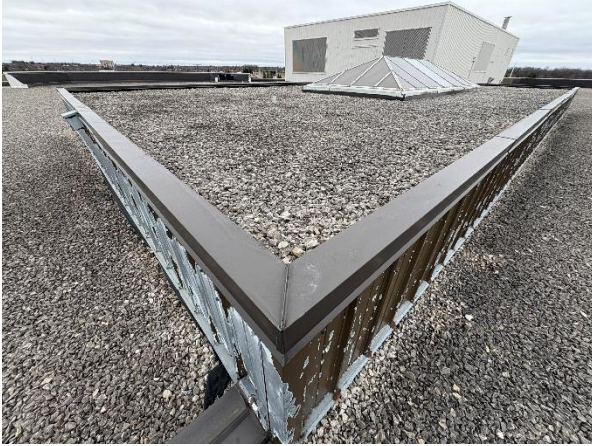
Figure 9: Peeling paint finish at metal siding.

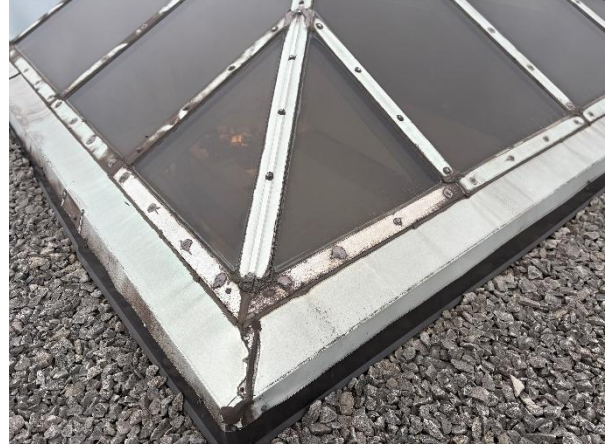
Figure 10: Deteriorated face sealant observed at skylight.
