This is the 1st Affidavit of Noor Mann
in this case and was made on February 27, 2025

Building Assessment Report

**3335-3345 Sexsmith Rd.
Kelowna, BC**

October, 2024

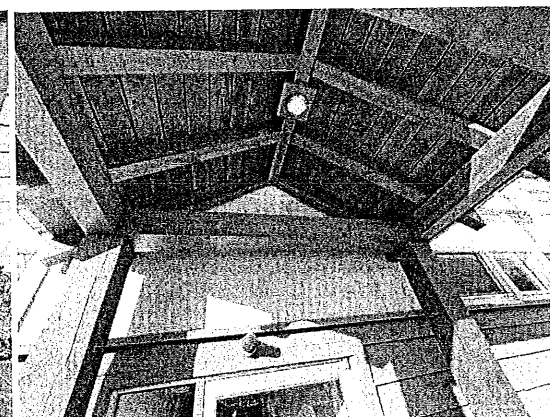
Wood structure not adequately secured to building

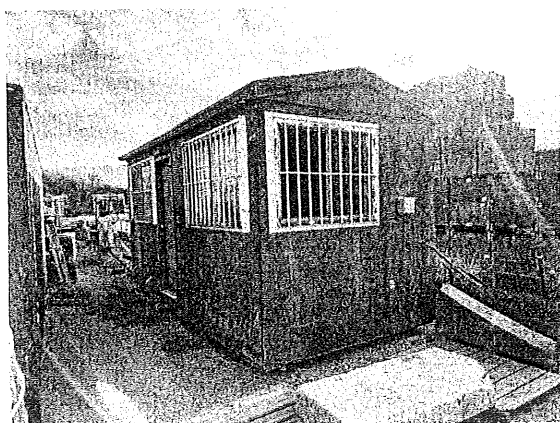
Old damaged storage shed

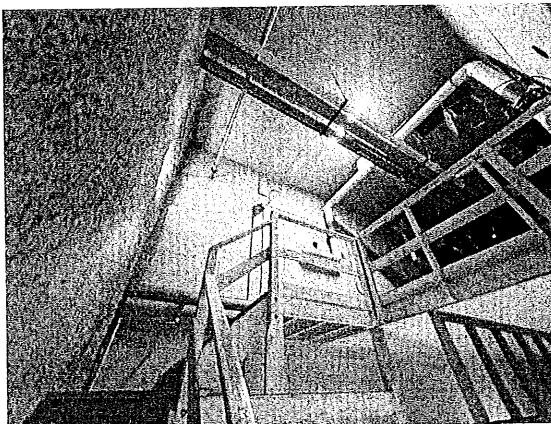
Non-standard guard openings and open structures

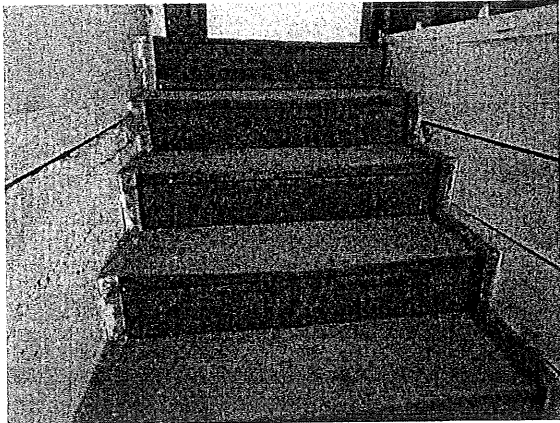
Uneven, unsafe stairway without handrailing

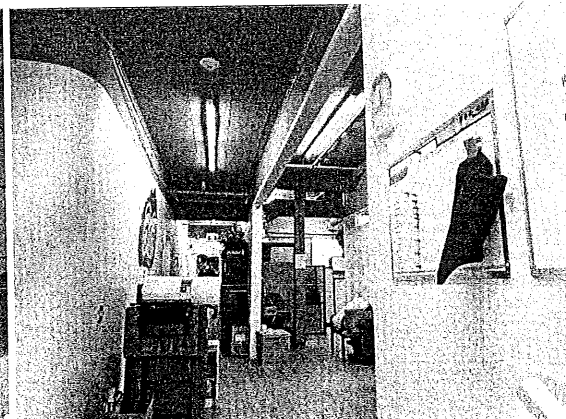
Well finished office spaces

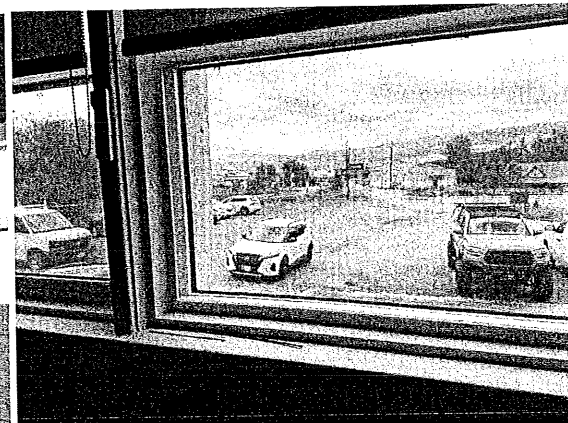
Newer double pane vinyl office windows.
