**RESPONDING MOTION RECORD
OF PRIMARIS MANAGEMENT INC.
(VOLUME 2 OF 3)**

FINAL **Baseline Property** **Condition Assessment**

2271 Harvey Avenue
Kelowna, British Columbia

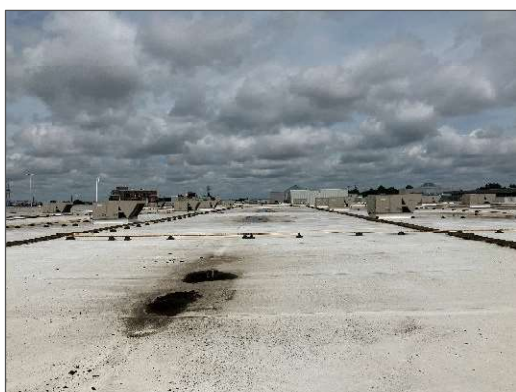
Findings	Remarks/Recommendations
Major Deficiencies/Findings	
<ul style="list-style-type: none"> The TPO membrane systems are approximately 17 years old and are anticipated to reach the end of their Expected Useful Life (EUL) within the term of analysis. 	<ul style="list-style-type: none"> Pinchin recommends and has included allowances for the replacement of the TPO membrane systems within the term of analysis.
Minor Deficiencies/Findings	
<ul style="list-style-type: none"> Several damaged walkway pavers noted atop the main TPO membrane system. 	<ul style="list-style-type: none"> Replace the damaged walkway pavers.
<ul style="list-style-type: none"> Partially obstructed debris guards noted at the roof drains. 	<ul style="list-style-type: none"> Ensure roof drains are unobstructed as part of ongoing general maintenance of the roof systems.
<ul style="list-style-type: none"> Perimeter flashing sealants noted to be deteriorated (i.e., aged, de-bonded, etc.). 	<ul style="list-style-type: none"> Replacement of deteriorated sealants is recommended as part of ongoing general maintenance of the roof systems.

General view of the main TPO membrane system.

It has been Pinchin's experience that the Expected Useful Life (EUL) of a TPO membrane system typically ranges between 17 to 20 years, depending on the quality of building materials used, the quality of workmanship during installation and the level to which the roof system has been maintained. The Site Representatives reported that the roof systems are original to the construction of the Site Building in 2008 (i.e., ~ 17 years old). Based on age, Pinchin recommends and has included allowances for the replacement of the roof systems within the term of analysis. Pinchin also recommends that regular annual maintenance be performed on the roof systems throughout the term of the analysis. Annual walk-on roof inspections are recommended to ensure any deficiencies or issues are discovered in a timely manner.

- Pinchin recommends and has included allowances for the replacement of the Thermoplastic Polyolefin (TPO) membrane systems within the term of analysis;

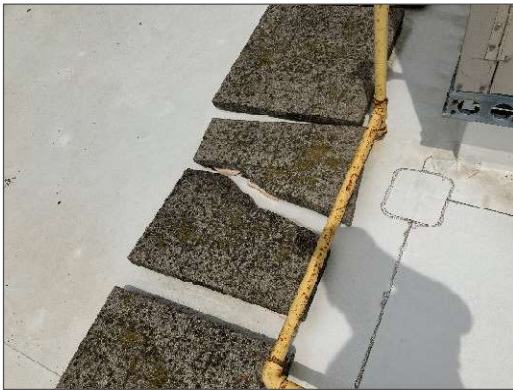
View of a damaged concrete walkway paver.

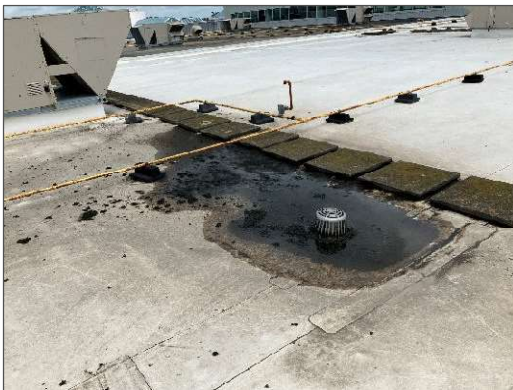
View of a partially obstructed roof drain debris guard.

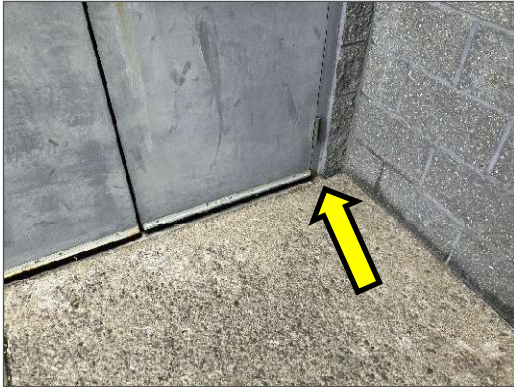
Findings	Remarks/Recommendations
Major Deficiencies/Findings	
<ul style="list-style-type: none"> None observed/reported. 	<ul style="list-style-type: none"> None required.
Minor Deficiencies/Findings	
<ul style="list-style-type: none"> Minor corrosion noted at the base of several metal door frames. 	<ul style="list-style-type: none"> Clean corrosion from the affected door frames and apply a corrosion inhibitive coating.
<ul style="list-style-type: none"> Minor impact damage observed at the EIFS. 	<ul style="list-style-type: none"> Repair the areas of minor impact damage and monitor for further deterioration throughout the term of analysis.
<ul style="list-style-type: none"> Linear cracking observed at the control joints of sections of EIFS. 	<ul style="list-style-type: none"> Seal areas of cracking in the EIFS.
<ul style="list-style-type: none"> Areas of minor step cracking noted at the concrete block masonry walls. 	<ul style="list-style-type: none"> Repoint the mortar in the affected areas and monitor for further deterioration throughout the term of analysis.

View of minor corrosion at the base of a metal door frame.

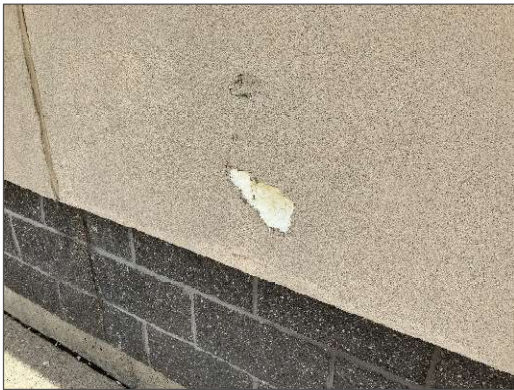
View of minor impact damage at EIFS.

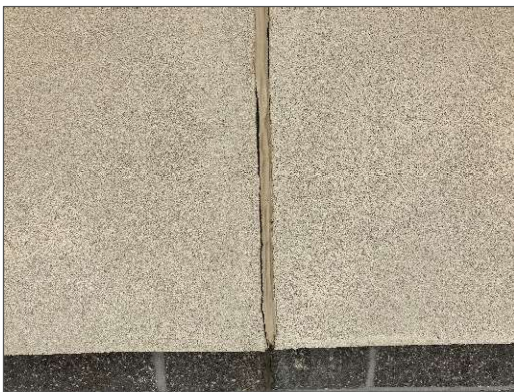
View of a linear crack at an EIFS panel joint.

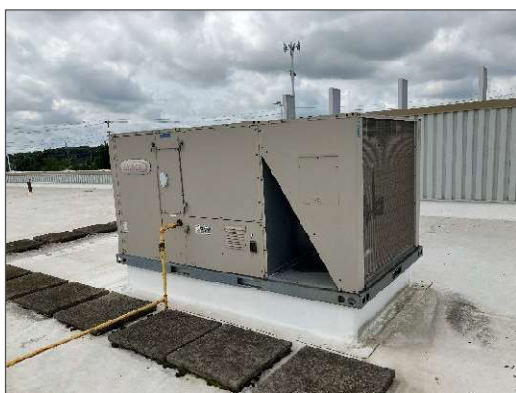
View of a typical rooftop packaged HVAC unit serving the Site Building.

It has been Pinchin's experience that the EUL of a packaged HVAC unit typically ranges between 15 to 20 years and the EUL of suspended unit heaters typically ranges between 20 to 25 years, depending on the quality of the unit the level to which the unit has been maintained.

- Based on age, Pinchin recommends and has included allowances for the phased replacement of the 25 rooftop packaged HVAC units within the term of analysis;

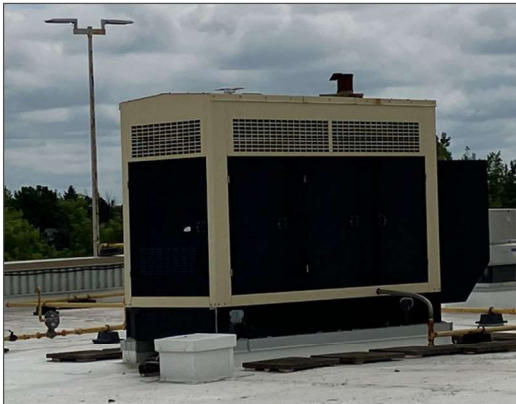
Findings	Remarks/Recommendations
Major Deficiencies/Findings	
<ul style="list-style-type: none"> The emergency generator and automatic transfer switch are approximately 18 years old and are anticipated to reach the end of their EUL in the latter portion of the term of analysis. 	<ul style="list-style-type: none"> Pinchin recommends and has included a preliminary allowance for the replacement of the emergency generator and the automatic transfer switch in the latter portion of the term of analysis. It is recommended that a specialist review of the generator systems and automatic transfer switch be completed prior to replacement to determine a precise scope for replacement requirements.
<ul style="list-style-type: none"> The fire alarm panel and annunciator panel are approximately 18 years old and are anticipated to reach the end of their EUL within the term of analysis. 	<ul style="list-style-type: none"> Pinchin recommends and has included a preliminary allowance for the replacement of the fire alarm panel and annunciator panel within the term of analysis. It is recommended that a specialist review of the fire alarm systems be completed prior to replacement to determine replacement requirements for concealed components of the fire alarm system including wiring, annunciators, etc.

Minor Deficiencies/Findings	
<ul style="list-style-type: none"> The previous testing and inspection of the emergency generator appears to have taken place in 2021. 	<ul style="list-style-type: none"> Annual testing and inspection of the emergency generator systems is recommended.

View of the emergency generator serving the Site Building.

- Pinchin recommends that a specialist review of the generator systems and automatic transfer switch be completed prior to replacement to determine a precise scope for replacement requirements.

- Pinchin recommends and has included a preliminary allowance for the replacement of the emergency generator and the automatic transfer switch in the latter portion of the term of analysis;

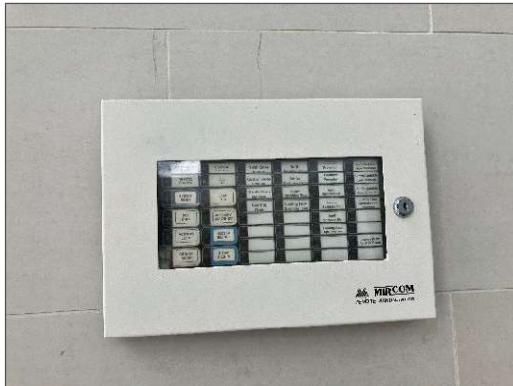
View of the annunciator panel.

- Pinchin recommends and has included a preliminary allowance for the replacement of the fire alarm panel and annunciator panel within the term of analysis.

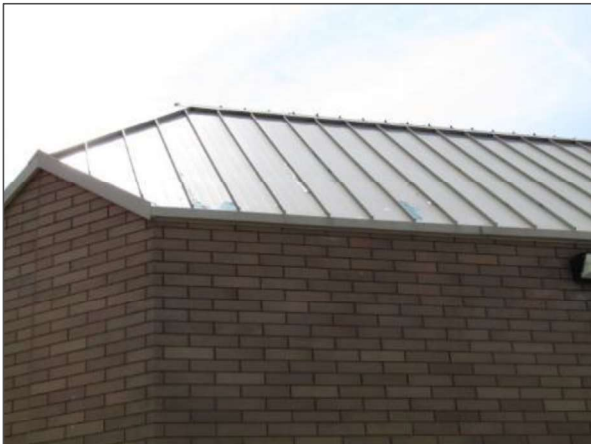
Findings	Remarks/Recommendations
<ul style="list-style-type: none"> Areas of delaminated paint were noted atop the sloped metal mansard style roof areas. 	<ul style="list-style-type: none"> Replace areas of delaminated paint.

General view of a typical sloped Metal mansard style roof area serving the Site Building.

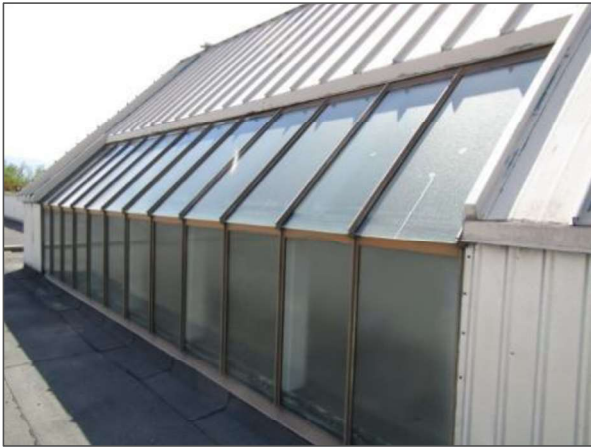
<ul style="list-style-type: none"> The glazed roof areas atop the Site Building are estimated to be in excess of 25 years of age and have attained their EUL. In addition, the glazed roof areas were noted to be exhibiting signs of age and ware (i.e., cracked glazed units, etc.). 	<ul style="list-style-type: none"> Based on estimate age and observed conditions, Pinchin recommends replacement of the glazed roof areas atop the Site Building of the Site Building within the early portion of the term of the analysis.
Minor Deficiencies/Findings	
<ul style="list-style-type: none"> Missing debris strainers were noted atop Roof Section 6. 	<ul style="list-style-type: none"> Install debris strainers.
<ul style="list-style-type: none"> Poorly executed service penetrations were noted in multiple locations atop the Roof Sections of the Site Building. 	<ul style="list-style-type: none"> Undertake localized repairs to prevent potential moisture infiltration.

General view of a typical glazed roof area serving the Site Building.

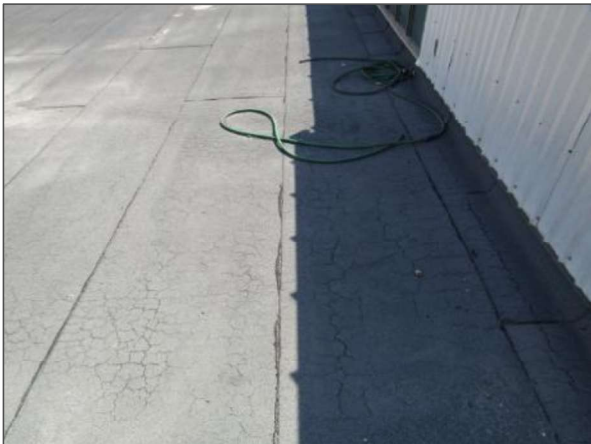
Areas of membrane crazing of the modified bitumen membrane roof system were noted atop Roof Section A3 in multiple locations.

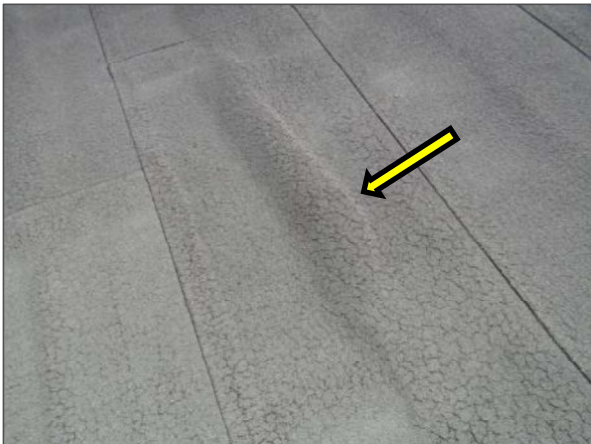
Areas of membrane blistering of the modified bitumen membrane roof system were noted atop Roof Section A3 in multiple locations.

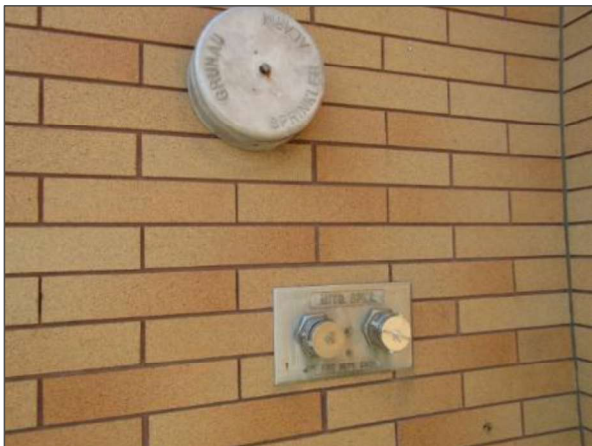
General view of the FDC noted on the south elevation.

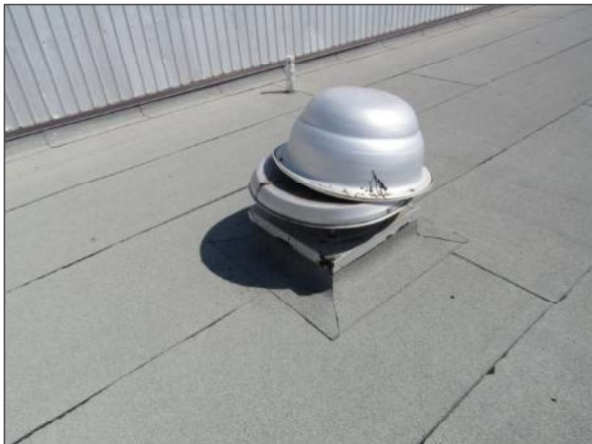
Damaged exhaust units were noted atop the Site Building.

The above-referenced mechanical systems vary in age and either have or will have attained their EUL within the term of the analysis. As such, Pinchin recommends budgeting for replacements of the above-referenced mechanical systems identified in Table 3.8 mentioned above within the term of the analysis.

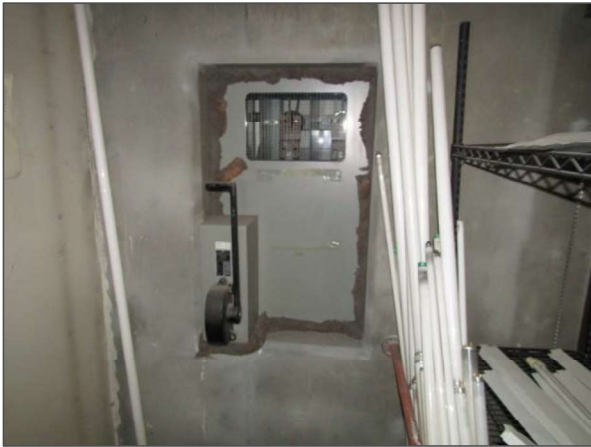
General view of the transformer vault.

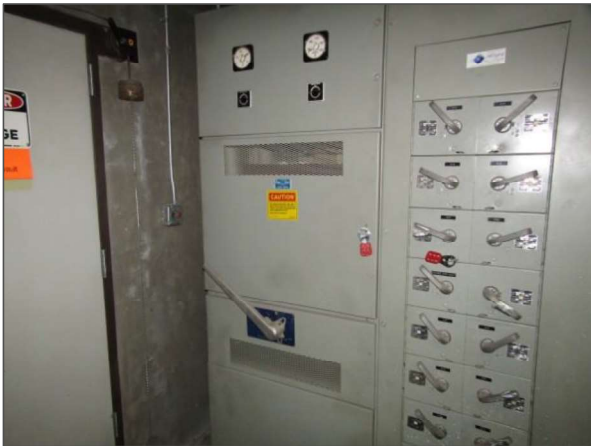
General view of the main electrical service.

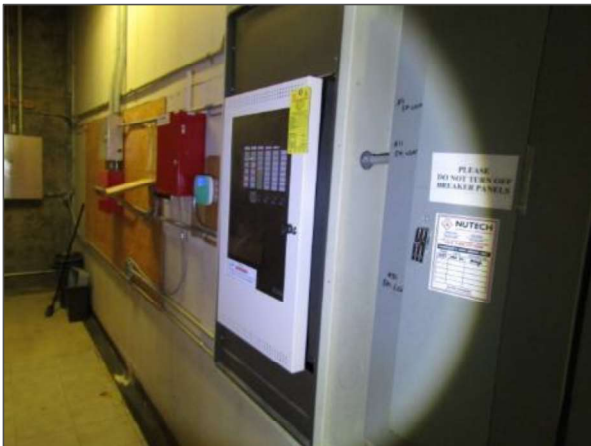
General view of the "Mircom" main fire alarm panel.

The fire alarm system was observed to be past-due its annual inspection date.

As previously mentioned, the fire alarm systems serving the Site Building is estimated to be approximately 15 to 20 years old and will attain its EUL within the term of the analysis. Based on estimated age, replacement of the fire alarm systems serving the Site Building is anticipated to be required within the mid portion of the term of the analysis. A specialist review of the fire alarm systems is recommended prior to replacement to verify its condition, cost, timing of replacement and identify additional upgrade/replacement requirements. Pinchin has excluded any cost related to repairs/replacement of the fire alarm systems and associate components as it is subject to findings.

The electrical systems were noted to be in serviceable condition at the time of the Site visit; however, the fire alarm system was observed to be past-due its annual inspection date. As such, Pinchin recommends the immediate inspection of the fire alarm system.

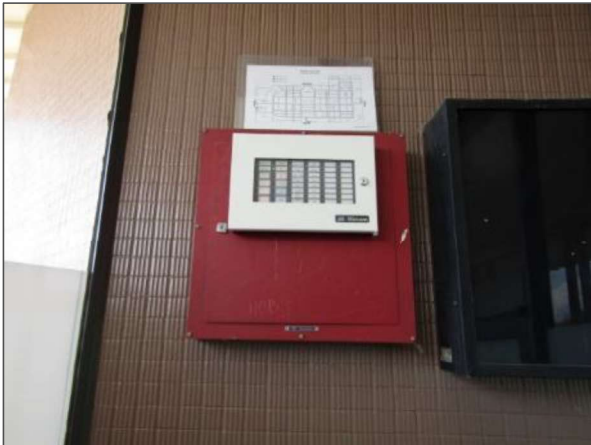
General view of the annunciator panel.
