**RESPONDING MOTION RECORD
OF PRIMARIS MANAGEMENT INC.
(VOLUME 1 OF 3)**

FINAL **Baseline Property** **Condition Assessment**

419 King Street West, Oshawa,
Ontario

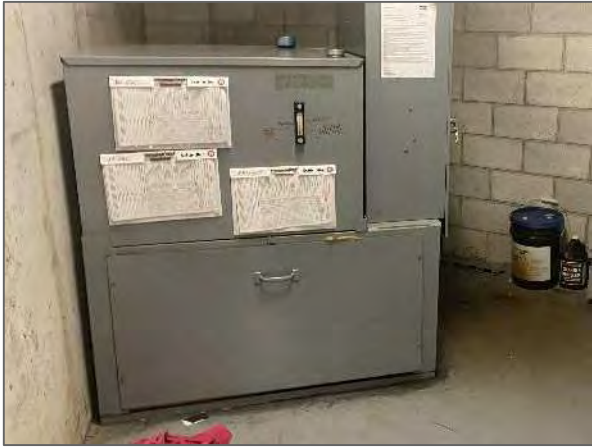
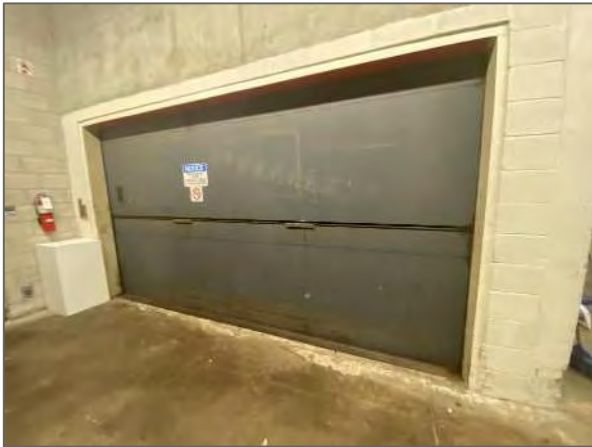
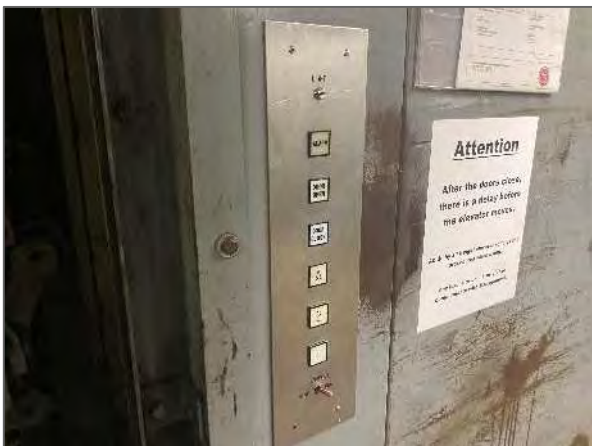
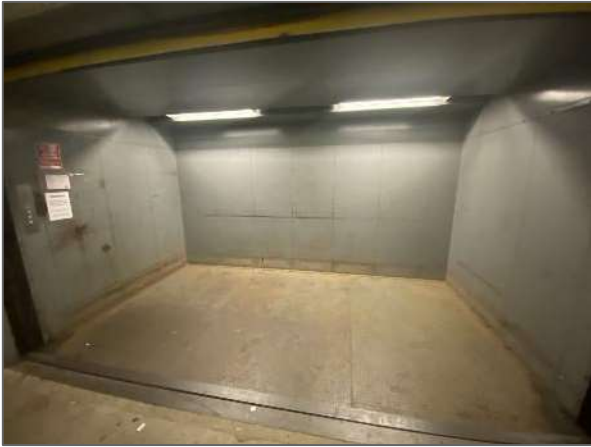
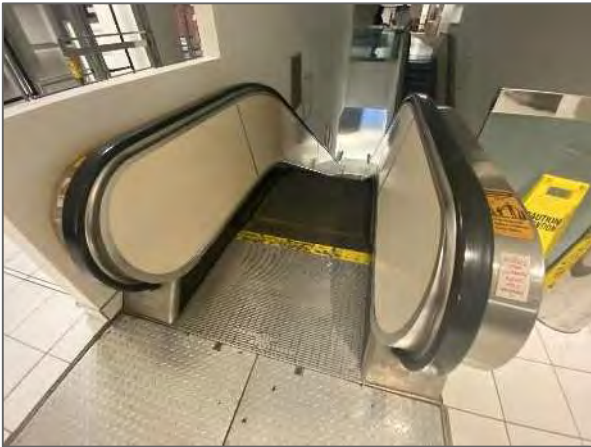
Findings	Remarks/Recommendations
Major Deficiencies/Findings	
<ul style="list-style-type: none">The elevator and escalator systems serving the Site Building are estimated to be original to the construction of the Site Building in 1977 (i.e., approximately 48 years old) with no reported modernizations and have exceeded the end of their EULs.	<ul style="list-style-type: none">Pinchin recommends a detailed review/survey of the elevator and escalator systems to be completed within the early portion of the term of analysis (which can be managed below the capital threshold) by a qualified elevator consultant to determine and better understand the condition of the elevator systems and identify/confirm the need, cost and timing for modernization/upgrading of the elevator system. Note: A preliminary allowance has been carried for modernization of the elevator and escalator systems; however, this cost can vary greatly depending on the results of the specialist review of the elevator system.

<ul style="list-style-type: none">The TSSA license certificates for the elevator systems were noted to be expired.	<ul style="list-style-type: none">The elevator systems are required to be inspected and certified by a certified TSSA personnel annually.
Minor Deficiencies/Findings	
<ul style="list-style-type: none">None observed/reported.	<ul style="list-style-type: none">None required.

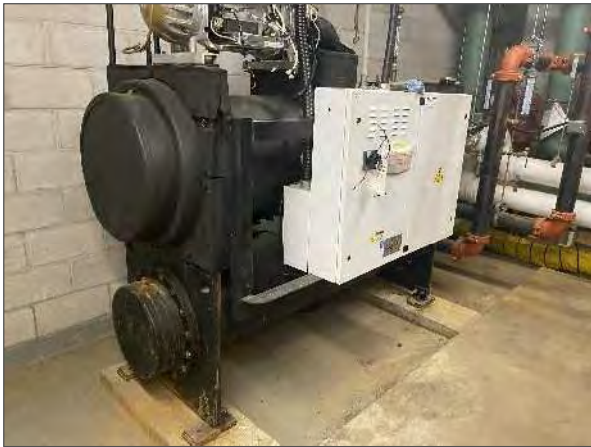
View of a "Smardt" chiller.

In summary, the mechanical systems within the Site Building are currently in serviceable condition. It has been Pinchin's experience that the EUL of an AHU, a chiller and a cooling tower typically ranges between 25 to 30 years, the EUL of a suspended unit heater typically ranges between 20 to 25 years and the EUL

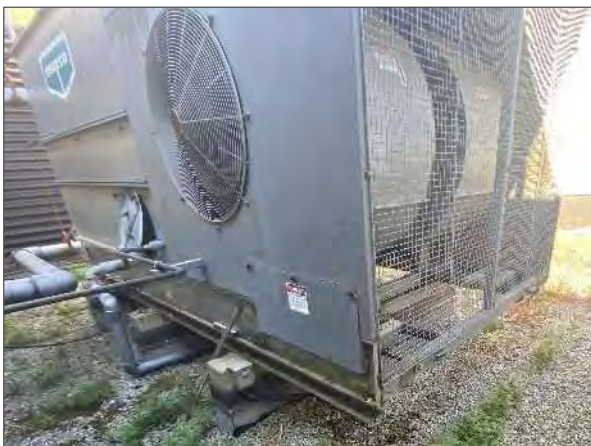
View of the "Evapco" cooling tower.

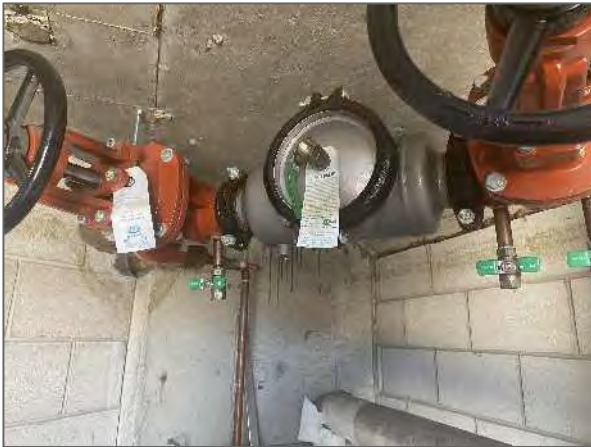
<ul style="list-style-type: none"> The backflow prevention device installed onto the domestic water main incoming line was noted to be missing annual inspection tags. 	<ul style="list-style-type: none"> The backflow prevention device is required to be inspected annually.
<ul style="list-style-type: none"> The fire sprinkler main riser is not equipped with a backflow prevention device. 	<ul style="list-style-type: none"> Consideration should be given to performing a cross-connection survey to determine the feasibility of equipping the Site Building with a backflow prevention device onto the fire sprinkler main riser.
<ul style="list-style-type: none"> Required signage indicating the location of the fire department connections was not observed. 	<ul style="list-style-type: none"> Install appropriate signage within the vicinity of the fire department connections.

View of the "Zurn Wilkins" backflow prevention device installed onto the domestic water main incoming line.

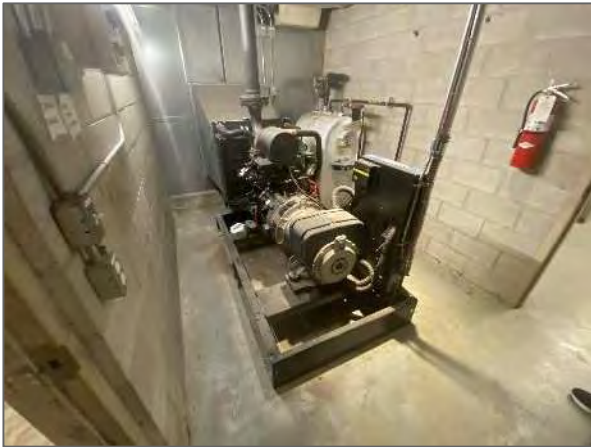
Findings	Remarks/Recommendations
Minor Deficiencies/Findings	
<ul style="list-style-type: none"> The main electrical distribution systems of the Site Building are operational with no major deficiencies noted or reported; however, some of the electrical components and distribution systems appear to be original to the construction of the Site Building in 1977 (i.e., approximately 48 years old) and will be approaching the end of their EUL within the term of analysis. 	<ul style="list-style-type: none"> Based on the age of the older electrical components and distribution systems, consideration should be given for review of the electrical systems within the Site Building by a qualified electrical engineer within the term of analysis to determine the condition and identify/confirm the need, cost and timing for replacement/upgrading if required.
<ul style="list-style-type: none"> A diesel fuel system complete with an above ground storage tank were noted to serve the emergency generator. 	<ul style="list-style-type: none"> Pinchin recommends a TSSA inspection of the diesel fuel system and above ground storage tank in order to determine code compliance and to confirm the working condition of the system.

View of the "SDMO" diesel-fired emergency generator.

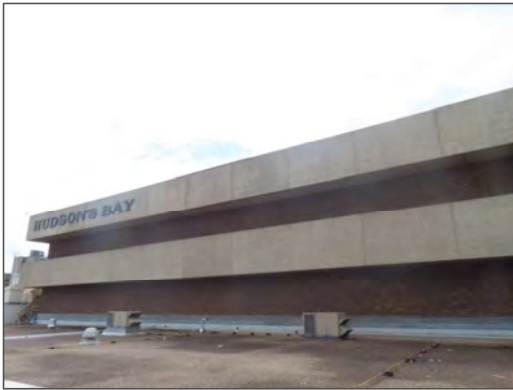
Partial view of the north elevation of the Site Building.

Note: Bounded by the “Southgate Centre” thus limiting visual assessment.

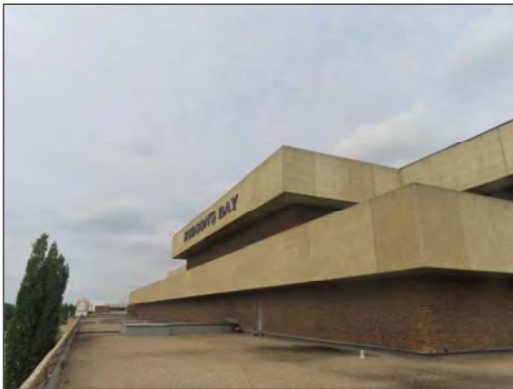
Partial view of the west elevation of the Site Building.

Note: Bounded by the “Southgate Centre” thus limiting visual assessment.

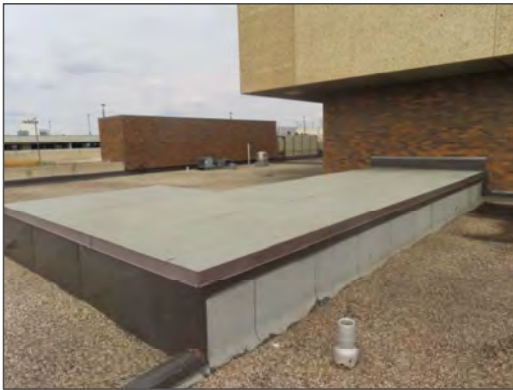
General view of typical raised modified bitumen membrane roof system atop Sections 8 and 9 of the Site Building.

Note: Section 9 is shown.

Findings	Remarks/Recommendations
<ul style="list-style-type: none"> Deteriorated pitch pocket serving the ladder footing was noted atop Section 8 of the Site Building. 	<ul style="list-style-type: none"> Replenish depleted pitch pocket to prevent potential moisture infiltration.
<ul style="list-style-type: none"> Vegetation growth was noted atop Section 9 of the Site Building. 	<ul style="list-style-type: none"> Remove the areas of vegetation growth as part of routine maintenance.
<ul style="list-style-type: none"> Deteriorated and ponding were noted atop raised modified bitumen membrane roof system atop Sections 8 and 9 of the Site Building. Unadhered modified modified membrane was noted atop raised modified bitumen membrane roof system atop Section 9 of the Site Building. 	<ul style="list-style-type: none"> Undertake proactive repairs to the areas of raised modified bitumen membrane roof system.

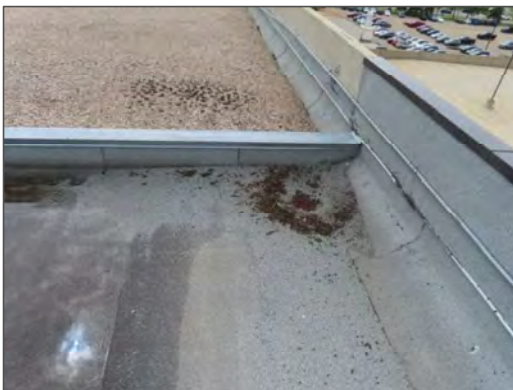
View of typical degranulation and deterioration of the modified bitumen membrane atop multiple sections of the Site Building.

Note: Section 1 is shown.

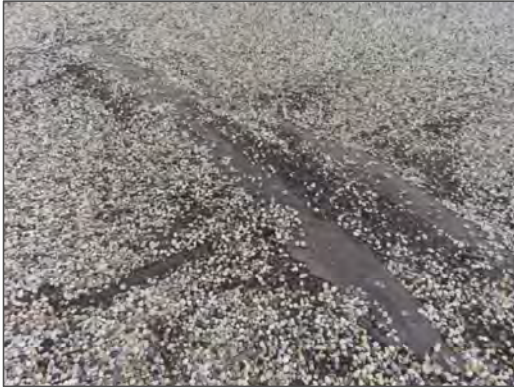
View of a blister within the BUR system of
Section 2 atop the Site Building.

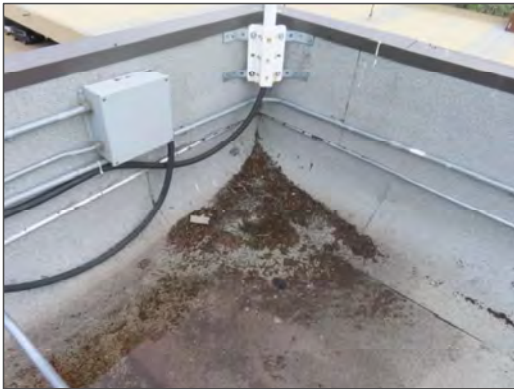
View of typical organic accumulation,
degranulation and deterioration of the modified
bitumen membrane atop multiple sections of the
Site Building.

Note: Section 3 is shown.

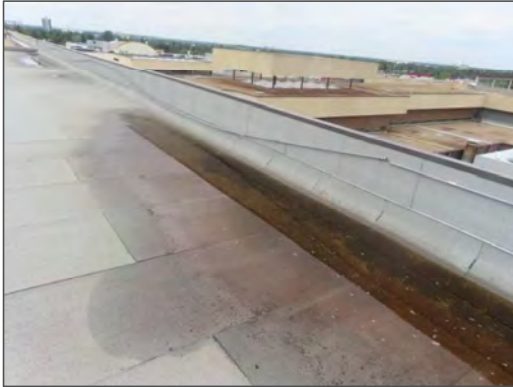
View of typical evidence of ponding atop multiple sections the Site Building.

Note: Section 3 is shown.

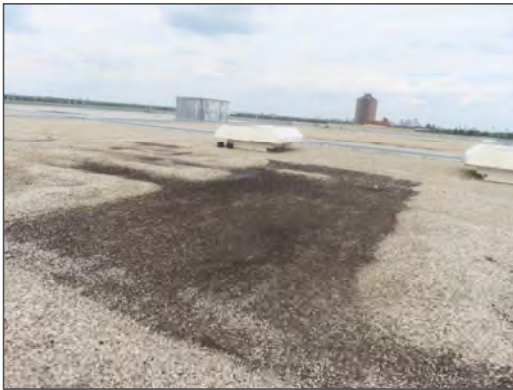
View of typical area of historic repairs atop multiple BUR sections the Site Building.

Note: Section 5 is shown.

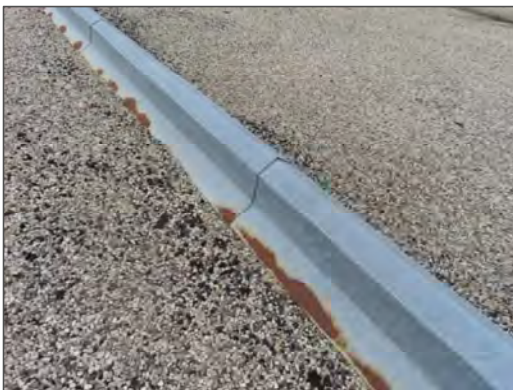
View of corroded flashing atop Section 5 of the Site Building.

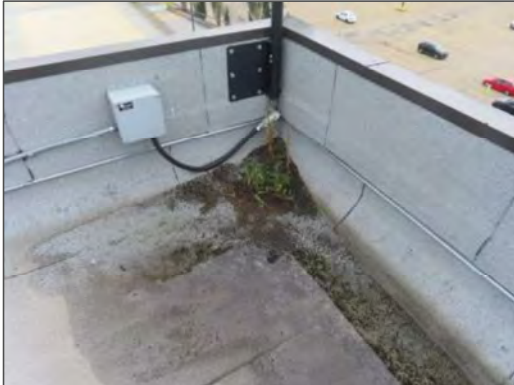
View of typical degranulation and deterioration of the modified bitumen membrane atop multiple Sections of the Site Building.

Note: Section 6 is shown.

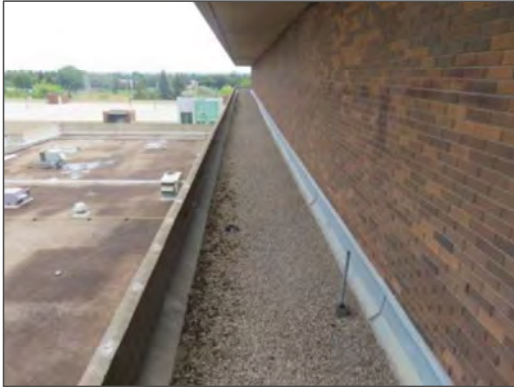
General view of a typical overhang roof area atop
Section 8 of the Site Building.

Note: Asphalt bleedthrough is noted.

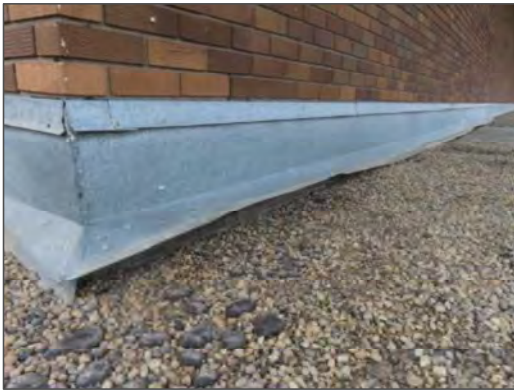
View of typical area of lifted flashing on the north
portion atop Section 8 of the Site Building.

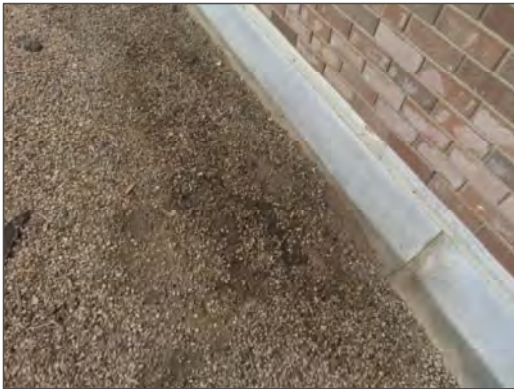
View of a blister within the BUR system of
Section 8 atop the Site Building.

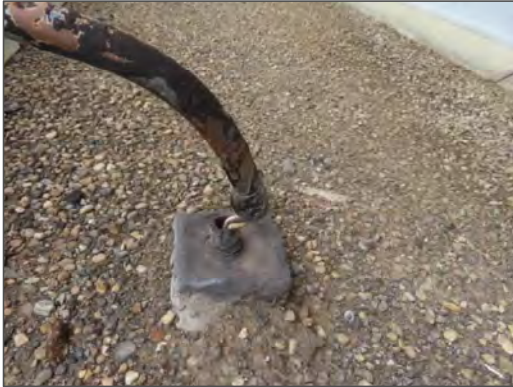
View of unsealed pitch pocket serving electrical conduit atop Section 8 of the Site Building.

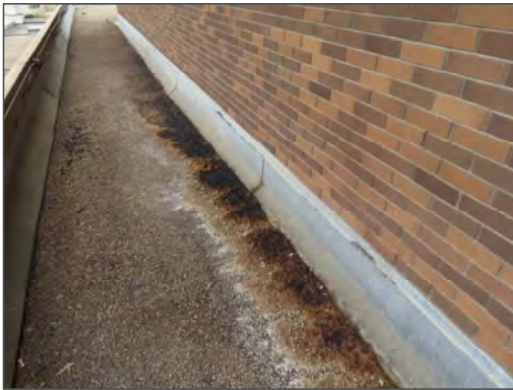
View of staining and debris accumulation atop Section 8 of the Site Building.

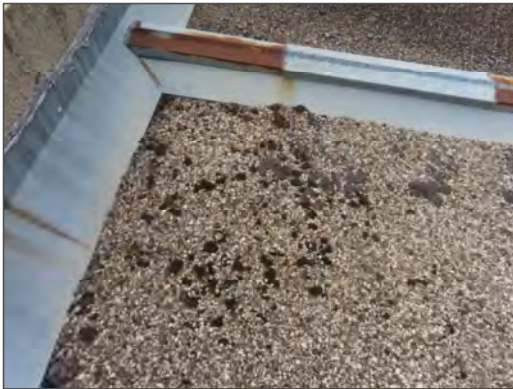
View of typical asphalt bleed through atop multiple BUR sections of the Site Building.

Note: Section 8 is shown.

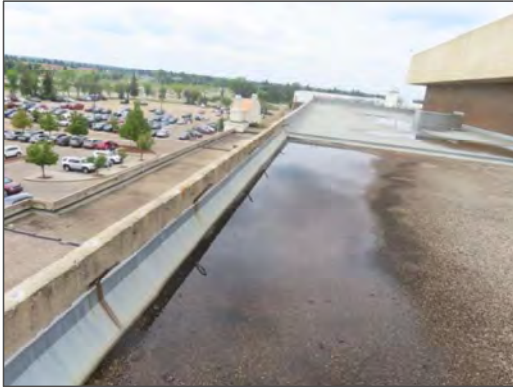
View of typical evidence of ponding atop multiple sections the Site Building.

Note: Section 8 is shown.

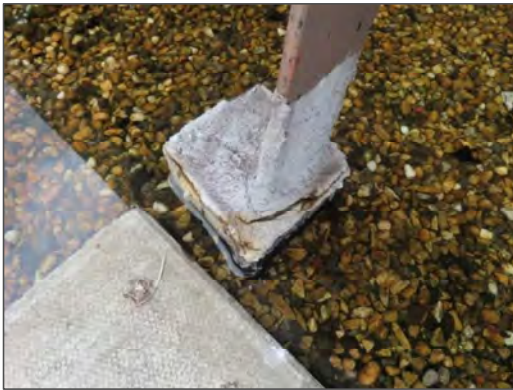
View of deteriorated pitch pocket serving the ladder footing atop Section 8 of the Site Building.

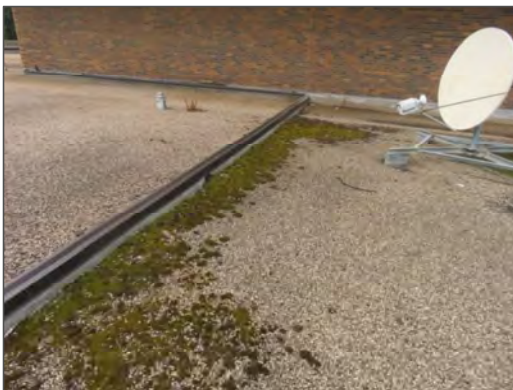
View of vegetation growth atop Section 9 of the Site Building.

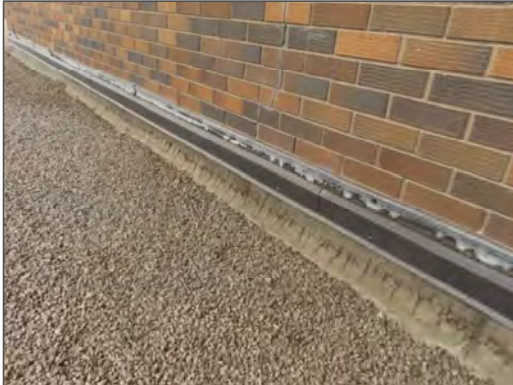
View of typical deteriorated membrane edge atop Sections 8 and 9 of the Site Building.

Note: Section 9 is shown.

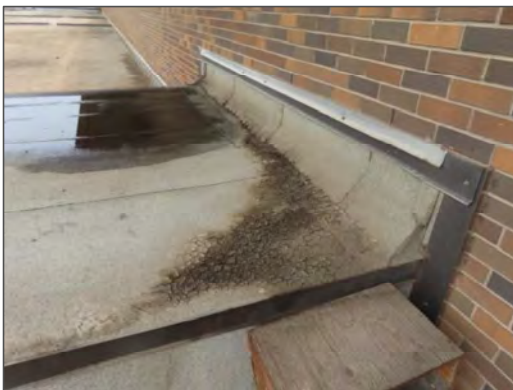
View of deteriorated and ponding atop raised modified bitumen membrane roof system atop Sections 8 and 9 of the Site Building.

Note: Section 9 is shown

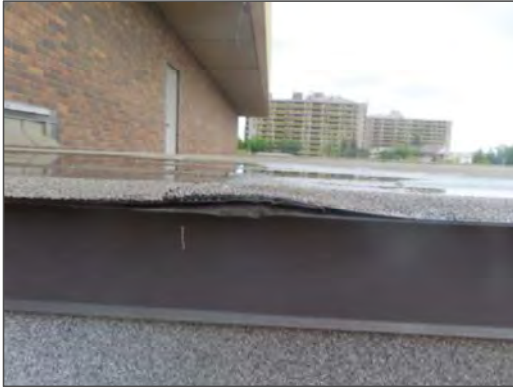
View of unadhered modified modified membrane atop raised modified bitumen membrane roof system atop Section 9 of the Site Building.

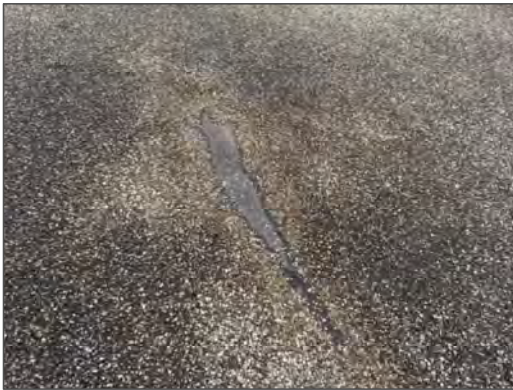
View of a blister within the BUR system of Section 9 atop the Site Building.

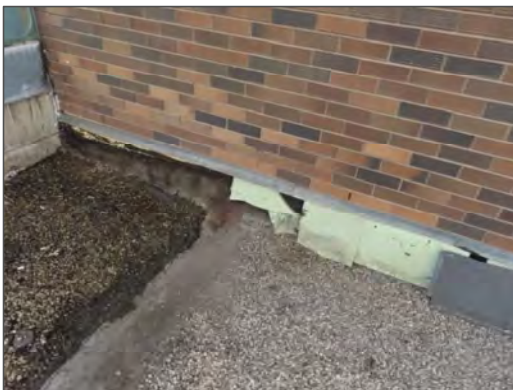
<ul style="list-style-type: none"> An area of missing insulation and lack of flashing was noted atop Section 9 of the Site Building. 	<ul style="list-style-type: none"> Undertake localized repairs to adequately seal the area and to prevent further damages.
<ul style="list-style-type: none"> An area which poorly diverts water was noted atop the northwest portion of Section 9 of the Site Building. 	<ul style="list-style-type: none"> Redirect the water drainage efficiently to prevent further damages.

View of an area of missing insulation and lack of flashing atop Section 9 of the Site Building.

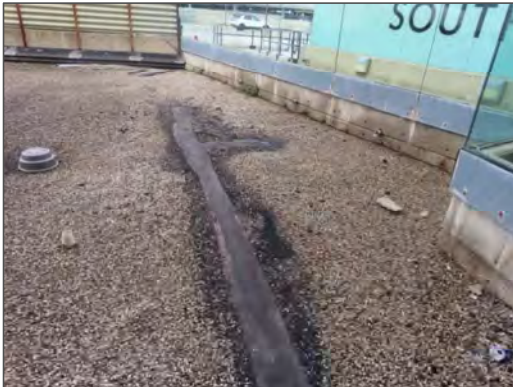
View of typical area of historic repairs atop multiple BUR sections the Site Building.

Note: Section 9 is shown.

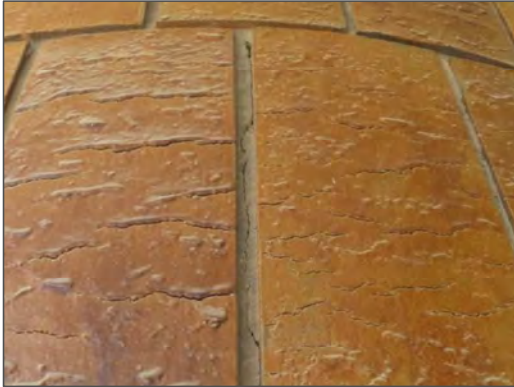
View of cracking in the ceramic tile joints on the east elevation the Site Building.

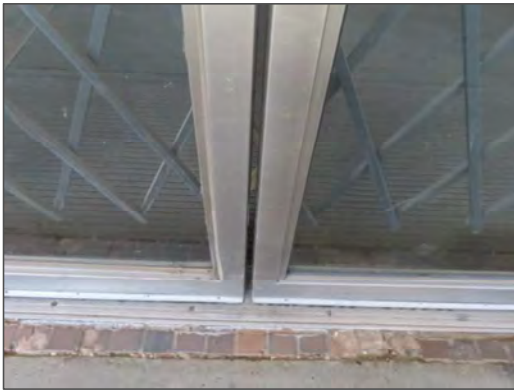
View of typical gap and lack of weatherstripping serving the exterior entrance doors on the east and south elevations of the Site Building.

Note: East elevation is shown.

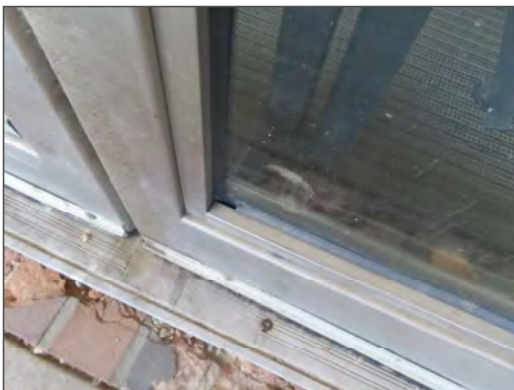
View of shrunk SG unit gasket on the east elevation the Site Building.

<ul style="list-style-type: none"> Shrunk SG unit gaskets were noted on the east and south elevations the Site Building. 	<ul style="list-style-type: none"> Replace the gaskets to prevent potential moisture infiltration.
<ul style="list-style-type: none"> Window sealant deterioration was noted on the east elevation the Site Building. 	<ul style="list-style-type: none"> Replace the deteriorated window sealants.
<ul style="list-style-type: none"> Damaged brick veneer masonry was noted on the east elevation the Site Building. 	<ul style="list-style-type: none"> Undertake localized repairs. Monitor the condition.
<ul style="list-style-type: none"> Impact damaged overhead door was noted on the south elevation the Site Building. 	<ul style="list-style-type: none"> Repair/replace the damaged overhead panels.
<ul style="list-style-type: none"> Detached weatherstripping was noted on the south elevation the Site Building. 	<ul style="list-style-type: none"> Reattach/replace the detached door weatherstripping.

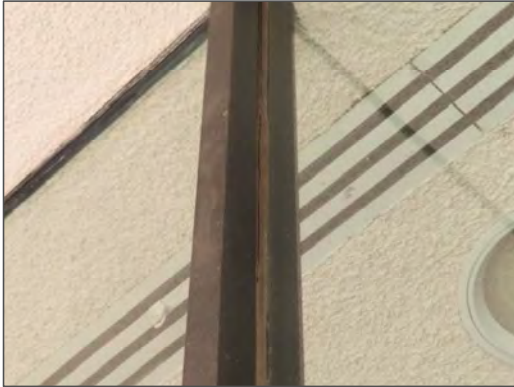
View of window sealant deterioration on the east elevation the Site Building.

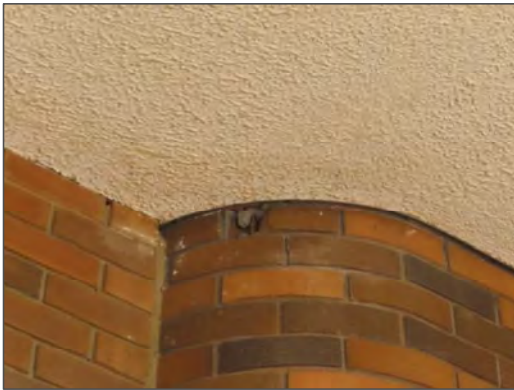
View of damaged brick veneer masonry on the east elevation the Site Building.

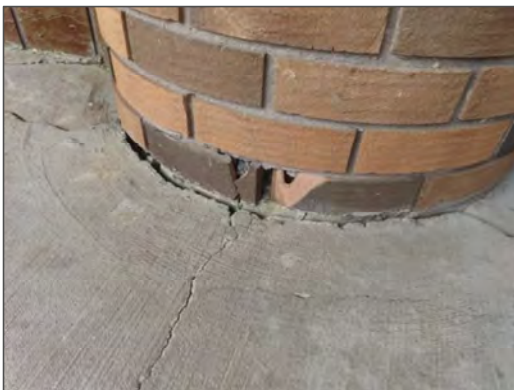
View of damaged brick veneer masonry on the east elevation the Site Building.

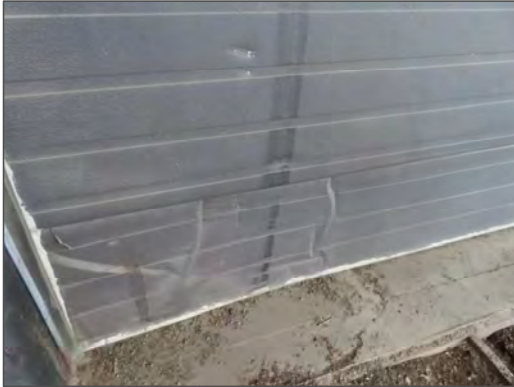
View of impact damaged overhead door on the south elevation the Site Building.

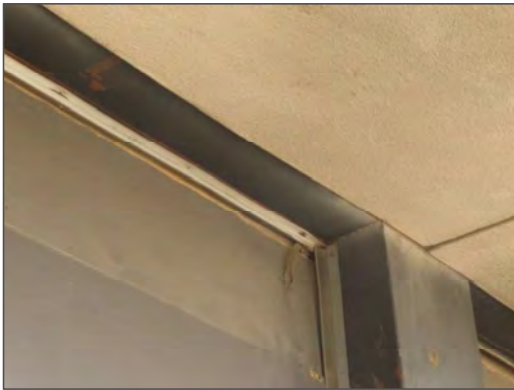
View of detached weatherstripping on the south elevation the Site Building.

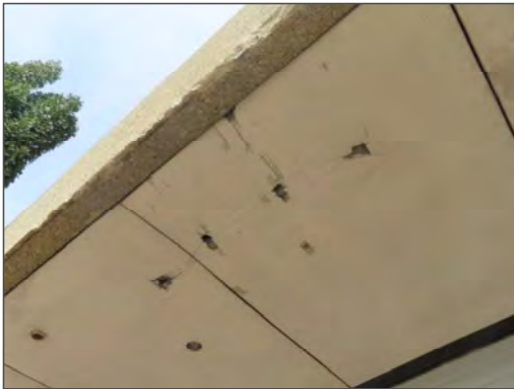
View of damaged and cracked soffit on the south elevation the Site Building.

<ul style="list-style-type: none"> Damaged and cracked soffit was noted on the south elevation the Site Building. 	<ul style="list-style-type: none"> Undertake localized repairs.
<ul style="list-style-type: none"> Damaged concrete panel was noted on the south elevation the Site Building. 	<ul style="list-style-type: none"> Undertake localized repairs.
<ul style="list-style-type: none"> Deteriorated ceramic tile finish was noted on the south elevation of the Site Building. 	<ul style="list-style-type: none"> Prepare and reapply finish as required.
<ul style="list-style-type: none"> Boarded-up door was noted on the south elevation of the Site Building. 	<ul style="list-style-type: none"> Replace the missing SG unit serving the door.
<ul style="list-style-type: none"> Detached gasket was noted on the south elevation of the Site Building. 	<ul style="list-style-type: none"> Replace the gaskets to prevent potential moisture infiltration.

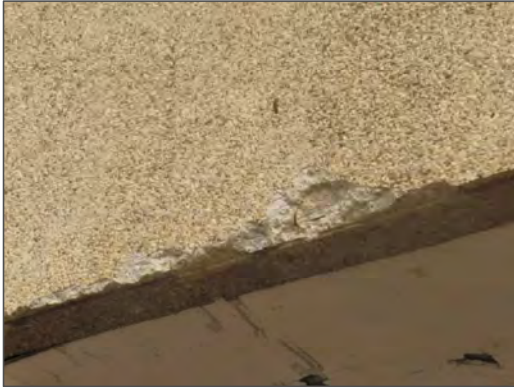
View of damaged concrete panel on the south elevation the Site Building.

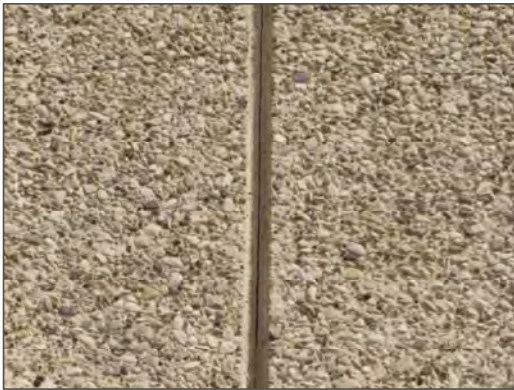
View of typical deteriorated precast concrete panel control joint sealant on multiple elevations the Site Building.

Note: South elevation is shown.

The wall, window and door systems of the Site Building were generally noted to be in serviceable condition at the time of the assessment with deteriorated precast concrete panel control joint sealants and minor movement between the precast concrete panels on multiple elevations which require correction in the short term to re-establish a satisfactory level of performance. As such, Pinchin recommends implementation of a phased sealant replacement program throughout the term of the analysis.

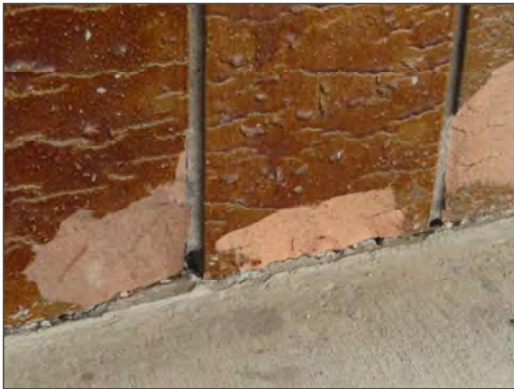
View of typical deteriorated ceramic tile finish on the south elevation of the Site Building.

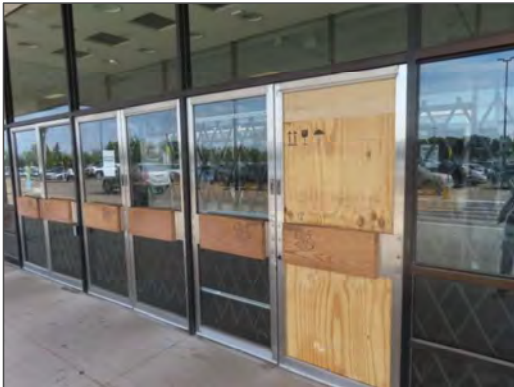
View of boarded-up door on the south elevation
of the Site Building.

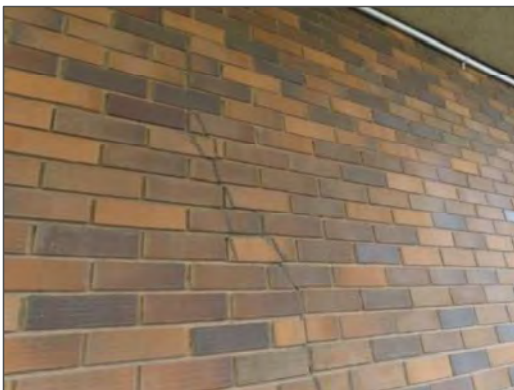
View of typical vertical crack in the brick veneer
masonry observed from the various roof areas
atop the Site Building.

Note: 2nd floor is shown.

<ul style="list-style-type: none"> Vertical cracks were noted in the brick veneer masonry observed from the various roof areas atop the Site Building. 	<ul style="list-style-type: none"> Undertake localized repairs.

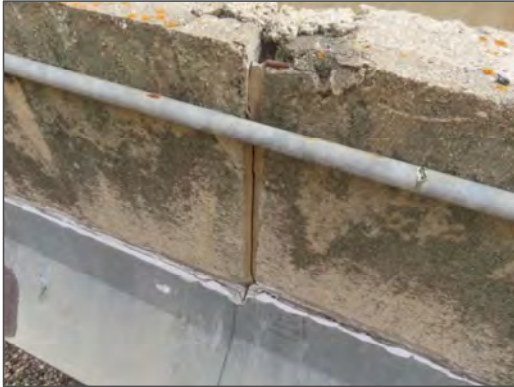
View of typical deteriorated precast concrete panel control joint sealant on multiple elevations the Site Building.

Note: East elevation is shown.

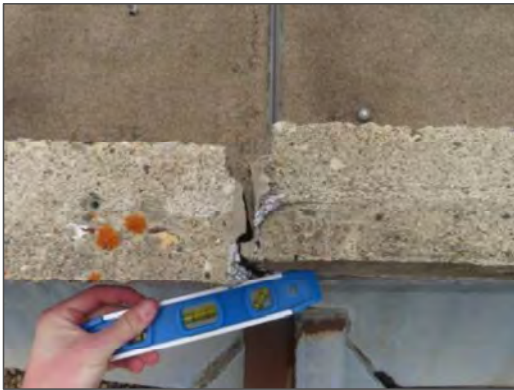
View of typical minor movement noted on precast concrete panels on multiple elevations the Site Building.

Note: South elevation is shown.

Furthermore, Pinchin recommends monitoring the precast concrete panels and to install stabilizing plates to prevent further movements. Should the condition of the precast concrete panels worsen, a specialist should be consulted to determine the extent of deterioration and implement an appropriate repair strategy. It is noted that the most estimates provided in this report are preliminary and provided only as an indication of the order of magnitude of the remedial work. More precise cost estimates would require more detailed investigation to define the scope of work

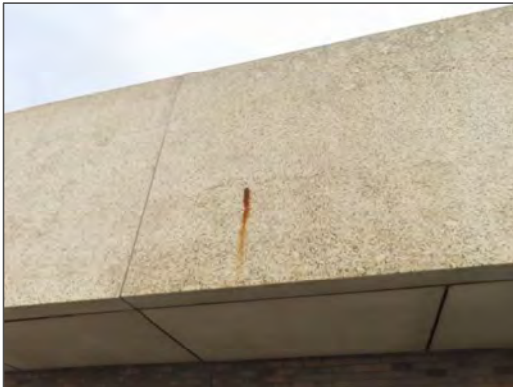
View of typical area of corrosion on precast concrete panels from the various roof areas atop the Site Building.

Note: 3rd floor is shown.

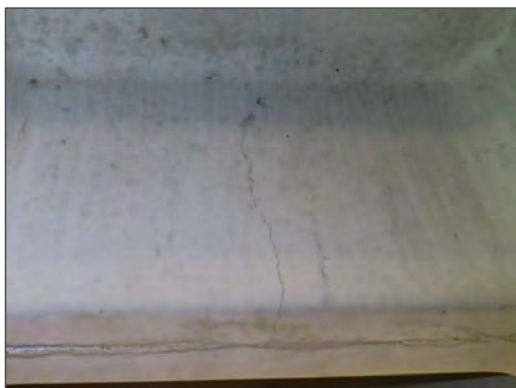
View of typical hairline cracking observed from the waffle slab observed from the main floor of the Site Building.

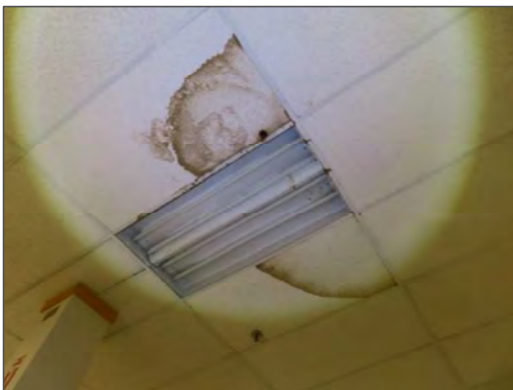
View of typical moisture stained ceiling tiles throughout the sales area of the Site Building.

Note: 3rd floor is shown.

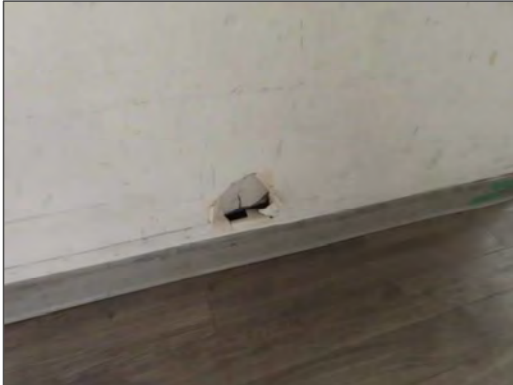
View of typical damaged gypsum board throughout the back room areas of the Site Building.

Note: Main floor is shown.

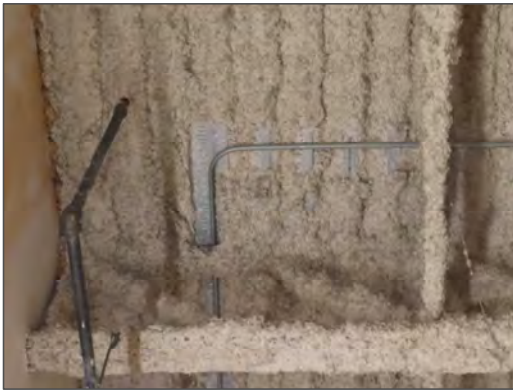
View of deteriorated fireproofing within the emergency exit stairwell of the Site Building.

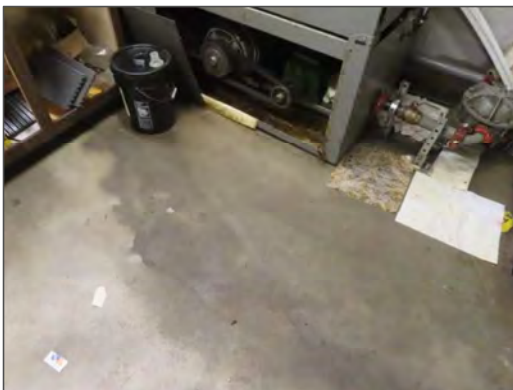
View of stained floor within the elevator controller room of the Site Building.

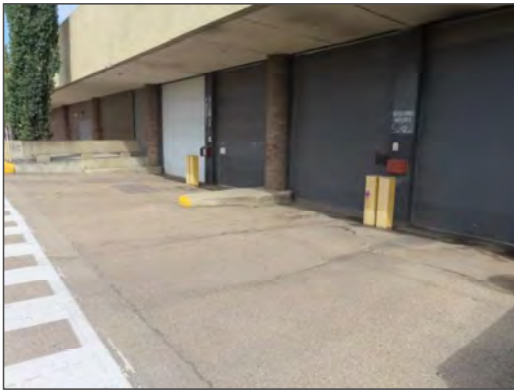
General view of the loading dock area adjacent to the south elevation of the Site Building.

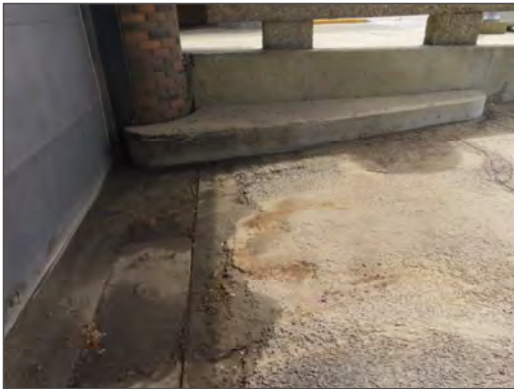
View of deteriorated asphalt surfaces adjacent to the south elevation of the Site Building.

Assuming that the above noted deficiencies are addressed and regular annual maintenance is performed, the Site features should perform in a satisfactory manner throughout the term of the analysis. Pinchin has included allowances for repairs to the Site features throughout the term of the analysis.

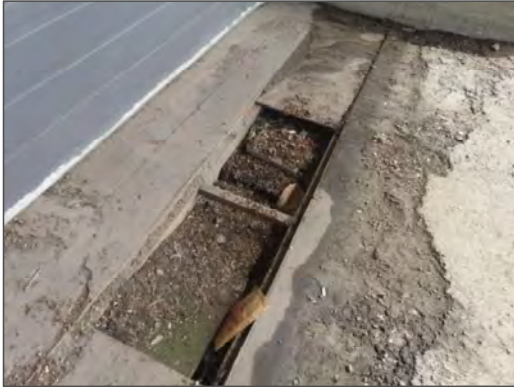
View of exposed trench with debris accumulation adjacent to the south elevation of the Site Building.

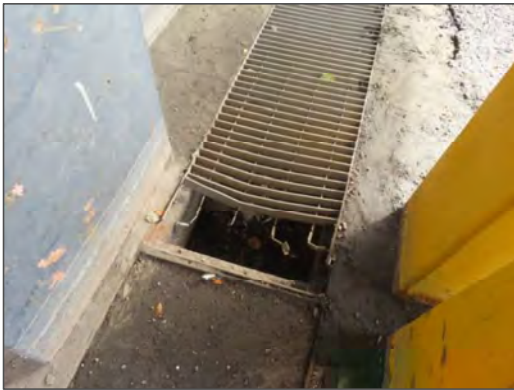
View of a bent and misaligned storm drain grate adjacent to the south elevation of the Site Building.

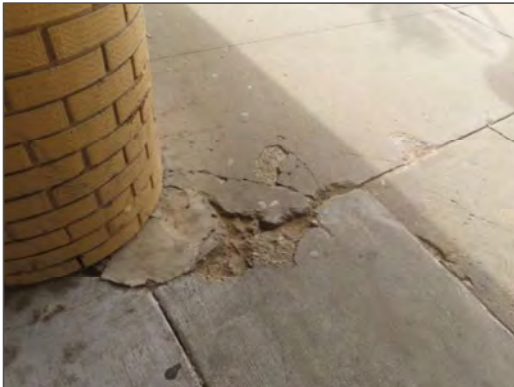
View of deteriorated concrete walkway adjacent to the south elevation of the Site Building.

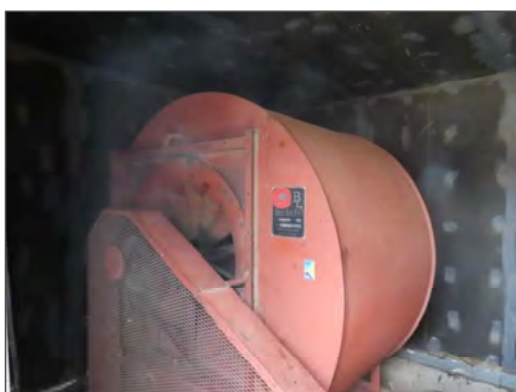
General view of the blower units within the AHU compartment atop the Site Building.

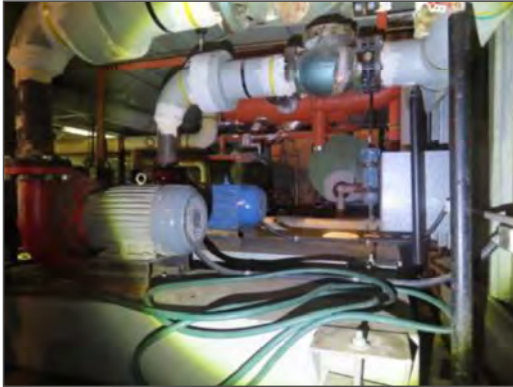
Partial view of the steam and chilled water conversion plant within the 2nd floor mechanical room of the Site Building.

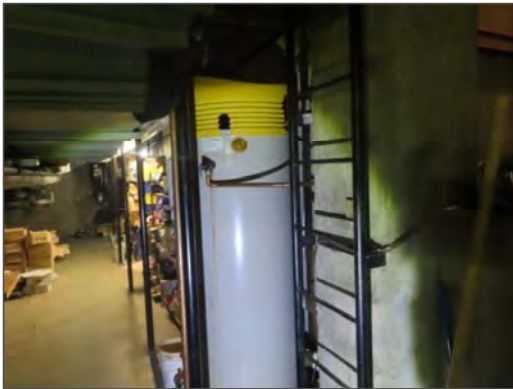
<ul style="list-style-type: none"> The DHW heating unit serving the Site Building is approximately 19 years old and has attained its EUL. 	<ul style="list-style-type: none"> Based on age, Pinchin recommends replacement of the DHW heating unit serving the Site Building within the early portion of the term of the analysis.
Minor Deficiencies/Findings	
<ul style="list-style-type: none"> The sprinkler systems and chemical fire extinguishers serving the Site Building were noted to be past due for inspection, with select fire extinguishers not mounted adequately and missing their inspection tag. 	<ul style="list-style-type: none"> Ensure the sprinkler systems and chemical fire extinguishers are inspected by a certified contractor on an annual basis and ensure inspection remains accessible and visible.

General view of the DHW heating unit serving the Site Building.

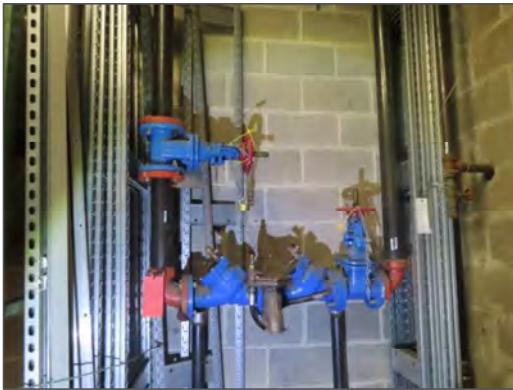
The main water line is located on the main floor of the Site Building. A backflow prevention device was observed with the most recent inspection completed and failed by “LFP” in January of 2024.

General view of the backflow prevention device serving the Site Building.

Major Deficiencies/Findings	Remarks/Recommendations
<ul style="list-style-type: none"> The backflow prevention device serving the Site Building was noted to have failed its most recent inspection. 	<ul style="list-style-type: none"> Undertake the necessary repairs to prevent further damages.
<ul style="list-style-type: none"> Corrosion and calcium build up was noted on piping fittings within the 2nd floor mechanical room of the Site Building. 	<ul style="list-style-type: none"> Undertake localized repairs/replacement at the area of corrosion/calcium build up and monitor for reoccurrence.
<ul style="list-style-type: none"> An active leaking drainage piping was noted on the third floor sales area of the Site Building. 	<ul style="list-style-type: none"> Address the leak in the short term to prevent further damages.
<ul style="list-style-type: none"> Moisture stained piping insulation observed was noted within various mechanical rooms of the Site Building. 	<ul style="list-style-type: none"> Investigate the source of the staining and undertake localized repairs.

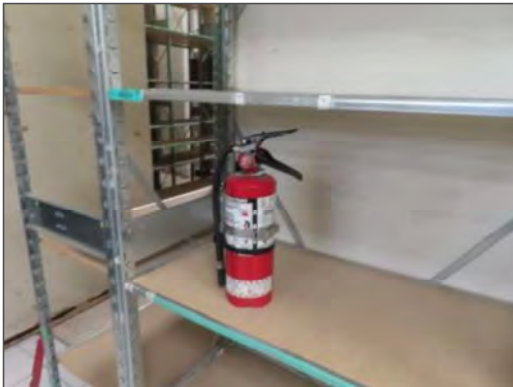
Supplemental fire protection is provided by chemical fire extinguishers and fire hose cabinets on each floor level. The inspection gauges on the fire extinguishers were noted to be charged to sufficient levels at observed locations. The chemical fire extinguishers were noted to be either past due for inspection, not mounted adequately or missing their inspection tag.

General view of a typical chemical fire extinguisher serving the Site Building.

Note: Missing an inspection tag and not adequately mounted.

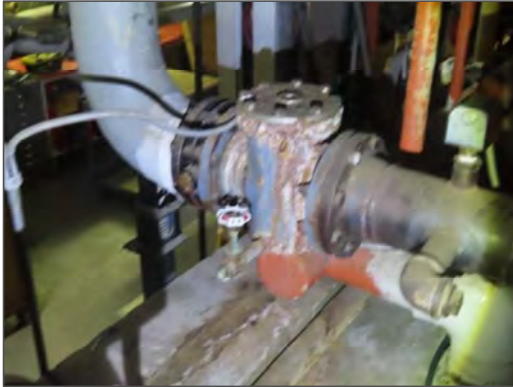
View of typical corrosion and calcium build up on piping fittings within the 2nd floor mechanical room of the Site Building.

Due to the age of the majority of the plumbing pipes and associated components, Pinchin anticipates and has included contingency allowances for ongoing repairs to the pipes and associated components throughout the term of the analysis.

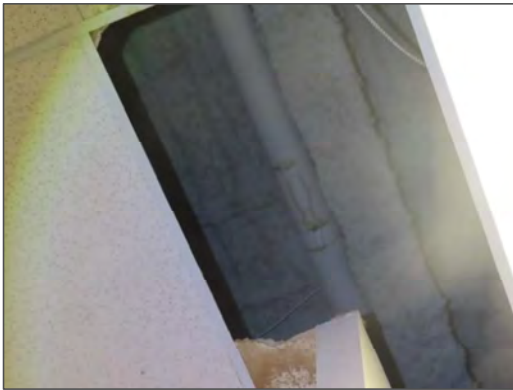
View of an active leaking drainage piping on the third floor sales area of the Site Building.

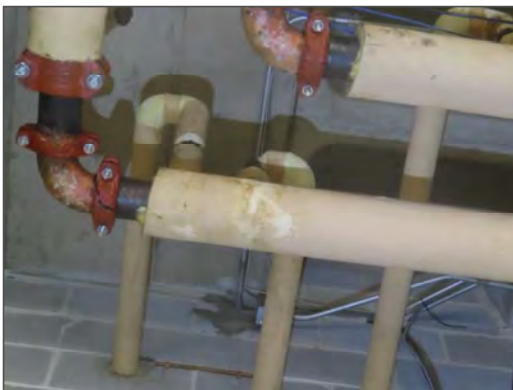
View of typical moisture stained piping insulation observed within various mechanical rooms of the Site Building.

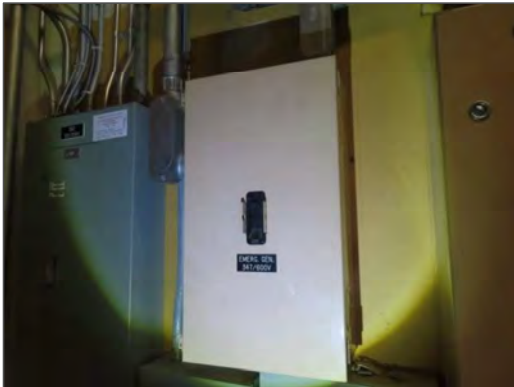
General view of the ATS observed within the electrical room of the Site Building.

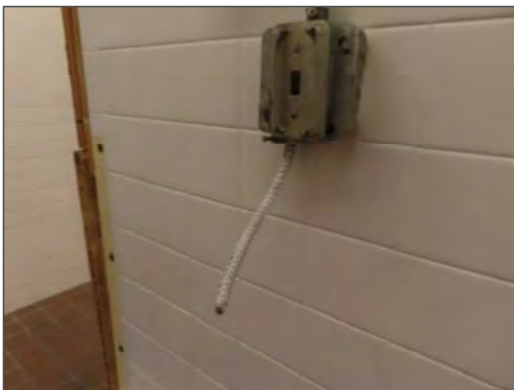
View of exposed wires within the kitchen area on the 2nd floor of the Site Building.

Findings	Remarks/Recommendations
Minor Deficiencies/Findings	
<ul style="list-style-type: none"> As previously mentioned, the Site Building may possess an emergency generator due to the presence of an Automatic Transfer Switch (ATS) within the main electrical room; however, it could not be located at the time of Site visit nor could the Site Representative confirm its presence. 	<ul style="list-style-type: none"> Pinchin recommends investigating the current emergency power configuration of the Site Building to gain a better understanding of potential repair/replacement requirements. It may be addressed as part of the aforementioned specialist reviews.
<ul style="list-style-type: none"> Exposed wires were noted within the kitchen area on the 2nd floor of the Site Building and atop the 2nd floor roof of the Site Building. 	<ul style="list-style-type: none"> Terminate the wires to prevent potential hazards

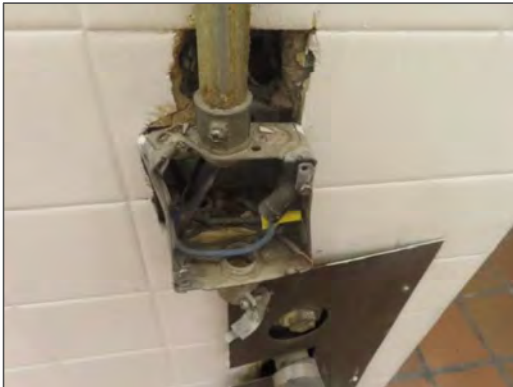
<ul style="list-style-type: none"> Exposed junction box was noted within the kitchen area on the 2nd floor of the Site Building. 	<ul style="list-style-type: none"> Seal the junction box to prevent potential hazards.

View of exposed junction box within the kitchen area on the 2nd floor of the Site Building.

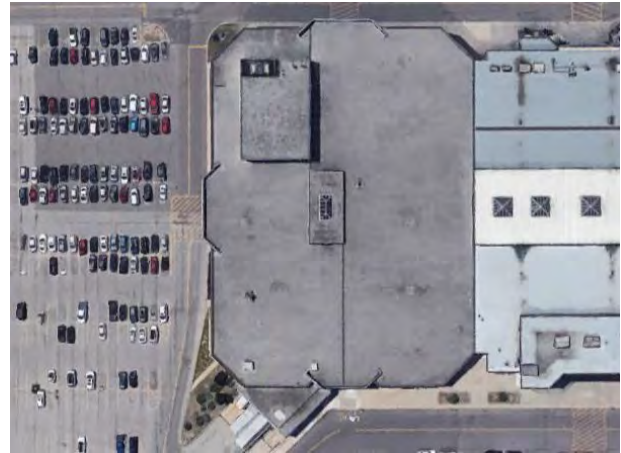
Figure 2: Satellite image of Hudson's Bay

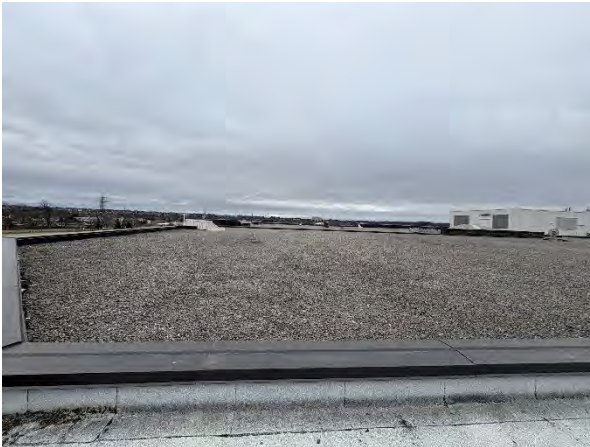
Figure 3: Overview of main roof area.

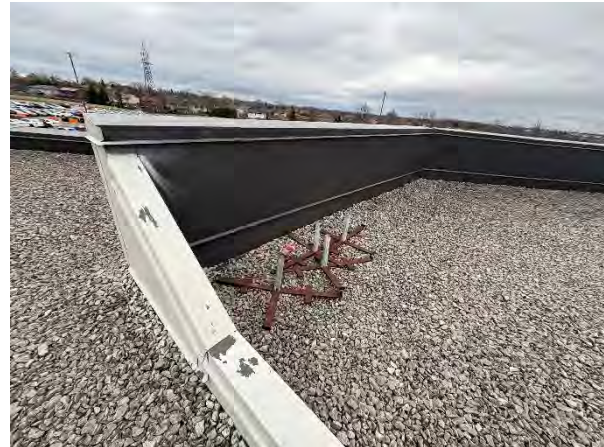
Figure 4: Debris throughout the roof to be removed.

Additionally, loose debris observed on the roof should be removed immediately. These items present a safety hazard, as they could become airborne during high wind events, potentially leading to property damage or personal injury.
