**ONTARIO
SUPERIOR COURT OF JUSTICE
COMMERCIAL LIST**

AFFIDAVIT OF PATRICK SULLIVAN

FINAL Baseline Property Condition Assessment

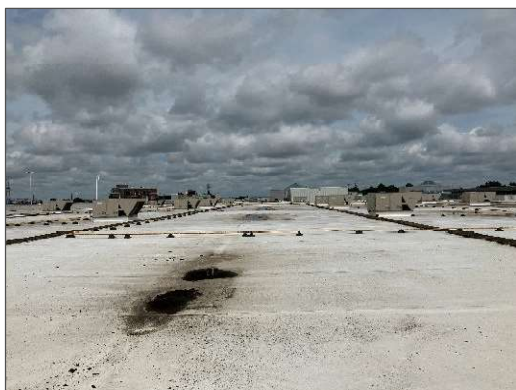
General view of the main TPO membrane system.

It has been Pinchin's experience that the Expected Useful Life (EUL) of a TPO membrane system typically ranges between 17 to 20 years, depending on the quality of building materials used, the quality of workmanship during installation and the level to which the roof system has been maintained. The Site Representatives reported that the roof systems are original to the construction of the Site Building in 2008 (i.e., ~ 17 years old). Based on age, Pinchin recommends and has included allowances for the replacement of the roof systems within the term of analysis. Pinchin also recommends that regular annual maintenance be performed on the roof systems throughout the term of the analysis. Annual walk-on roof inspections are recommended to ensure any deficiencies or issues are discovered in a timely manner.

- Pinchin recommends and has included allowances for the replacement of the Thermoplastic Polyolefin (TPO) membrane systems within the term of analysis;

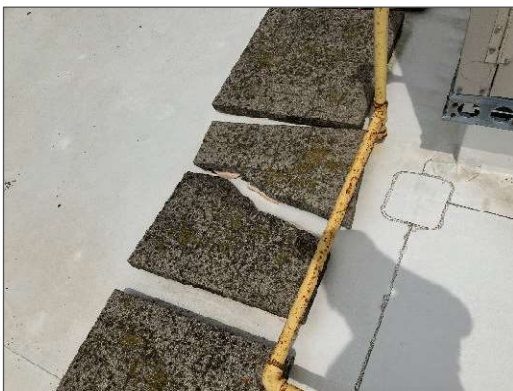
View of a damaged concrete walkway paver.

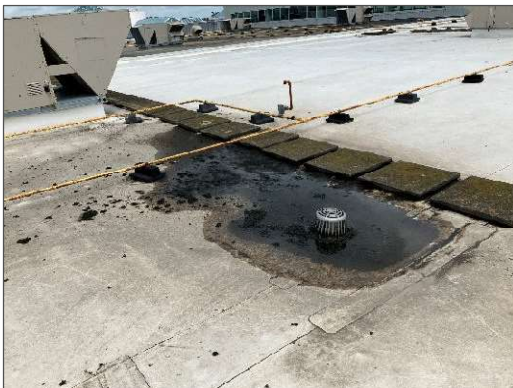
View of a partially obstructed roof drain debris guard.

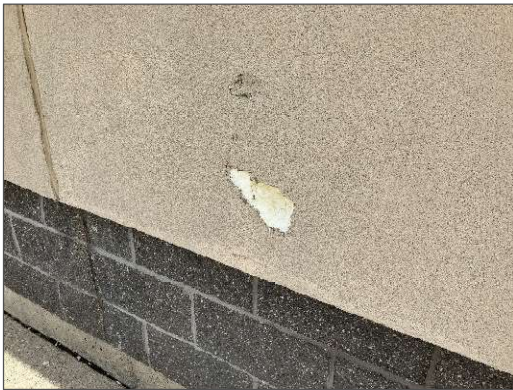
View of minor impact damage at EIFS.

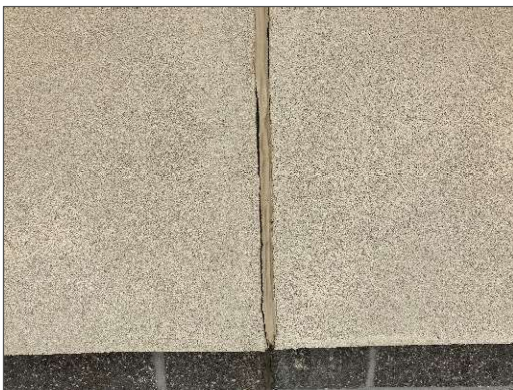
View of a linear crack at an EIFS panel joint.

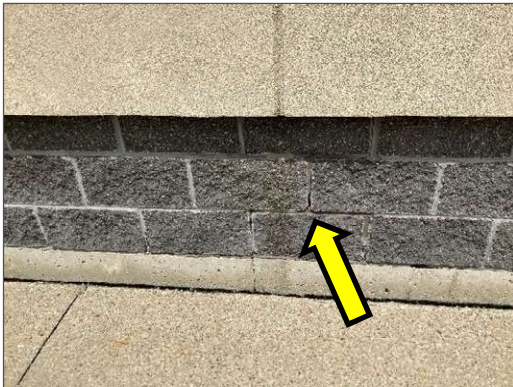
View of an area of minor step cracking in a masonry wall.

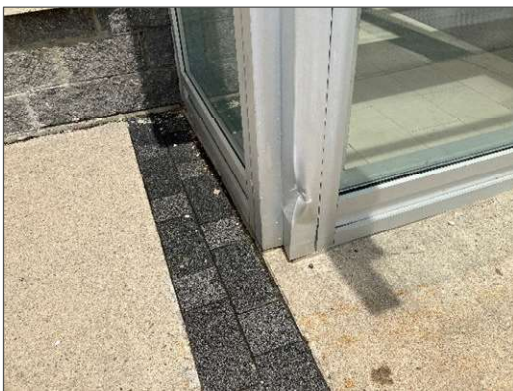
<ul style="list-style-type: none"> Minor impact damage noted at an aluminum frame at the south entrance. 	<ul style="list-style-type: none"> Monitor the affected frame for further deterioration.
<ul style="list-style-type: none"> Deteriorated EIFS perimeter sealants noted at the decorative glass feature at the southwest corner of the Site Building and at door perimeters. 	<ul style="list-style-type: none"> Replacement of deteriorated sealants is recommended as part of ongoing general maintenance of the exterior wall systems.

View of minor impact damage at an aluminum frame at the south entrance to the Site Building.

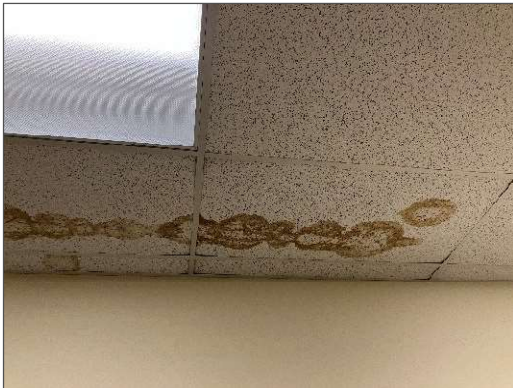
View of moisture-stained ceiling tiles.

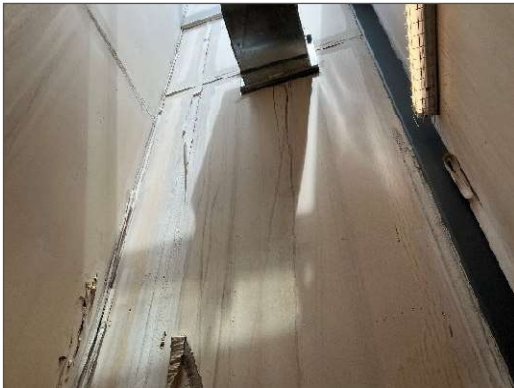
View of moisture staining noted at the gypsum board below the decorative glass exterior feature at the southwest corner of the Site Building.

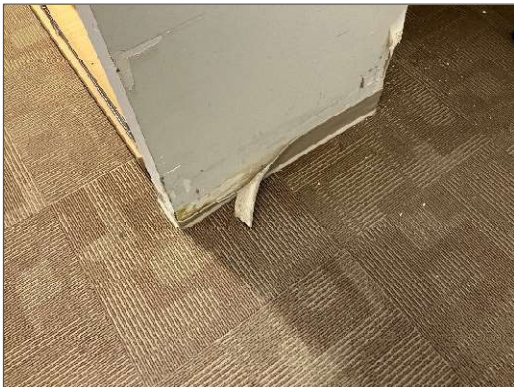
View of a damaged vinyl baseboard.

Findings	Remarks/Recommendations
<ul style="list-style-type: none"> Damaged vinyl baseboards noted in select locations. 	<ul style="list-style-type: none"> Replace the damaged vinyl baseboards.
<ul style="list-style-type: none"> Moisture damaged gypsum board noted at the ceiling within the retail area at the southwest portion of the Site Building. 	<ul style="list-style-type: none"> It was reported to Pinchin that the damage is the result of a roof leak that has since been repaired. Remove and replace the affected gypsum board.

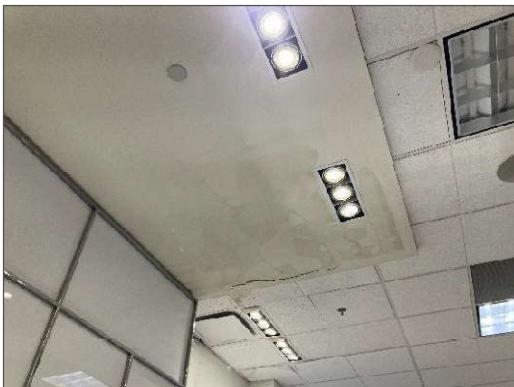
View of moisture damaged gypsum board noted at the ceiling within the retail area at the southwest portion of the Site Building.

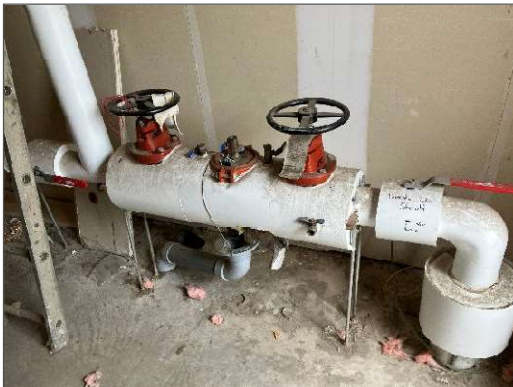
Findings	Remarks/Recommendations
Minor Deficiencies/Findings	
<ul style="list-style-type: none"> No inspection tag was observed at the backflow prevention device at the main incoming domestic water line. 	<ul style="list-style-type: none"> Annual testing and inspection of the backflow prevention device is recommended.
<ul style="list-style-type: none"> The DHW heaters are approximately 17 years old and are anticipated to reach the end of their EUL within the term of analysis. 	<ul style="list-style-type: none"> Replacement of the DHW heaters is recommended as they reach the end of their EUL. Replacement can be completed at a below threshold cost.
<ul style="list-style-type: none"> A drain within the shipping/receiving area was noted to be filled with debris. 	<ul style="list-style-type: none"> Clear the affected drain as part of regular ongoing maintenance of the Site Building.

View of the backflow prevention device at the main incoming domestic water line.

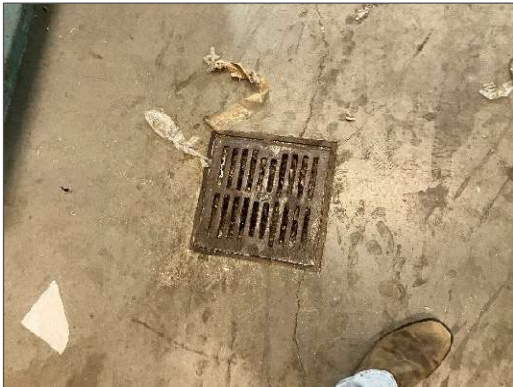
View of the obstructed drain within the shipping/receiving area.

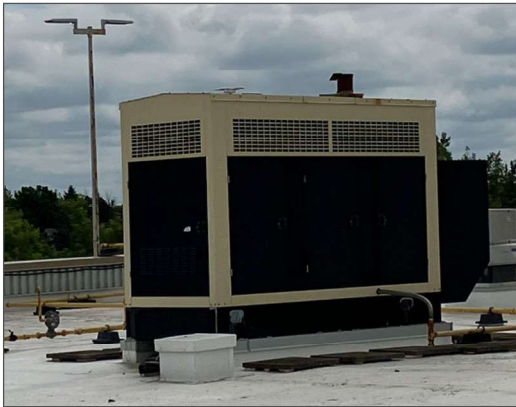
Findings	Remarks/Recommendations
Major Deficiencies/Findings	
<ul style="list-style-type: none"> The emergency generator and automatic transfer switch are approximately 18 years old and are anticipated to reach the end of their EUL in the latter portion of the term of analysis. 	<ul style="list-style-type: none"> Pinchin recommends and has included a preliminary allowance for the replacement of the emergency generator and the automatic transfer switch in the latter portion of the term of analysis. It is recommended that a specialist review of the generator systems and automatic transfer switch be completed prior to replacement to determine a precise scope for replacement requirements.
<ul style="list-style-type: none"> The fire alarm panel and annunciator panel are approximately 18 years old and are anticipated to reach the end of their EUL within the term of analysis. 	<ul style="list-style-type: none"> Pinchin recommends and has included a preliminary allowance for the replacement of the fire alarm panel and annunciator panel within the term of analysis. It is recommended that a specialist review of the fire alarm systems be completed prior to replacement to determine replacement requirements for concealed components of the fire alarm system including wiring, annunciators, etc.

View of the emergency generator serving the Site Building.

- Pinchin recommends that a specialist review of the generator systems and automatic transfer switch be completed prior to replacement to determine a precise scope for replacement requirements.

- Pinchin recommends and has included a preliminary allowance for the replacement of the emergency generator and the automatic transfer switch in the latter portion of the term of analysis;

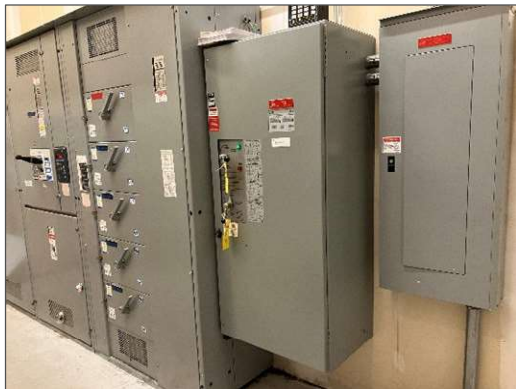
View of the automatic transfer switch.

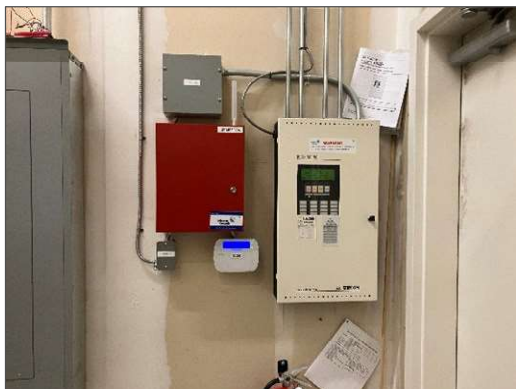
View of the main fire alarm panel serving the Site Building.

- Pinchin recommends that a specialist review of the fire alarm systems be completed prior to replacement to determine a precise scope for replacement requirements of the fire alarm system and concealed components of the fire alarm system including wiring, annunciators, etc.; and

- Pinchin recommends and has included a preliminary allowance for the replacement of the fire alarm panel and annunciator panel within the term of analysis.

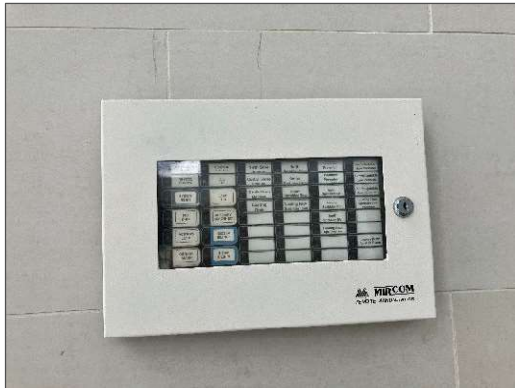
View of the annunciator panel.

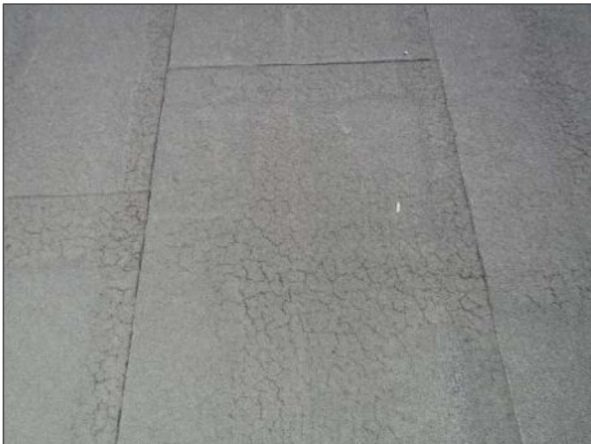
Areas of membrane crazing of the modified bitumen membrane roof system were noted atop Roof Section A3 in multiple locations.

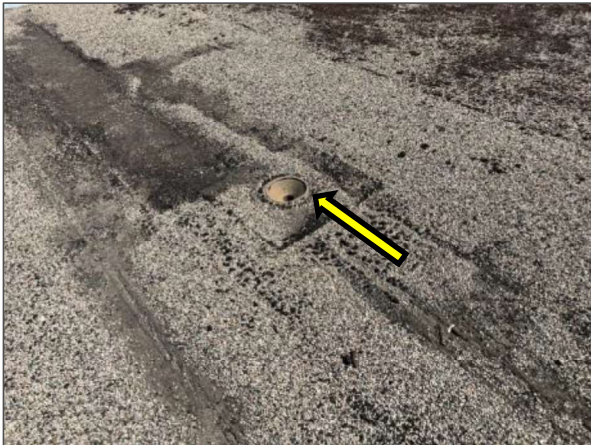
Missing debris strainers were noted atop Roof Section 6.

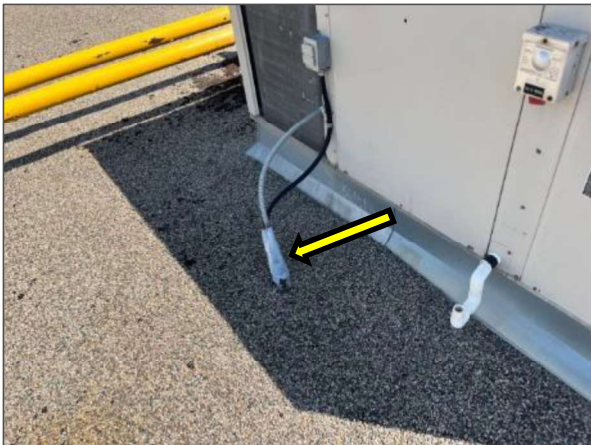
Poorly executed service penetrations were noted in multiple locations atop the Roof Sections of the Site Building.

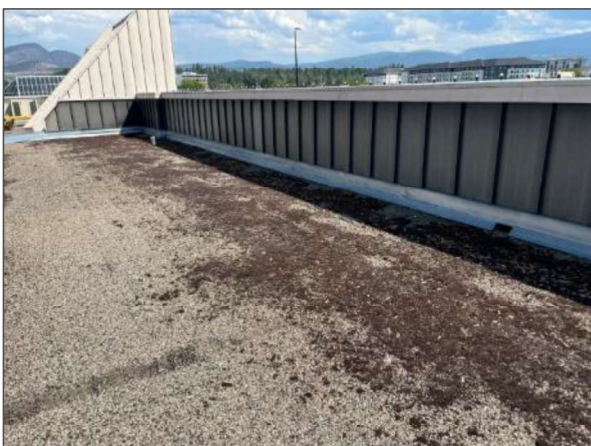
Areas of organic growth/debris were noted atop the Roof Sections of the Site Building.

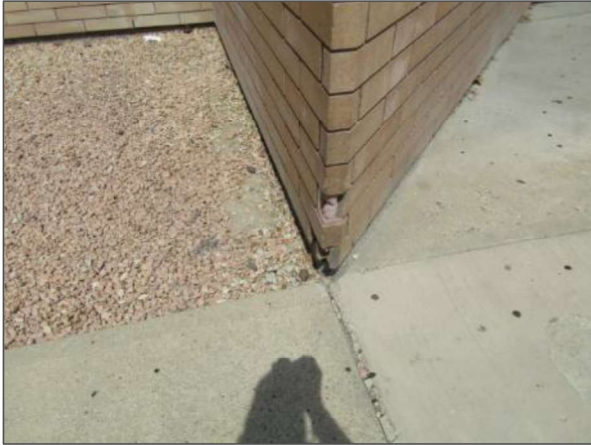
Areas of damaged brick veneer masonry were noted on the south elevation of the Site Building.

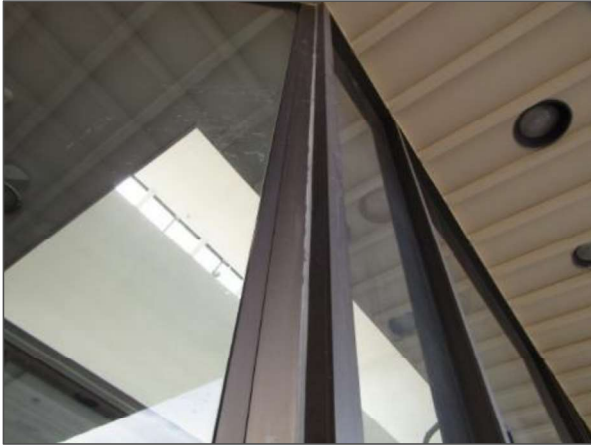
Note: North elevation shown.

Aged door sealants were noted in multiple locations.

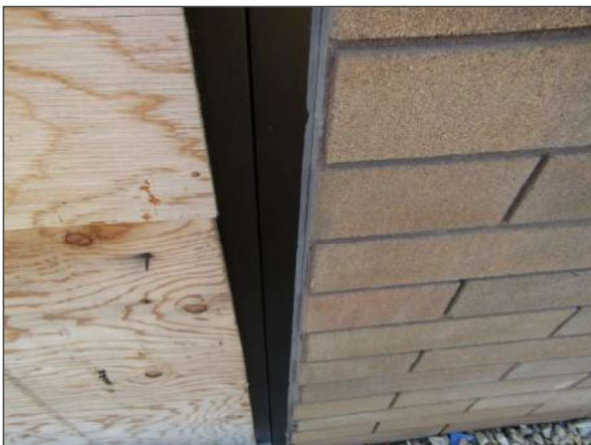
Note: North elevation shown.

Aged door sealants were noted in multiple locations.

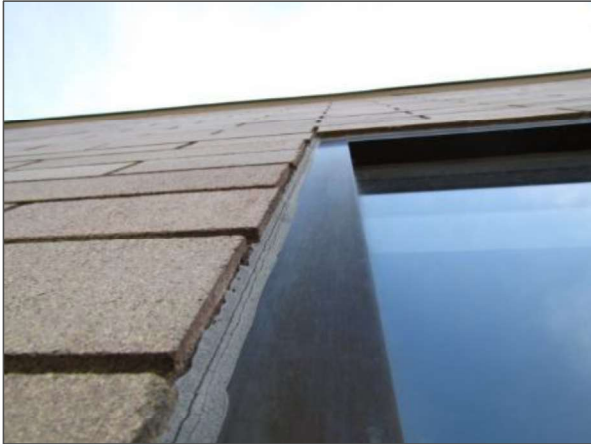
Aged window sealants were noted on the north elevation.

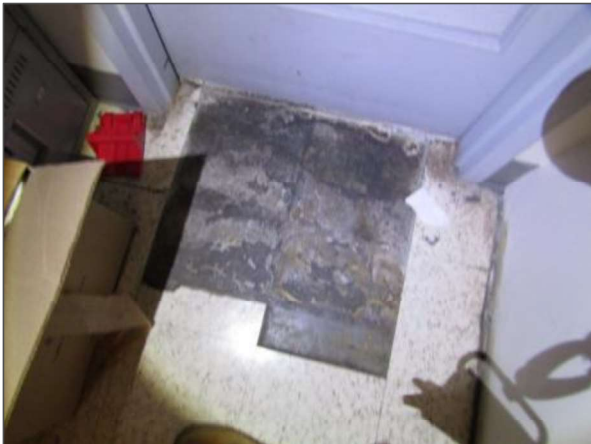
Damaged vinyl flooring was noted in multiple locations of the Site Building.

It is anticipated that future tenant improvements will include the restoration of interior finishes to a satisfactory condition. Therefore, no cost allowances have been included in this report, as these repairs are assumed to be the responsibility of incoming tenants as part of their fit-out work.

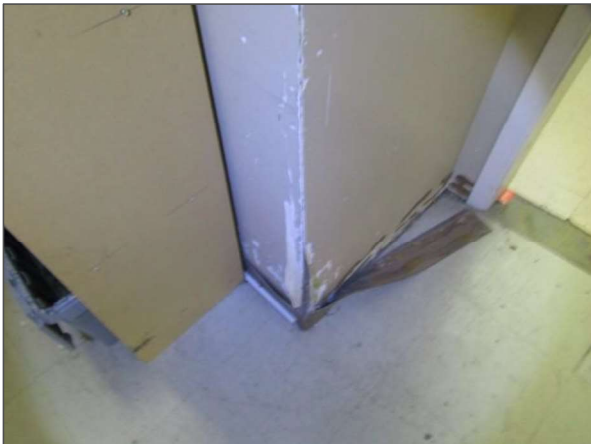
Damaged gypsum wall board was noted in multiple locations of the Site Building.

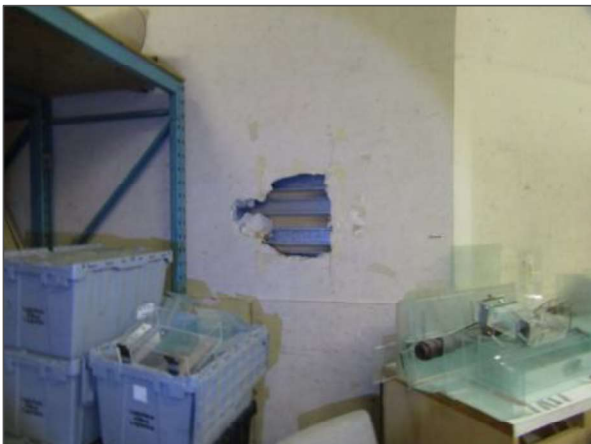
Damaged gypsum wall board was noted in multiple locations of the Site Building.

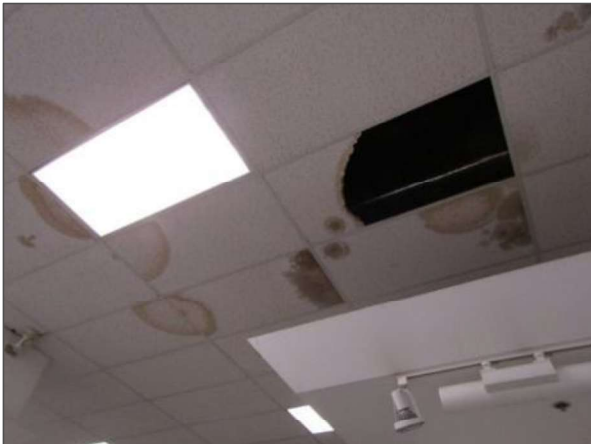
Missing/damaged/moisture stained ceiling tiles were noted in multiple locations of the Site Building.

Additionally, as reported, the ceiling tiles will be replaced in preparation for new tenancies. Given water damaged materials were noted during the assessment, mould may be present. If present, Pinchin recommends that the Client undertake mould mitigation procedures in accordance with Canadian Construction Association (CCA) guidelines based on area. Please note that other materials may be affected by the past roof leaks; as such, an investigation should be conducted prior to any tenant improvement work or remedial work being undertaken to determine the full extent of impacted materials. Given the full extent of impacted materials is not known at this time, Pinchin recommends that the Client carry construction contingencies during tenant improvement works to address this potential issue.

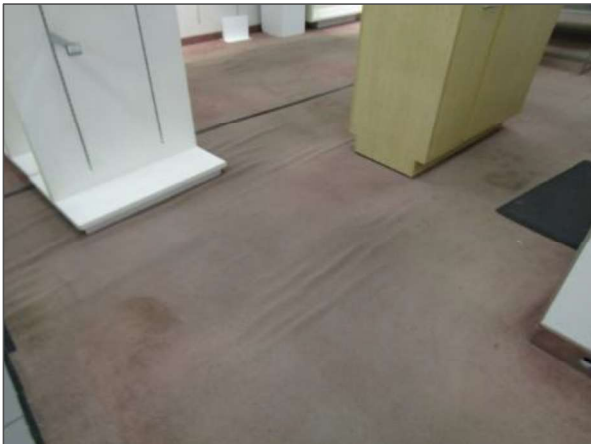
Damaged carpeting was noted in multiple locations of the Site Building.

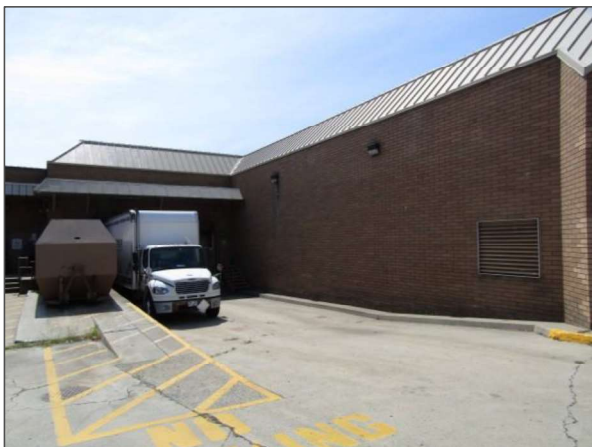
General view of the concrete loading area noted adjacent to the north elevation.

Localized areas of cracking were noted within the north concrete loading ramp.

Table 3.7 – Site Features	
Findings	Remarks/Recommendations
Major Deficiencies/Findings	
<ul style="list-style-type: none"> • None observed/reported. 	<ul style="list-style-type: none"> • None required.
Minor Deficiencies/Findings	
<ul style="list-style-type: none"> • Localized areas of cracking were noted within the north concrete loading ramp. 	<ul style="list-style-type: none"> • Repair/seal affected areas of cracking.

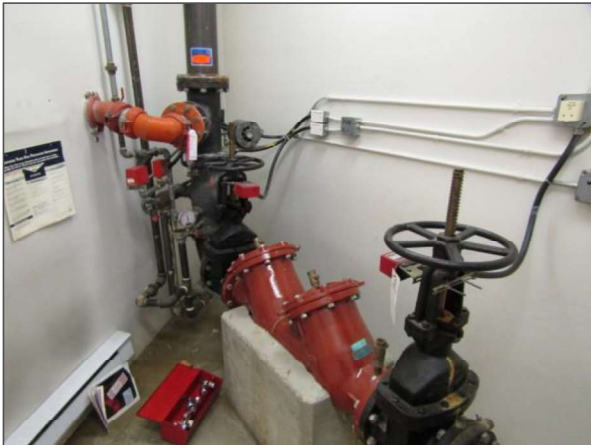
General view of a typical sprinkler riser and the observed backflow prevention device.

Note: The cabinet containing a extra supply of sprinkler heads and an installation tool was dislodged from its mounting spot.

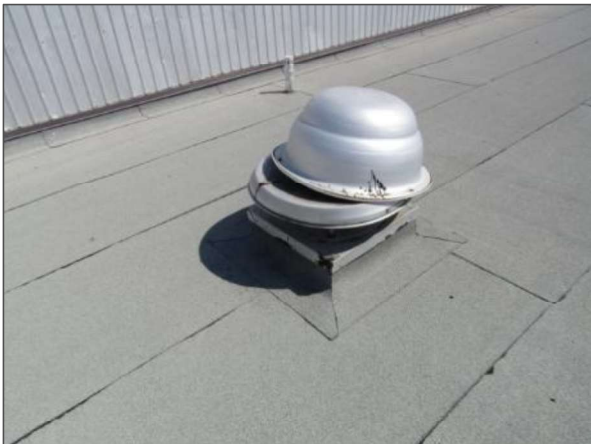
Damaged exhaust units were noted atop the Site Building.

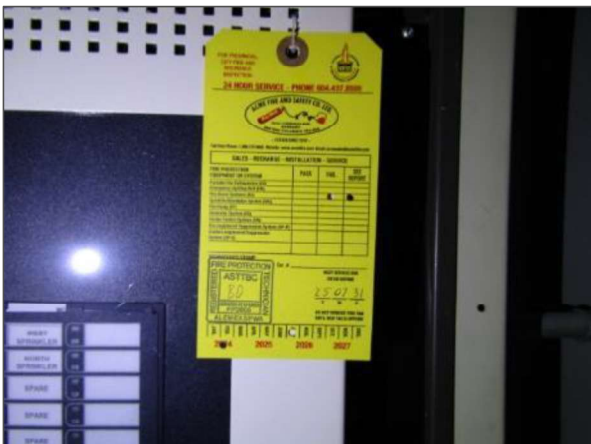
The fire alarm system was observed to be past-due its annual inspection date.

The electrical systems were noted to be in serviceable condition at the time of the Site visit; however, the fire alarm system was observed to be past-due its annual inspection date. As such, Pinchin recommends the immediate inspection of the fire alarm system.

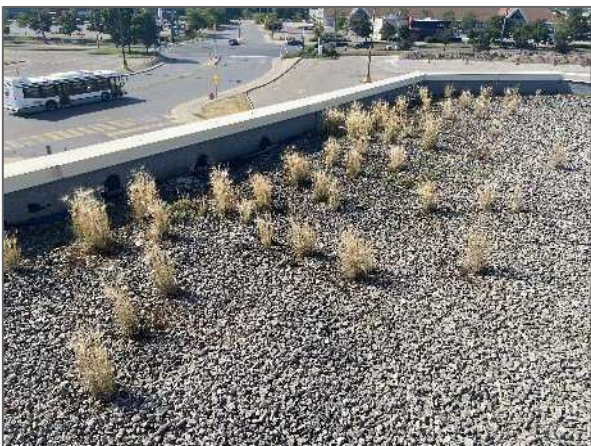
View of organic growth noted on the south portion of the Site Building.

Findings	Remarks/Recommendations
<ul style="list-style-type: none"> Organic growth was noted at various locations atop the roof systems. 	<ul style="list-style-type: none"> Remove/clean the organic growth as part of regular annual maintenance of the roof systems.
<ul style="list-style-type: none"> Partially clogged/obstructed roof drain guards were noted at various locations atop the roof systems. 	<ul style="list-style-type: none"> Clean/unplug the roof drains regularly as part of regular annual maintenance of the roof systems.
<ul style="list-style-type: none"> Deteriorated and split/de-bonded sealants were noted at various locations of the roof systems. 	<ul style="list-style-type: none"> Replace the deteriorated and split/de-bonded sealants.
<ul style="list-style-type: none"> Redundant HVAC curbs were noted on the east of the primary roof system. 	<ul style="list-style-type: none"> Monitor the redundant HVAC curbs for potential moisture infiltration at the curb flashings.

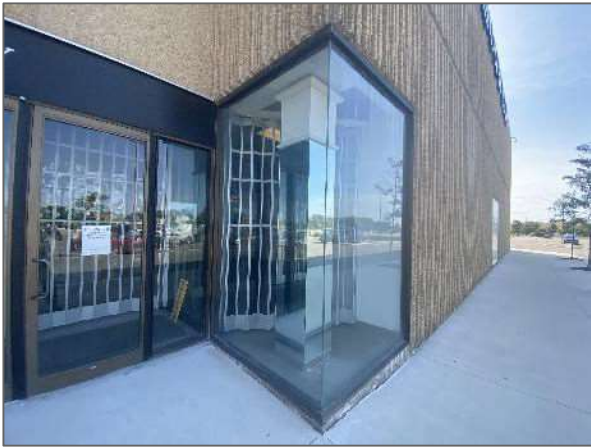
View of typical SG storefront windows noted on the west elevation of the Site Building.

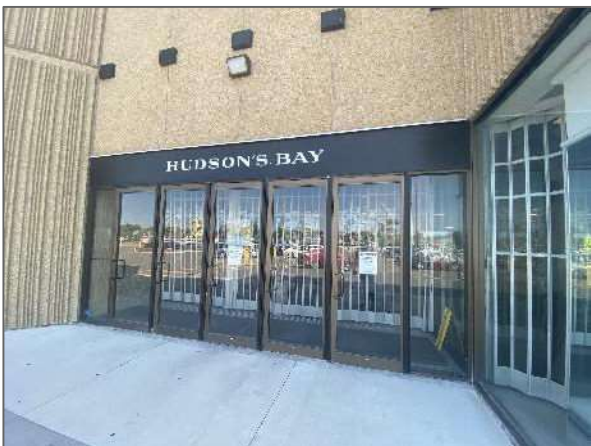
View of typical SG doors noted on the west elevation of the Site Building.

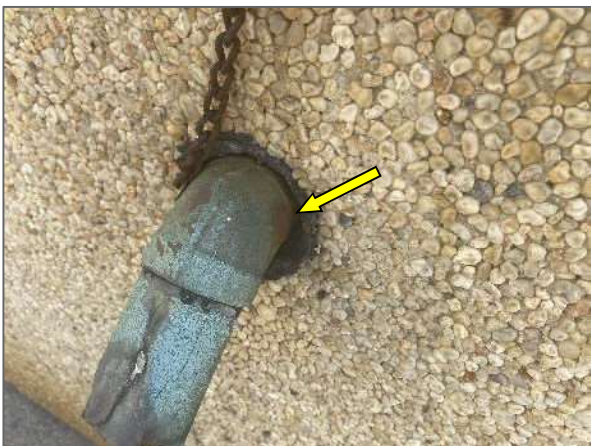
View of a typical unsealed penetration noted on the south elevation of the Site Building.

Pinchin has carried allowances for current and anticipated localized repairs to the exterior wall systems (i.e., concrete panels and) as well as replacement of the wall joint sealants throughout the term of analysis.

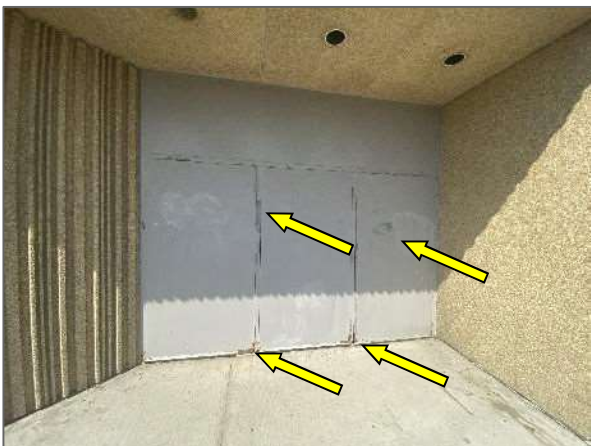
View of typical worn corrosion and worn finishes noted on hollow metal doors on the east elevation of the Site Building.

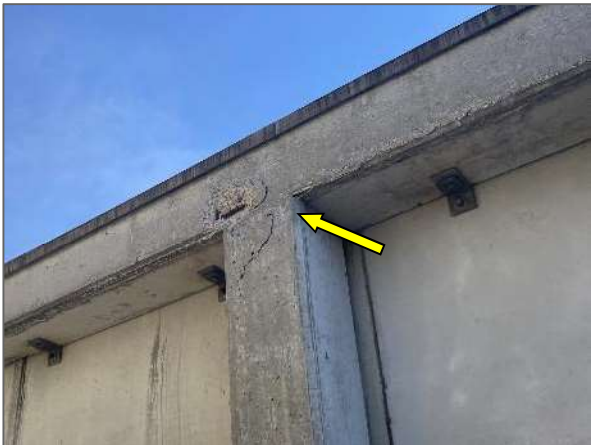
View of deteriorated concrete noted on a reinforced concrete beam in the southeast portion above the secondary roof.

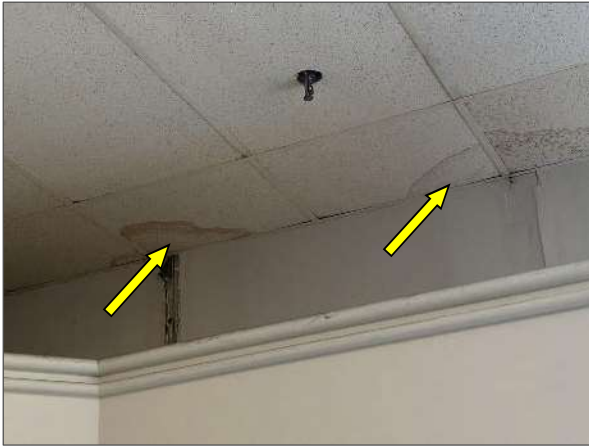
View of water damage in the gypsum wall and ceilings boards, reportedly due to a previous pipe leak noted adjacent to the south entrance of the Site Building.

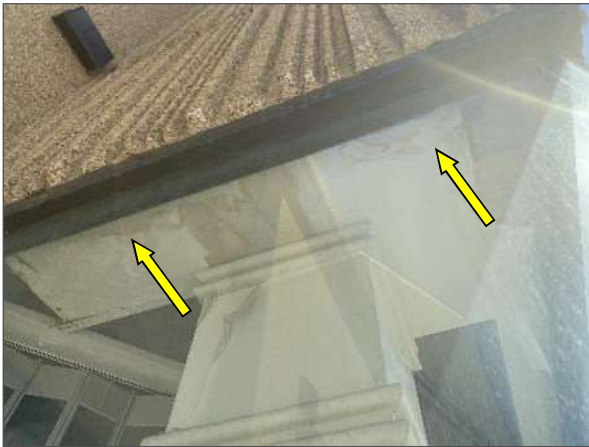
View of typical damaged gypsum wall board noted in the stairwell in the southeast portion.

Findings	Remarks/Recommendations
Major Deficiencies/Findings	
<ul style="list-style-type: none"> None observed/reported. 	<ul style="list-style-type: none"> None required.
Minor Deficiencies/Findings	
<ul style="list-style-type: none"> Localized areas of moisture/water-stained ceiling tiles were noted at various locations within the office areas of the Site Building. 	<ul style="list-style-type: none"> Determine/repair the source(s) of the staining and replace the moisture/water-stained ceiling tile. Monitor the affected area for future water leaks.
<ul style="list-style-type: none"> Water damage in the gypsum wall and ceilings boards, reportedly due to a previous pipe leak was noted adjacent to the south elevation of the Site Building. 	<ul style="list-style-type: none"> Repair the water damaged gypsum wall and ceilings boards and refinish. Monitor the affected area for future water leaks.
<ul style="list-style-type: none"> Localized areas of damaged gypsum board were noted at various locations of the Site Building. 	<ul style="list-style-type: none"> Repair/replace the affected areas of damaged gypsum board.

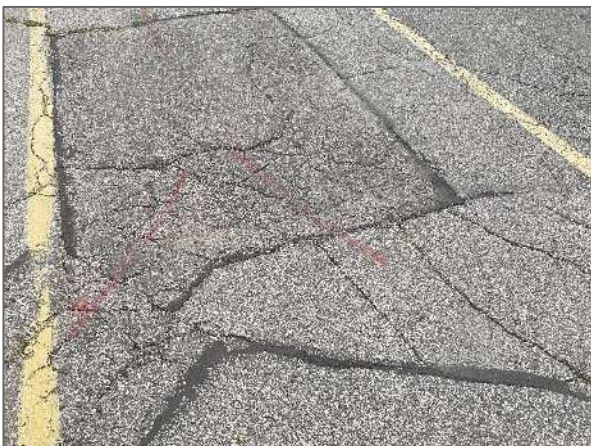
View of deterioration in the cast-in-place concrete apron serving the shipping/receiving area.

Findings	Remarks/Recommendations
Major Deficiencies/Findings	
<ul style="list-style-type: none">• Areas of deterioration in the asphalt pavements were noted to the south of the Site Building.	<ul style="list-style-type: none">• Repair/replace the cracked areas in the asphalt pavements, reportedly the responsibility of the landlord.
Minor Deficiencies/Findings	
<ul style="list-style-type: none">• Localized areas of cracking and deterioration were noted in the cast-in-place concrete apron serving the shipping/receiving area.	<ul style="list-style-type: none">• Repair/replace the affected areas of deteriorated concrete.
<ul style="list-style-type: none">• A localized area of deteriorated/delaminated concrete was noted at the concrete stairs in the southeast portion.	<ul style="list-style-type: none">• Repair the affected area of deteriorated/delaminated concrete.
<ul style="list-style-type: none">• Localized areas of cracking in cast-in-place concrete walkways were noted adjacent to the south and east elevations of the Site Building.	<ul style="list-style-type: none">• Repair/replace the cracked areas in the concrete walkways, reportedly the responsibility of the landlord.

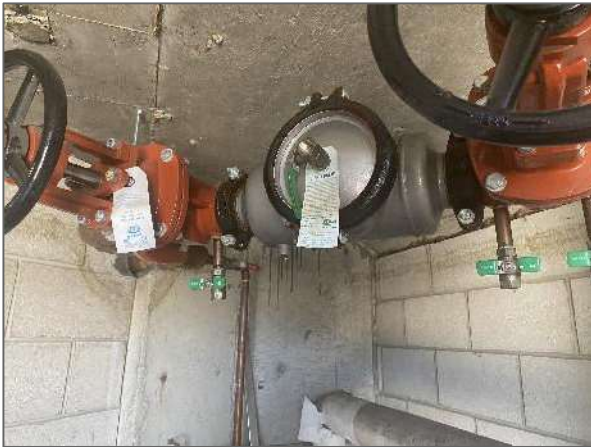
<ul style="list-style-type: none"> The backflow prevention device installed onto the domestic water main incoming line was noted to be missing annual inspection tags. 	<ul style="list-style-type: none"> The backflow prevention device is required to be inspected annually.
<ul style="list-style-type: none"> The fire sprinkler main riser is not equipped with a backflow prevention device. 	<ul style="list-style-type: none"> Consideration should be given to performing a cross-connection survey to determine the feasibility of equipping the Site Building with a backflow prevention device onto the fire sprinkler main riser.
<ul style="list-style-type: none"> Required signage indicating the location of the fire department connections was not observed. 	<ul style="list-style-type: none"> Install appropriate signage within the vicinity of the fire department connections.

View of the "wet" fire sprinkler main riser and shut-off valves.

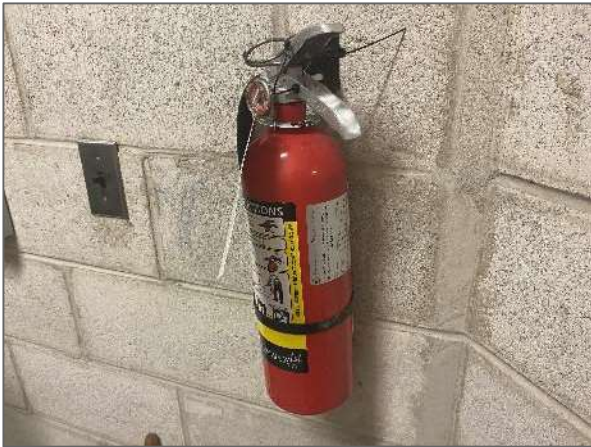
View of a typical standalone "dry" chemical fire extinguisher.

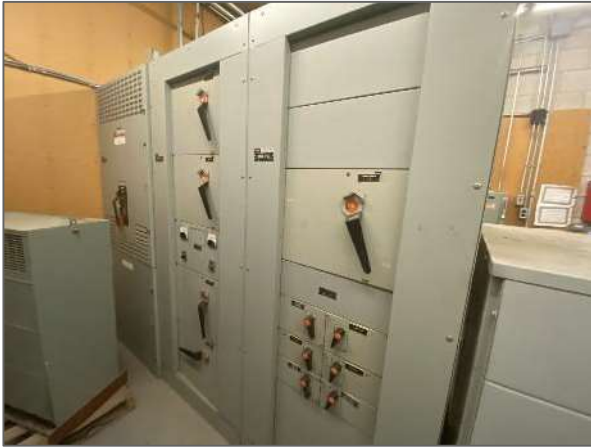
View of the "Federal Pioneer" main electrical disconnect switch.

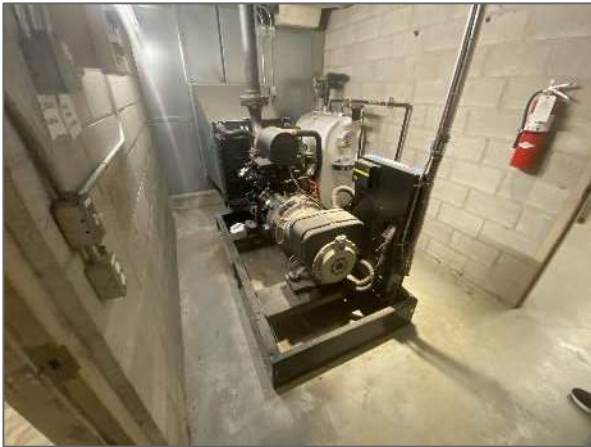
View of the "SDMO" diesel-fired emergency generator.

The emergency generator is noted to be approximately 9 years old and will reach the mid- point of its EUL within the term of analysis. As such, Pinchin has carried an allowance for overhaul of the emergency generator within the mid- portion of the term of analysis, as well as a TSSA inspection of the fuel distribution system and above-ground storage tank in order to determine code compliance and to confirm the working condition of the system. Additionally, Pinchin has carried an allowance for replacement of the aged automatic transfer switch in within the early portion of the term of analysis.

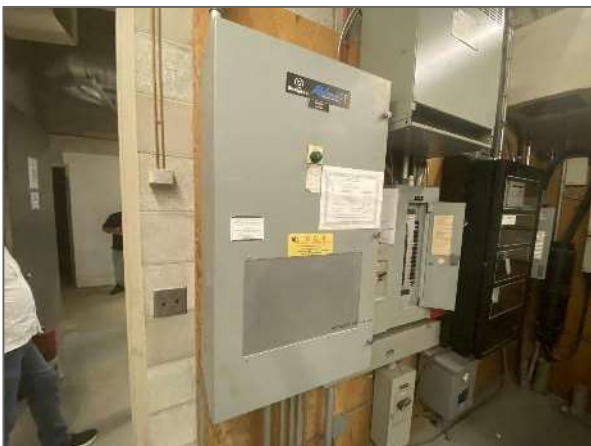
View of the "Westinghouse" automatic transfer switch.

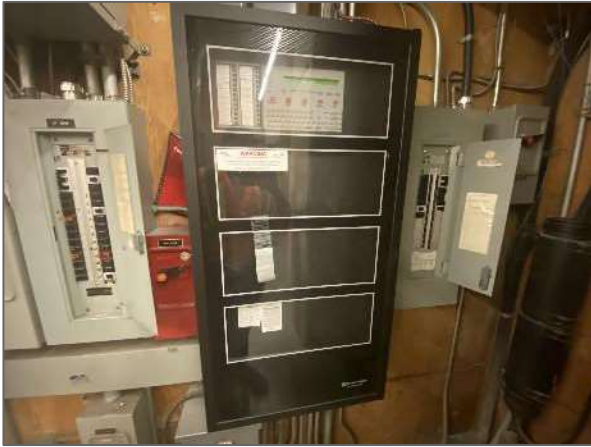
View of the "Notifier" fire alarm main control panel.

As previously mentioned, the fire alarm main control panel is approximately 15 years old and will reach the end of its EUL within the term of analysis. As such, based on age and the difficulty of maintaining the systems, Pinchin recommends replacement of the fire alarm main control panel within the mid- portion of the term of analysis (wiring and end devices are not budgeted to be replaced); however, it is noted that the new fire alarm main control panel may not be compatible with existing wiring, initiating and notification devices which can be verified by a qualified fire protection and life safety contractor prior to installation, as there is a potential for significant remedial costs for upgrades and/or replacements. The cost of replacing the wiring, initiating and notification devices (if required) cannot be estimated without a specialist review and a defined scope of work. A preliminary allowance for replacement of the fire alarm panel has been carried in the Table of Anticipated Expenditures.

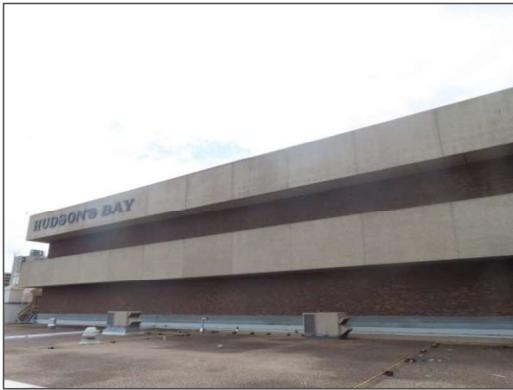
Partial view of the north elevation of the Site Building.

Note: Bounded by the “Southgate Centre” thus limiting visual assessment.

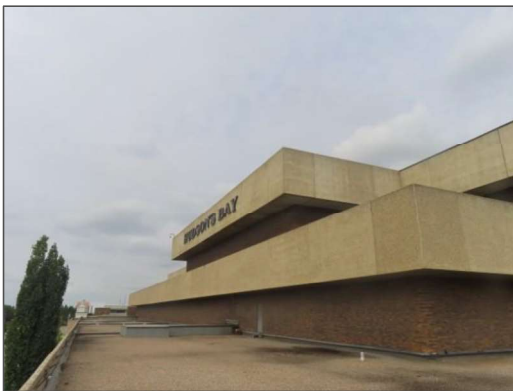
Partial view of the west elevation of the Site Building.

Note: Bounded by the “Southgate Centre” thus limiting visual assessment.

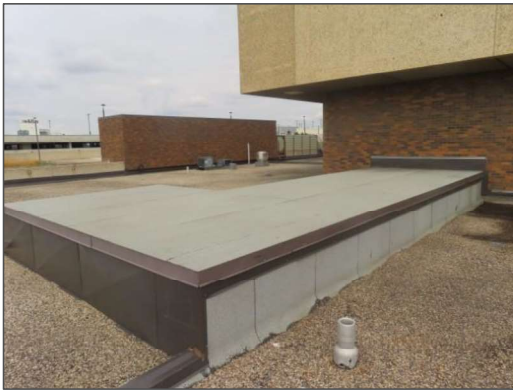
General view of typical raised modified bitumen membrane roof system atop Sections 8 and 9 of the Site Building.

Note: Section 9 is shown.

Findings	Remarks/Recommendations
<ul style="list-style-type: none"> Deteriorated pitch pocket serving the ladder footing was noted atop Section 8 of the Site Building. 	<ul style="list-style-type: none"> Replenish depleted pitch pocket to prevent potential moisture infiltration.
<ul style="list-style-type: none"> Vegetation growth was noted atop Section 9 of the Site Building. 	<ul style="list-style-type: none"> Remove the areas of vegetation growth as part of routine maintenance.
<ul style="list-style-type: none"> Deteriorated and ponding were noted atop raised modified bitumen membrane roof system atop Sections 8 and 9 of the Site Building. Unadhered modified modified membrane was noted atop raised modified bitumen membrane roof system atop Section 9 of the Site Building. 	<ul style="list-style-type: none"> Undertake proactive repairs to the areas of raised modified bitumen membrane roof system.

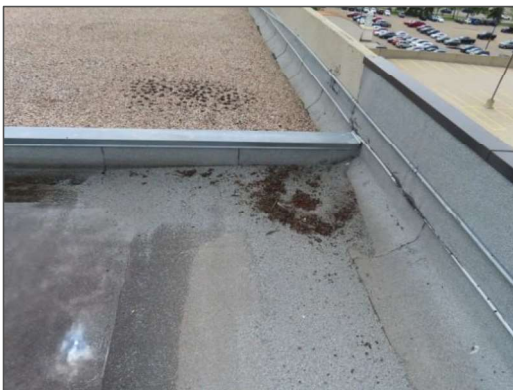
View of typical degranulation and deterioration of the modified bitumen membrane atop multiple sections of the Site Building.

Note: Section 1 is shown.

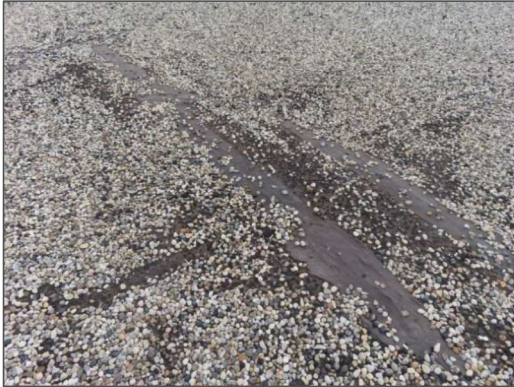
View of a blister within the BUR system of
Section 2 atop the Site Building.

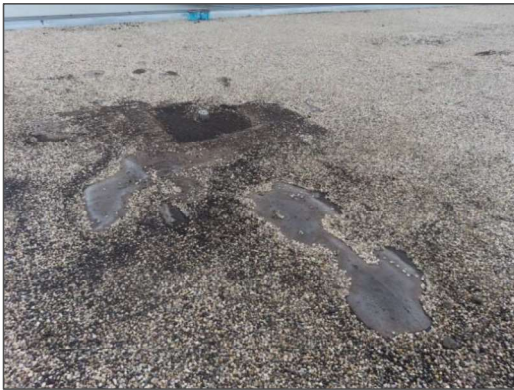
View of typical area of historic repairs atop
multiple BUR sections of the Site Building.

Note: Section 2 is shown.

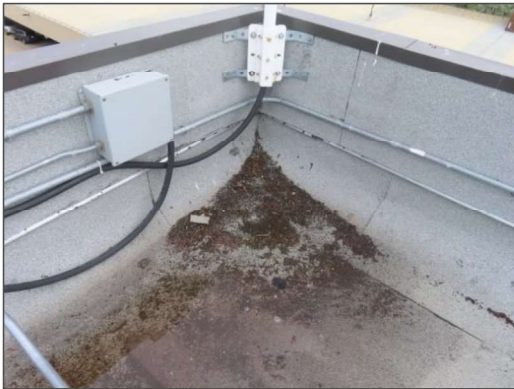
View of typical organic accumulation,
degranulation and deterioration of the modified
bitumen membrane atop multiple sections of the
Site Building.

Note: Section 3 is shown.

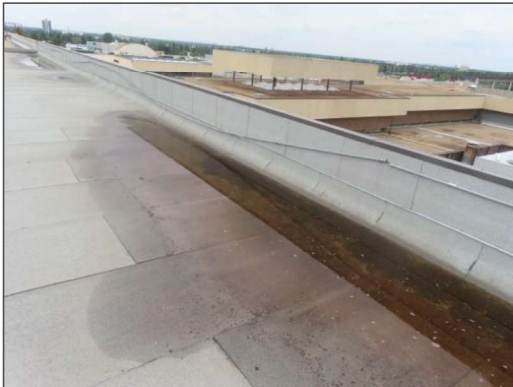
View of typical evidence of ponding atop multiple sections the Site Building.

Note: Section 3 is shown.

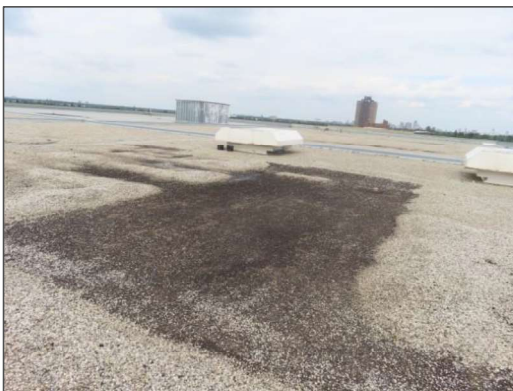
View of typical area of historic repairs atop multiple BUR sections the Site Building.

Note: Section 5 is shown.

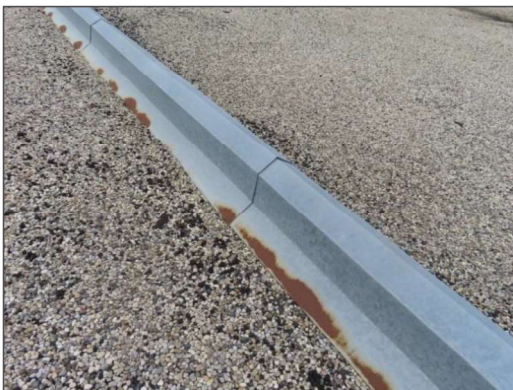
View of corroded flashing atop Section 5 of the Site Building.

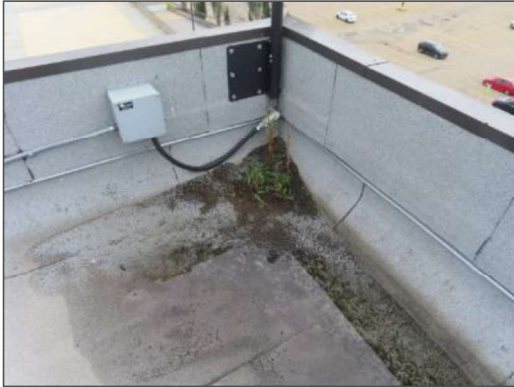
View of typical degranulation and deterioration of the modified bitumen membrane atop multiple Sections of the Site Building.

Note: Section 6 is shown.

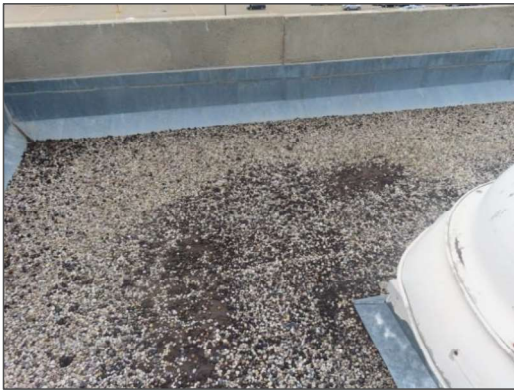
View of typical asphalt bleed through atop multiple BUR sections of the Site Building.

Note: Section 7 is shown.

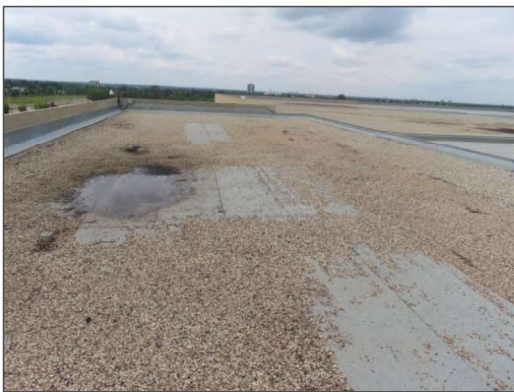
View of typical area of historic repairs atop multiple BUR sections the Site Building.

Note: Section 7 is shown.

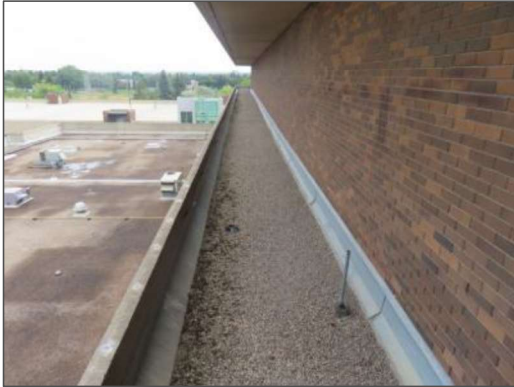
General view of a typical overhang roof area atop
Section 8 of the Site Building.

Note: Asphalt bleedthrough is noted.

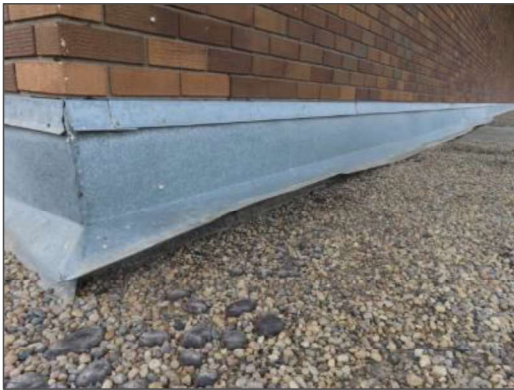
View of typical area of lifted flashing on the north
portion atop Section 8 of the Site Building.

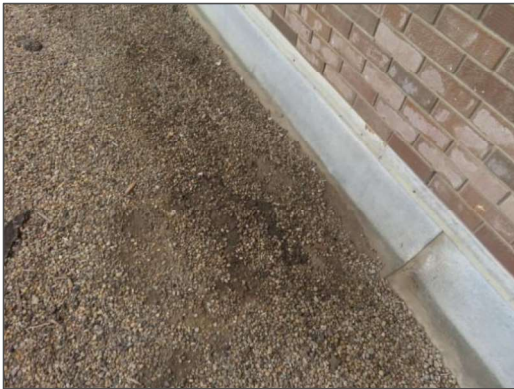
View of a blister within the BUR system of
Section 8 atop the Site Building.

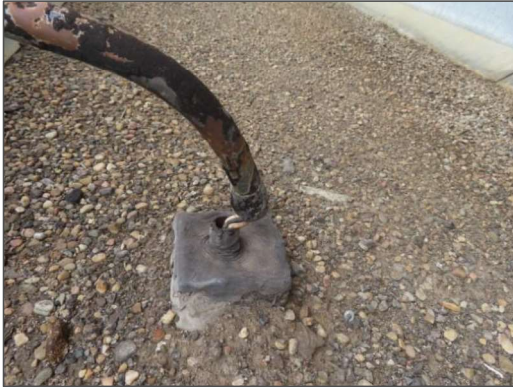
View of unsealed pitch pocket serving electrical conduit atop Section 8 of the Site Building.

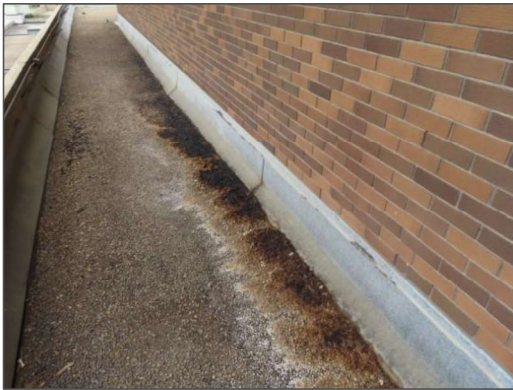
View of staining and debris accumulation atop Section 8 of the Site Building.

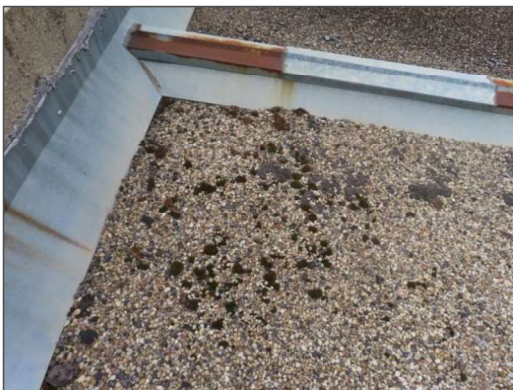
View of typical asphalt bleed through atop multiple BUR sections of the Site Building.

Note: Section 8 is shown.

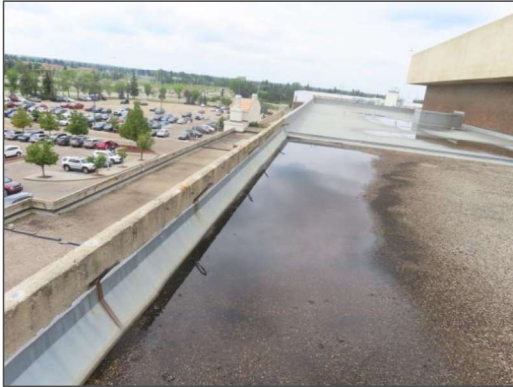
Note: Section 8 is shown.

View of typical evidence of ponding atop multiple sections the Site Building.

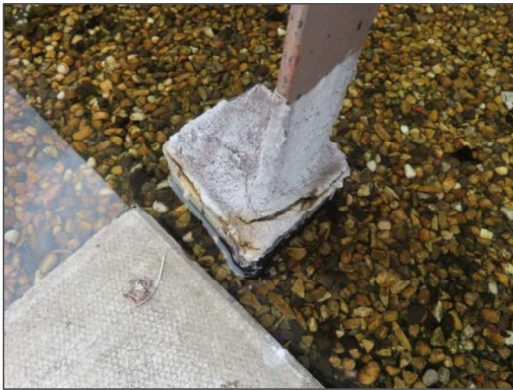
View of deteriorated pitch pocket serving the ladder footing atop Section 8 of the Site Building.

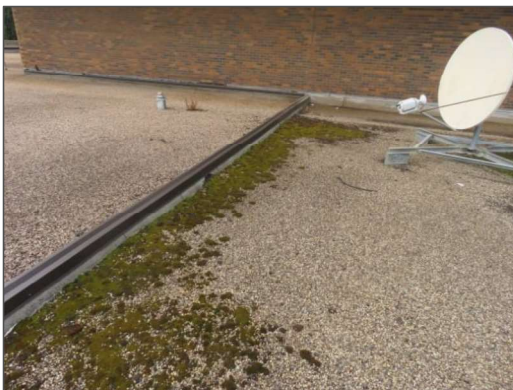
View of vegetation growth atop Section 9 of the Site Building.

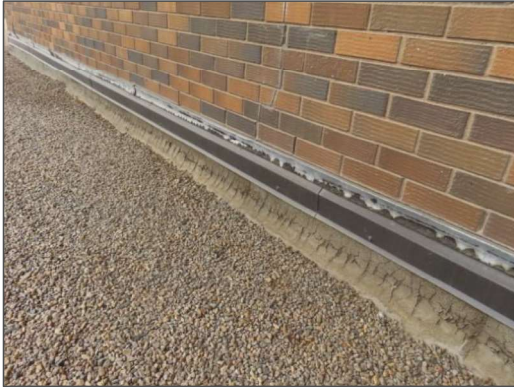
Note: Section 9 is shown.

View of typical deteriorated membrane edge atop
Sections 8 and 9 of the Site Building.

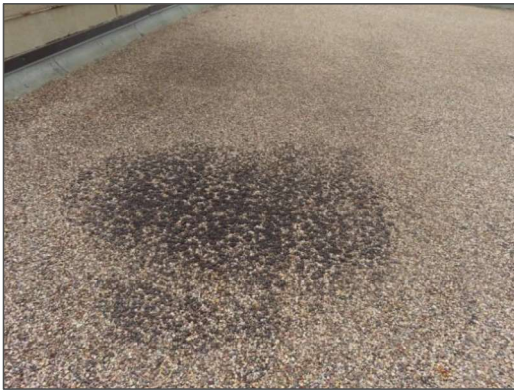
Note: Section 9 is shown.

View of typical asphalt bleed through atop
multiple BUR sections of the Site Building.

As previously mentioned, the BUR systems atop Sections 2, 5, 7, 8 and 9 the Site Building are estimated to be in excess of 25 years old and have attained their EUL. Based on estimate age and observed conditions, Pinchin recommends phased replacement of the BUR systems atop Sections 2, 5, 7, 8 and 9 of the Site Building beginning in the early portion of the term of the analysis.
