**ONTARIO
SUPERIOR COURT OF JUSTICE
COMMERCIAL LIST**

AFFIDAVIT OF PATRICK SULLIVAN

FINAL Baseline Property Condition Assessment

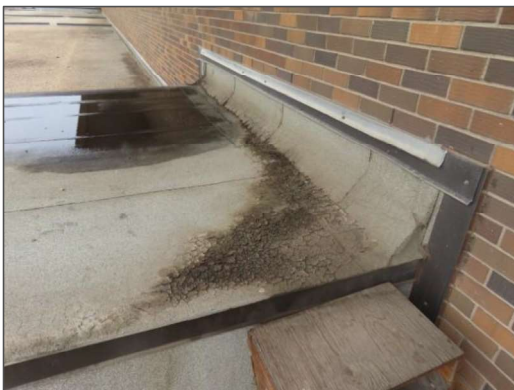
Note: Section 9 is shown

View of deteriorated and ponding atop raised
modified bitumen membrane roof system atop
Sections 8 and 9 of the Site Building.

Pinchin recommends that a higher degree of maintenance be performed on the raised modified bitumen membrane roof system atop Sections 8 and 9 of the Site Building as they will be approaching their EUL and replacement maybe required soon after the term of the analysis.

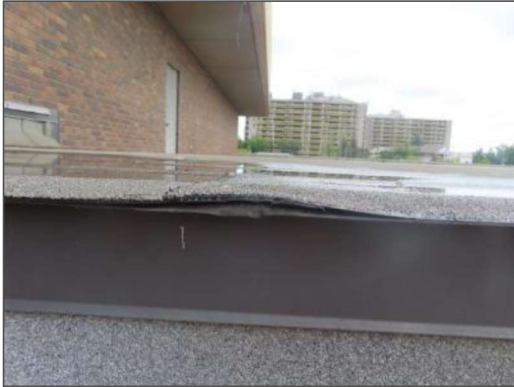
View of unadhered modified modified membrane atop raised modified bitumen membrane roof system atop Section 9 of the Site Building.

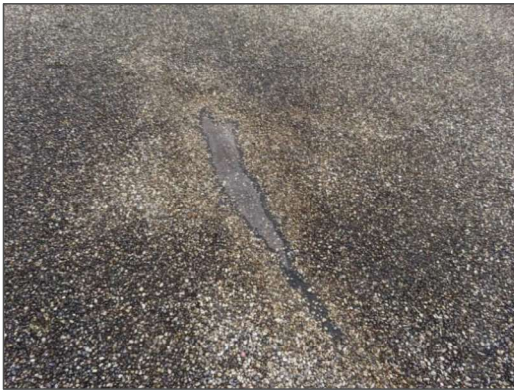
View of a blister within the BUR system of Section 9 atop the Site Building.

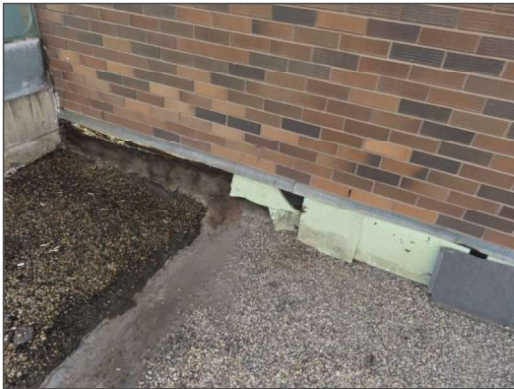
View of an area of missing insulation and lack of flashing atop Section 9 of the Site Building.

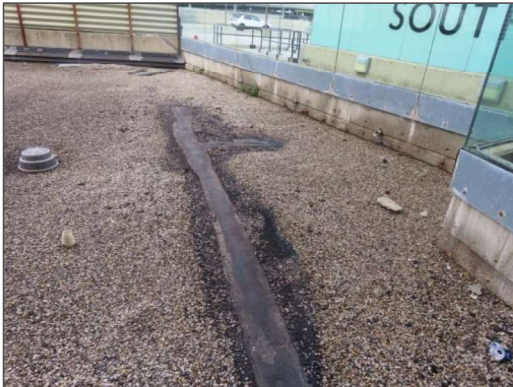
Note: Section 9 is shown.

View of typical area of historic repairs atop multiple BUR sections the Site Building.

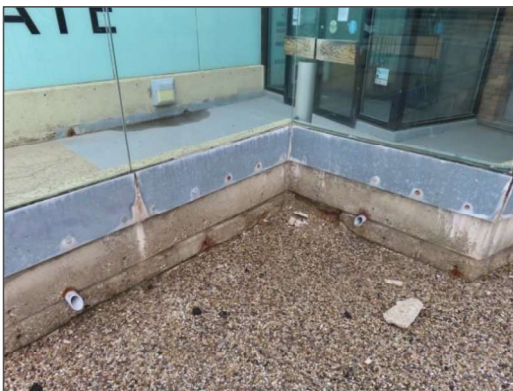
View of an area which poorly diverts water atop the northwest portion of Section 9 of the Site Building.

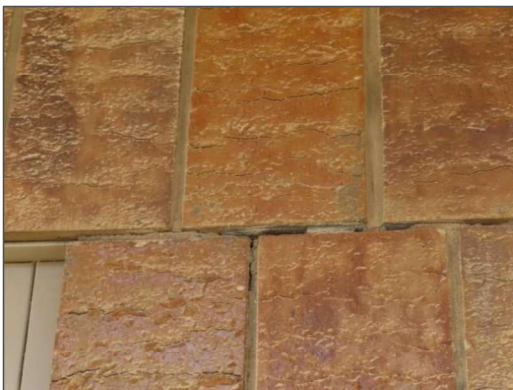
View of cracking in the ceramic tile joints on the east elevation the Site Building.

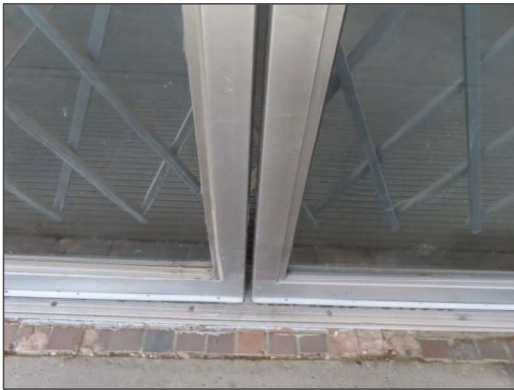
View of shrunk SG unit gasket on the east elevation the Site Building.

<ul style="list-style-type: none"> Shrunk SG unit gaskets were noted on the east and south elevations the Site Building. 	<ul style="list-style-type: none"> Replace the gaskets to prevent potential moisture infiltration.
<ul style="list-style-type: none"> Window sealant deterioration was noted on the east elevation the Site Building. 	<ul style="list-style-type: none"> Replace the deteriorated window sealants.
<ul style="list-style-type: none"> Damaged brick veneer masonry was noted on the east elevation the Site Building. 	<ul style="list-style-type: none"> Undertake localized repairs. Monitor the condition.
<ul style="list-style-type: none"> Impact damaged overhead door was noted on the south elevation the Site Building. 	<ul style="list-style-type: none"> Repair/replace the damaged overhead panels.
<ul style="list-style-type: none"> Detached weatherstripping was noted on the south elevation the Site Building. 	<ul style="list-style-type: none"> Reattach/replace the detached door weatherstripping.

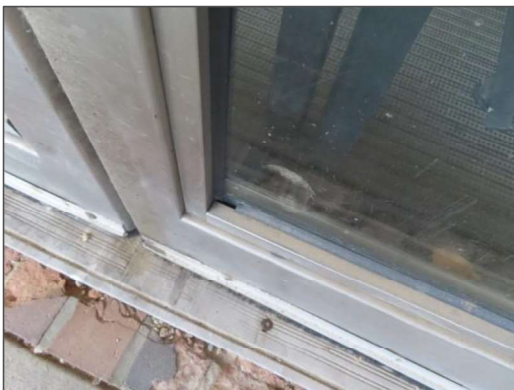
View of window sealant deterioration on the east elevation the Site Building.

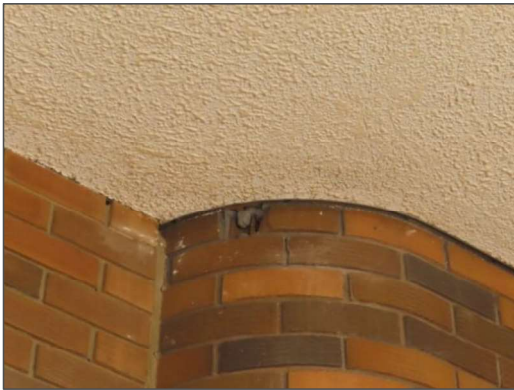
View of damaged brick veneer masonry on the east elevation the Site Building.

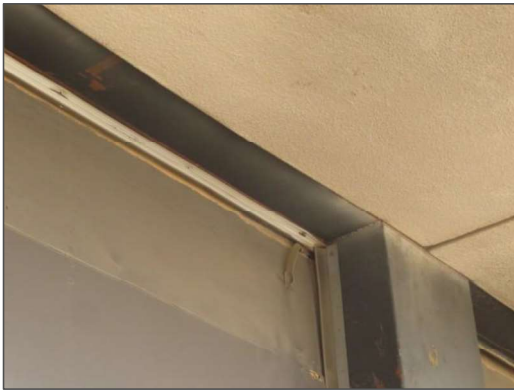
View of damaged and cracked soffit on the south elevation the Site Building.

<ul style="list-style-type: none"> Damaged and cracked soffit was noted on the south elevation the Site Building. 	<ul style="list-style-type: none"> Undertake localized repairs.
<ul style="list-style-type: none"> Damaged concrete panel was noted on the south elevation the Site Building. 	<ul style="list-style-type: none"> Undertake localized repairs.
<ul style="list-style-type: none"> Deteriorated ceramic tile finish was noted on the south elevation of the Site Building. 	<ul style="list-style-type: none"> Prepare and reapply finish as required.
<ul style="list-style-type: none"> Boarded-up door was noted on the south elevation of the Site Building. 	<ul style="list-style-type: none"> Replace the missing SG unit serving the door.
<ul style="list-style-type: none"> Detached gasket was noted on the south elevation of the Site Building. 	<ul style="list-style-type: none"> Replace the gaskets to prevent potential moisture infiltration.

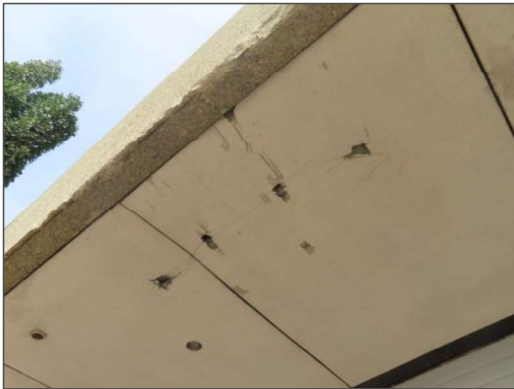
View of damaged concrete panel on the south elevation the Site Building.

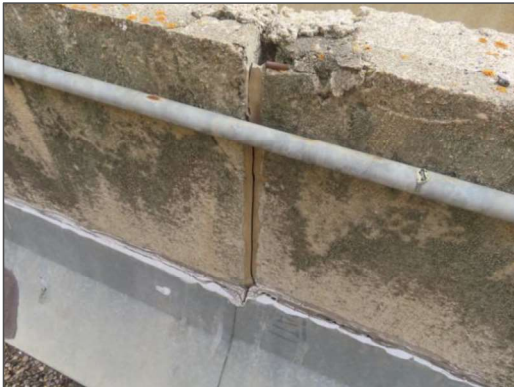
Note: South elevation is shown.

View of typical minor movement noted on precast concrete panels on multiple elevations the Site Building.

Furthermore, Pinchin recommends monitoring the precast concrete panels and to install stabilizing plates to prevent further movements. Should the condition of the precast concrete panels worsen, a specialist should be consulted to determine the extent of deterioration and implement an appropriate repair strategy. It is noted that the most estimates provided in this report are preliminary and provided only as an indication of the order of magnitude of the remedial work. More precise cost estimates would require more detailed investigation to define the scope of work

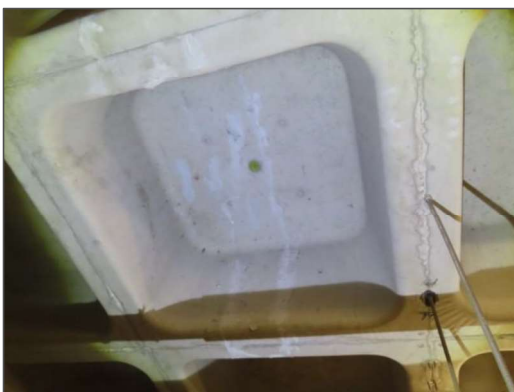
View of typical hairline cracking observed from the waffle slab observed from the main floor of the Site Building.

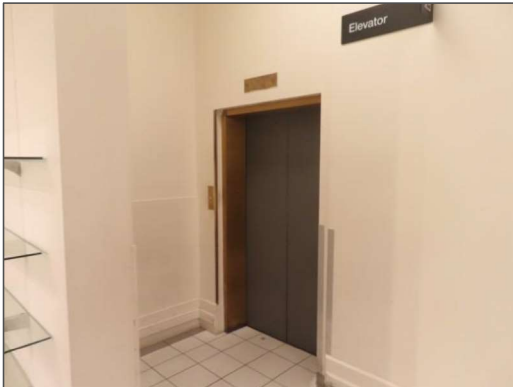
Minor Deficiencies/Findings	
<ul style="list-style-type: none">The elevator systems serving the Site Building are past due for inspection.	<ul style="list-style-type: none">Ensure the elevator systems are maintained on an all-inclusive contract in advance of new occupancy and, keep up to date logs within the elevator controller room.

General view of the elevator serving the Site Building.

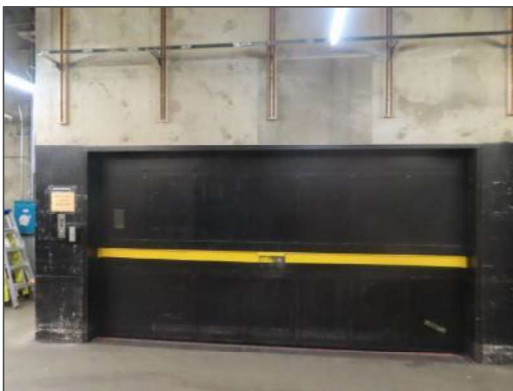
General view of the freight elevator serving the Site Building.

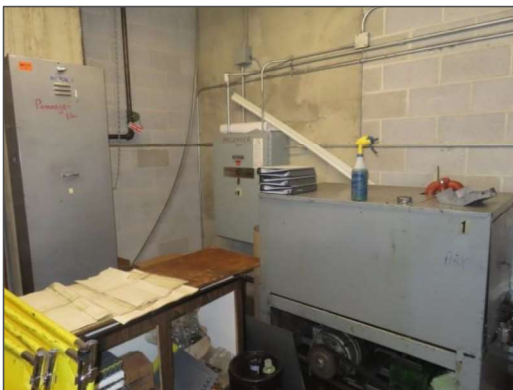
General view of the elevator controllers serving the Site Building.

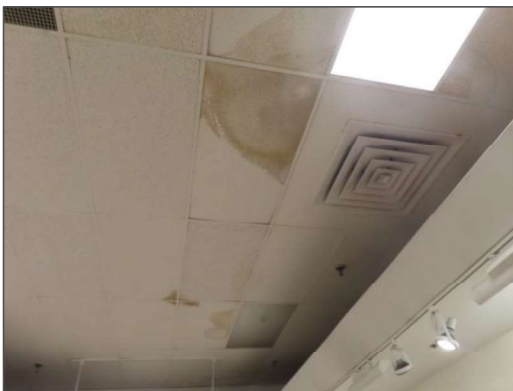
Note: Main floor is shown.

View of typical moisture stained ceiling tiles throughout the sales area of the Site Building.

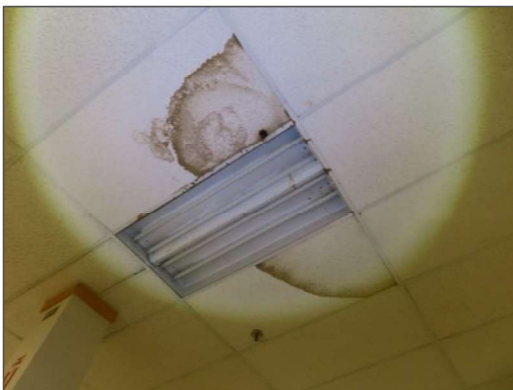
Note: 3rd floor is shown.

View of typical moisture stained ceiling tiles throughout the sales area of the Site Building.

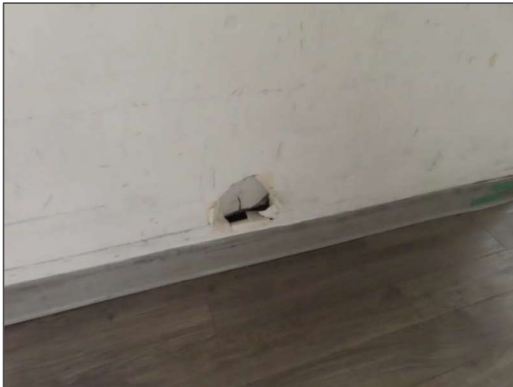
Note: Main floor is shown.

View of typical damaged gypsum board throughout the back room areas of the Site Building.

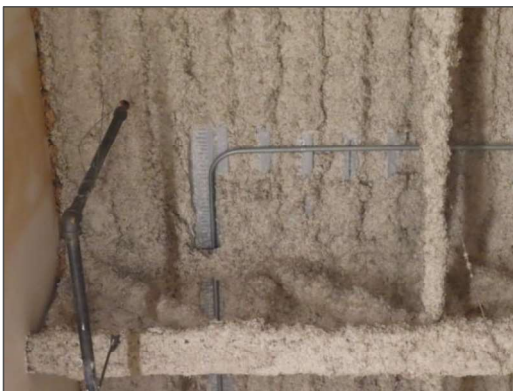
View of deteriorated fireproofing within the emergency exit stairwell of the Site Building.

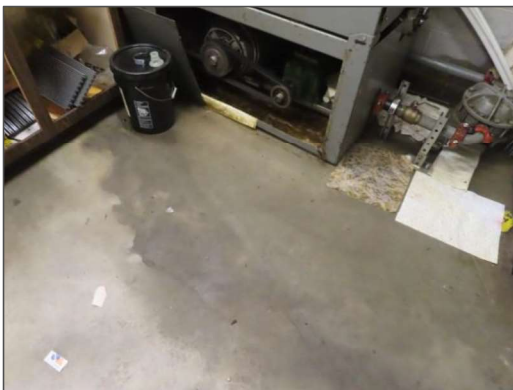
View of stained floor within the elevator controller room of the Site Building.

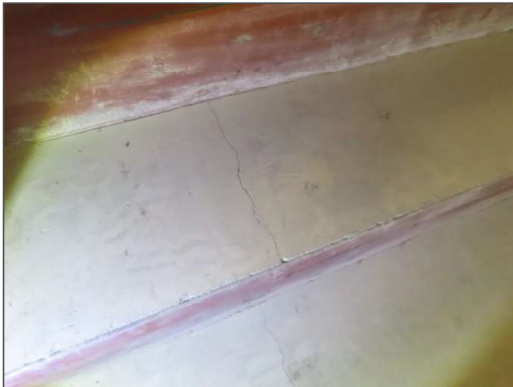
View of typical cracked concrete floor stair tread within the emergency exit stairwell of the Site Building.

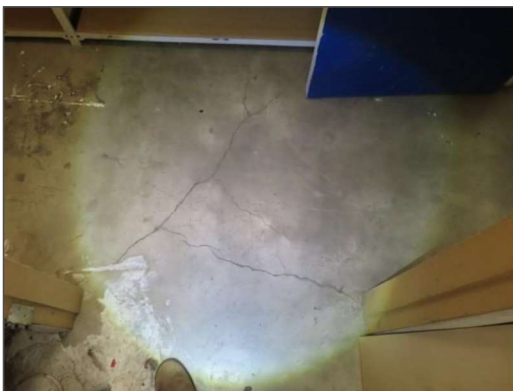
Note: Main floor back room is shown.

View of typical cracked concrete floor slab throughout the Site Building.

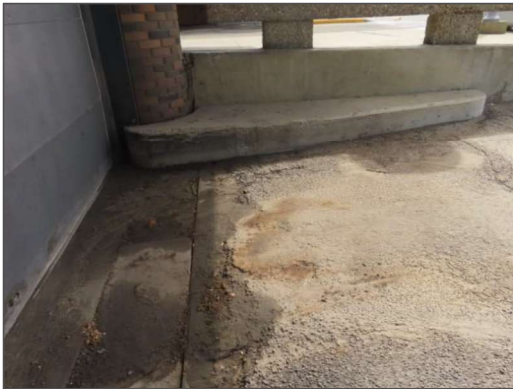
View of deteriorated asphalt surfaces adjacent to the south elevation of the Site Building.

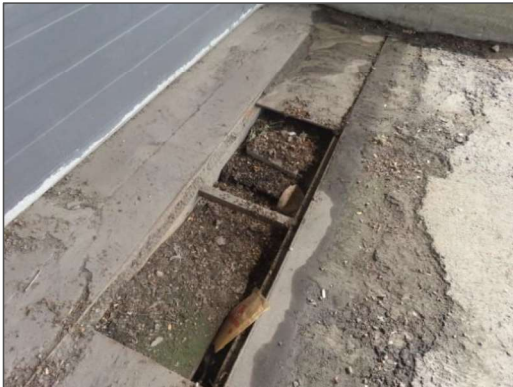
View of exposed trench with debris accumulation adjacent to the south elevation of the Site Building.

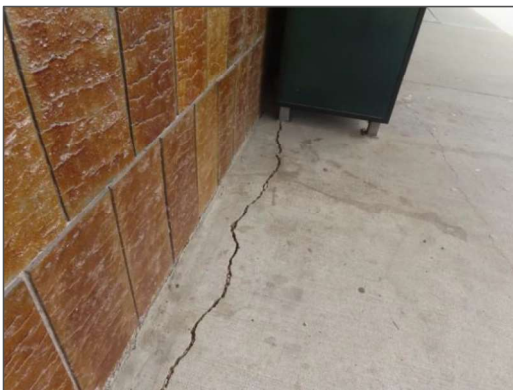
Note: Adjacent to south elevation is shown.

View of typical cracked concrete walkway adjacent to the south and east elevations of the Site Building.

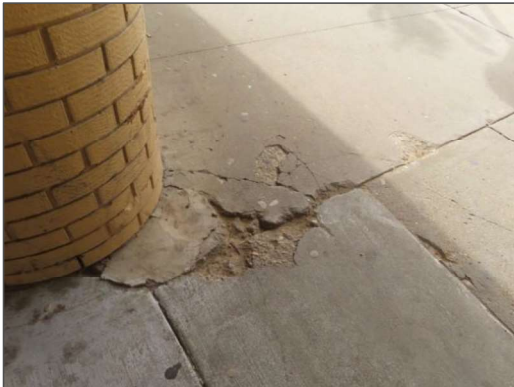
View of deteriorated concrete walkway adjacent to the south elevation of the Site Building.

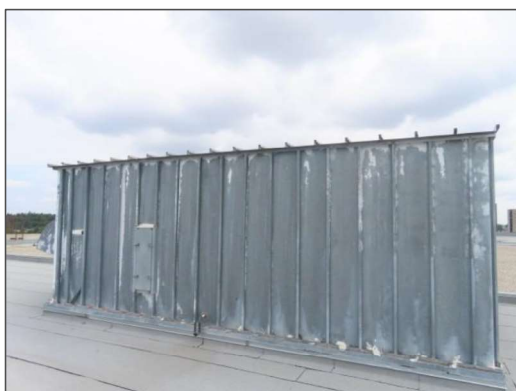
General view of the AHU compartment atop the Site Building.

As previously mentioned, the AHUs serving the Site Building are estimated to be original to construction in approximately 1969 (i.e., 56 years old) with no major reported overhauls throughout the years. Based on estimated age, Pinchin recommends replacement the AHUs throughout the term of the analysis.

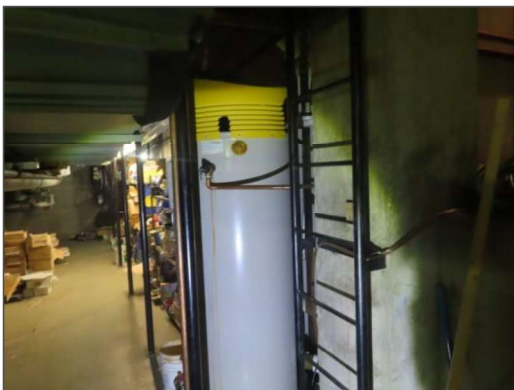
<ul style="list-style-type: none"> The DHW heating unit serving the Site Building is approximately 19 years old and has attained its EUL. 	<ul style="list-style-type: none"> Based on age, Pinchin recommends replacement of the DHW heating unit serving the Site Building within the early portion of the term of the analysis.
Minor Deficiencies/Findings	
<ul style="list-style-type: none"> The sprinkler systems and chemical fire extinguishers serving the Site Building were noted to be past due for inspection, with select fire extinguishers not mounted adequately and missing their inspection tag. 	<ul style="list-style-type: none"> Ensure the sprinkler systems and chemical fire extinguishers are inspected by a certified contractor on an annual basis and ensure inspection remains accessible and visible.

General view of the DHW heating unit serving the Site Building.

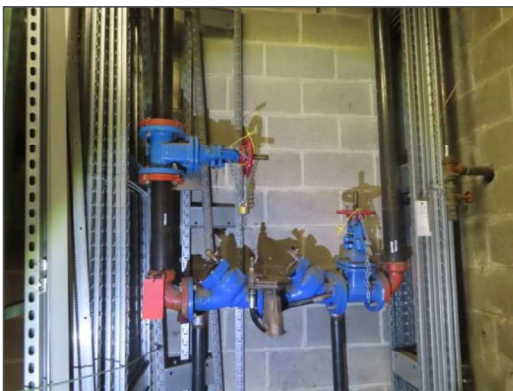
Major Deficiencies/Findings	Remarks/Recommendations
<ul style="list-style-type: none"> The backflow prevention device serving the Site Building was noted to have failed its most recent inspection. 	<ul style="list-style-type: none"> Undertake the necessary repairs to prevent further damages.
<ul style="list-style-type: none"> Corrosion and calcium build up was noted on piping fittings within the 2nd floor mechanical room of the Site Building. 	<ul style="list-style-type: none"> Undertake localized repairs/replacement at the area of corrosion/calcium build up and monitor for reoccurrence.
<ul style="list-style-type: none"> An active leaking drainage piping was noted on the third floor sales area of the Site Building. 	<ul style="list-style-type: none"> Address the leak in the short term to prevent further damages.
<ul style="list-style-type: none"> Moisture stained piping insulation observed was noted within various mechanical rooms of the Site Building. 	<ul style="list-style-type: none"> Investigate the source of the staining and undertake localized repairs.

General view of the backflow prevention device serving the Site Building.

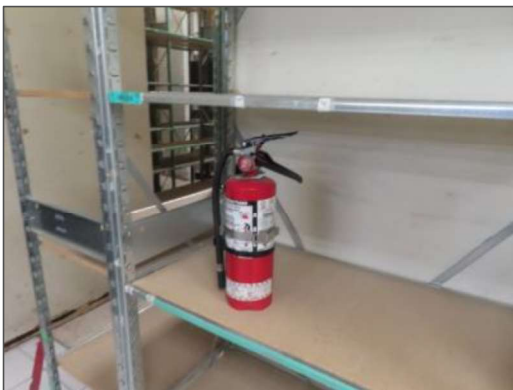
General view of a typical chemical fire extinguisher serving the Site Building.

Note: Missing an inspection tag and not adequately mounted.

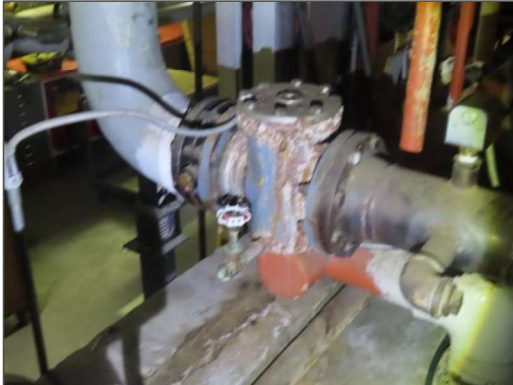
View of typical corrosion and calcium build up on piping fittings within the 2nd floor mechanical room of the Site Building.

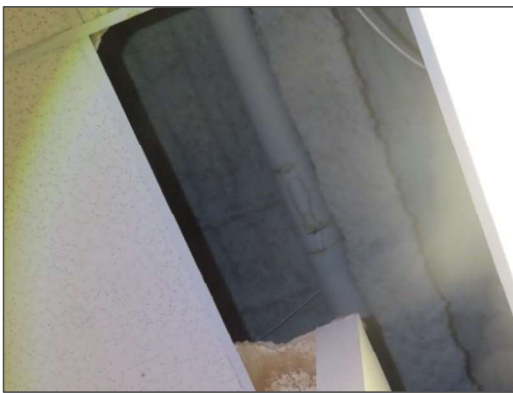
View of an active leaking drainage piping on the third floor sales area of the Site Building.

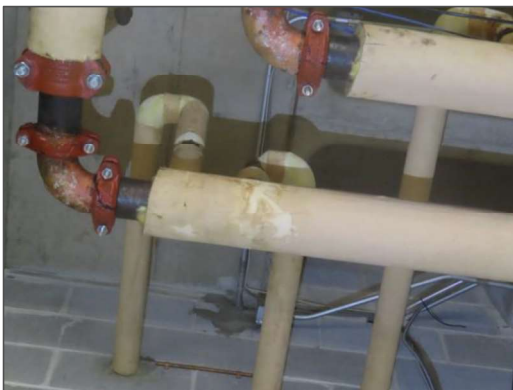
View of typical moisture stained piping insulation observed within various mechanical rooms of the Site Building.

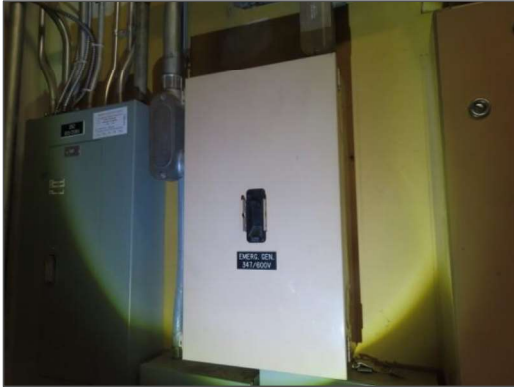
Findings	Remarks/Recommendations
Minor Deficiencies/Findings	
<ul style="list-style-type: none"> As previously mentioned, the Site Building may possess an emergency generator due to the presence of an Automatic Transfer Switch (ATS) within the main electrical room; however, it could not be located at the time of Site visit nor could the Site Representative confirm its presence. 	<ul style="list-style-type: none"> Pinchin recommends investigating the current emergency power configuration of the Site Building to gain a better understanding of potential repair/replacement requirements. It may be addressed as part of the aforementioned specialist reviews.
<ul style="list-style-type: none"> Exposed wires were noted within the kitchen area on the 2nd floor of the Site Building and atop the 2nd floor roof of the Site Building. 	<ul style="list-style-type: none"> Terminate the wires to prevent potential hazards

General view of the ATS observed within the electrical room of the Site Building.

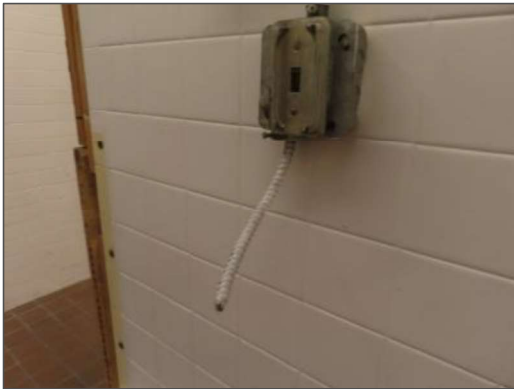
View of exposed wires within the kitchen area on the 2nd floor of the Site Building.

Due to the age of the Site Building, there may be aluminum wiring present throughout the Site Building. As a result the Owner should retain the services of a licensed electrician to review the wiring and connections throughout to ensure there are no loose connections within the Site Building.

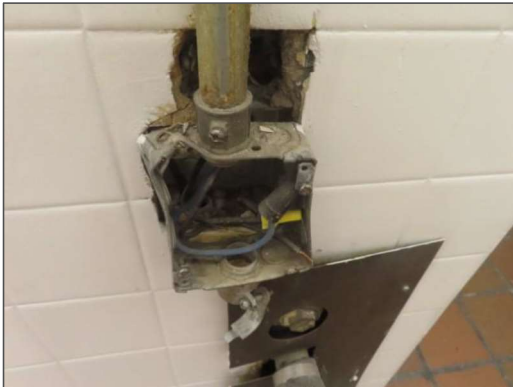
View of exposed junction box within the kitchen area on the 2nd floor of the Site Building.

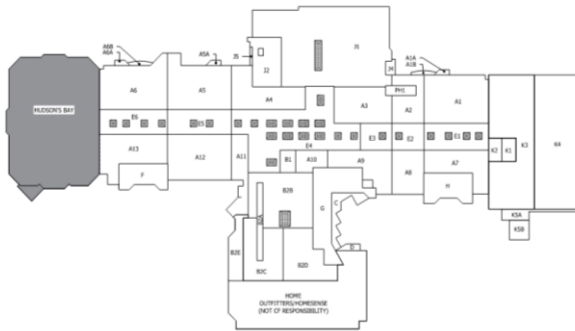
Figure 1: Roof plan showing Hudson's Bay roof at the south side of building.

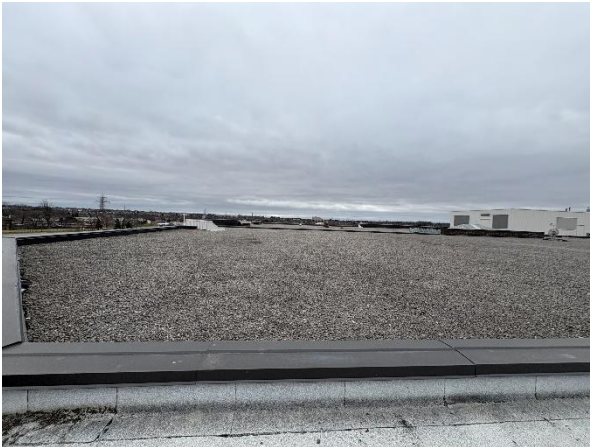
The existing roofing system is an inverted assembly, which limits the visibility of the membrane during visual inspection. Nevertheless, where visible, the roof appears to be in fair condition. Based on the estimated age, full replacement is recommended within the next ten years. An intrusive inspection is recommended to verify the age and condition of the membrane.

Figure 3: Overview of main roof area.

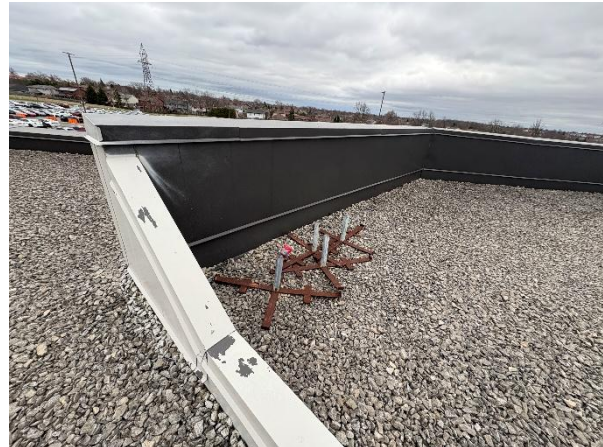
Figure 4: Debris throughout the roof to be removed.
